Contents lists available at ScienceDirect

Engineering Fracture Mechanics

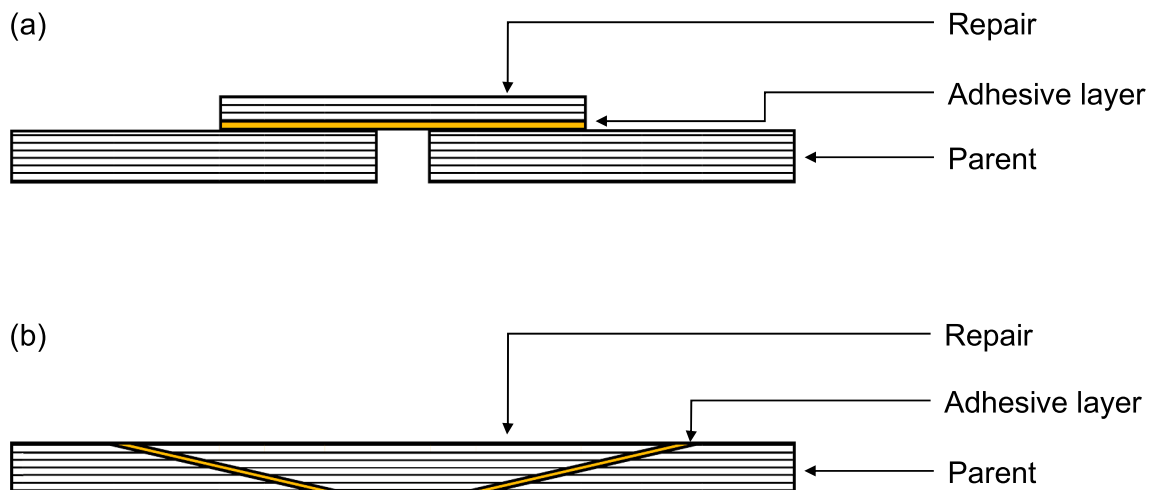
Fig. 1. Schematic of the two main types of repair configurations: (a) patch repair and (b) scarf repair.

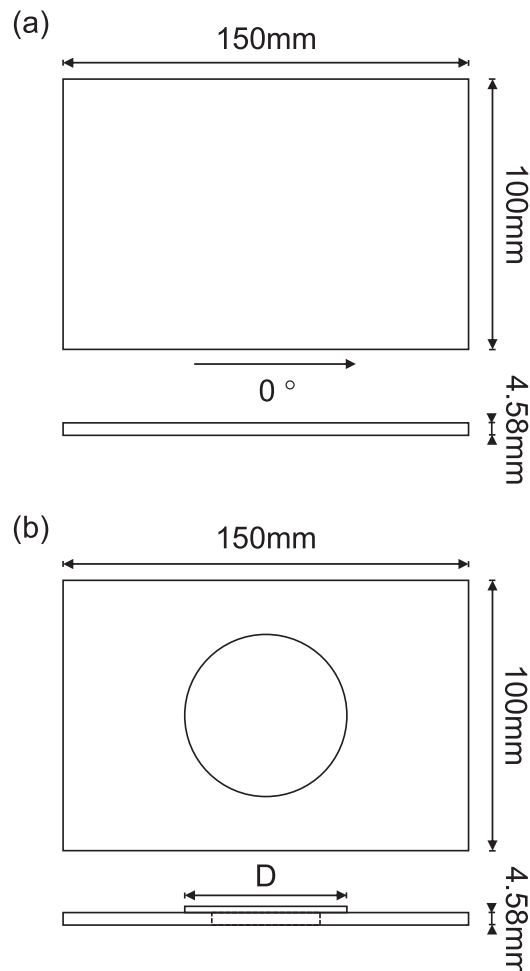
Fig. 2. Plan- and side-views of (a) the pristine panel and (b) the patch-repair CFRP panel.

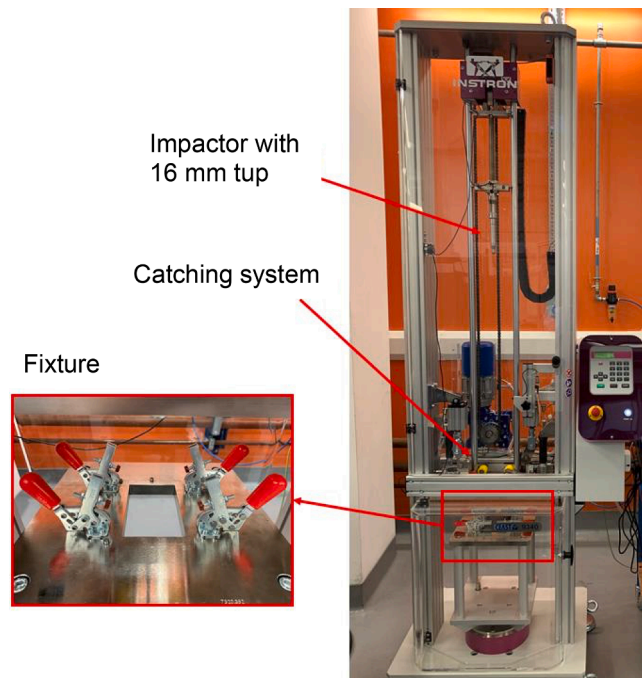
Fig. 3. Drop-weight tower set-up.

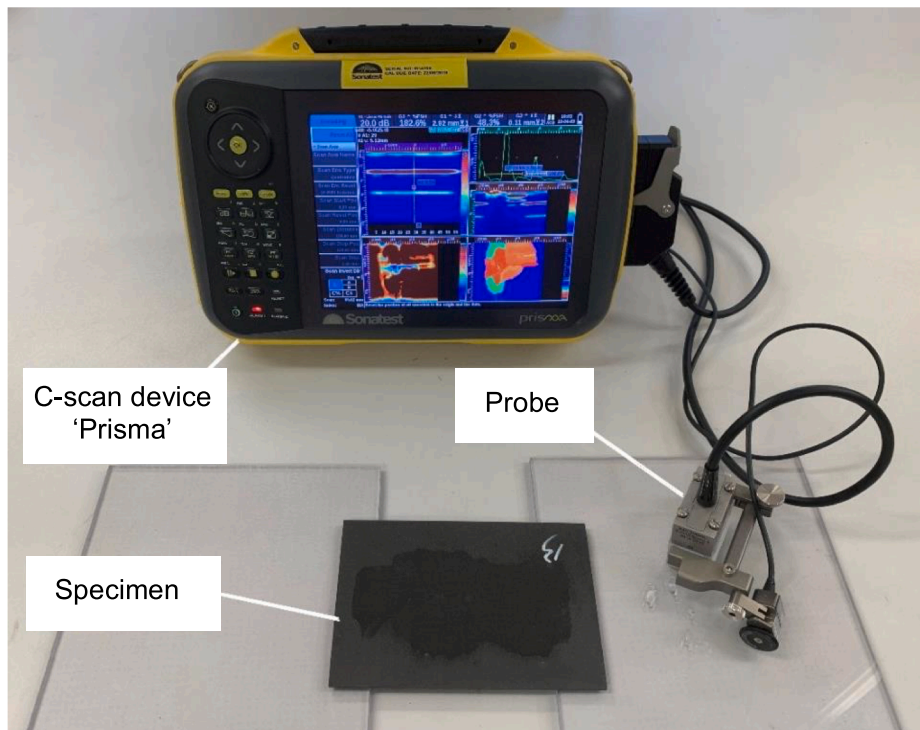
Fig. 4. Ultrasonic C-scan equipment set-up.

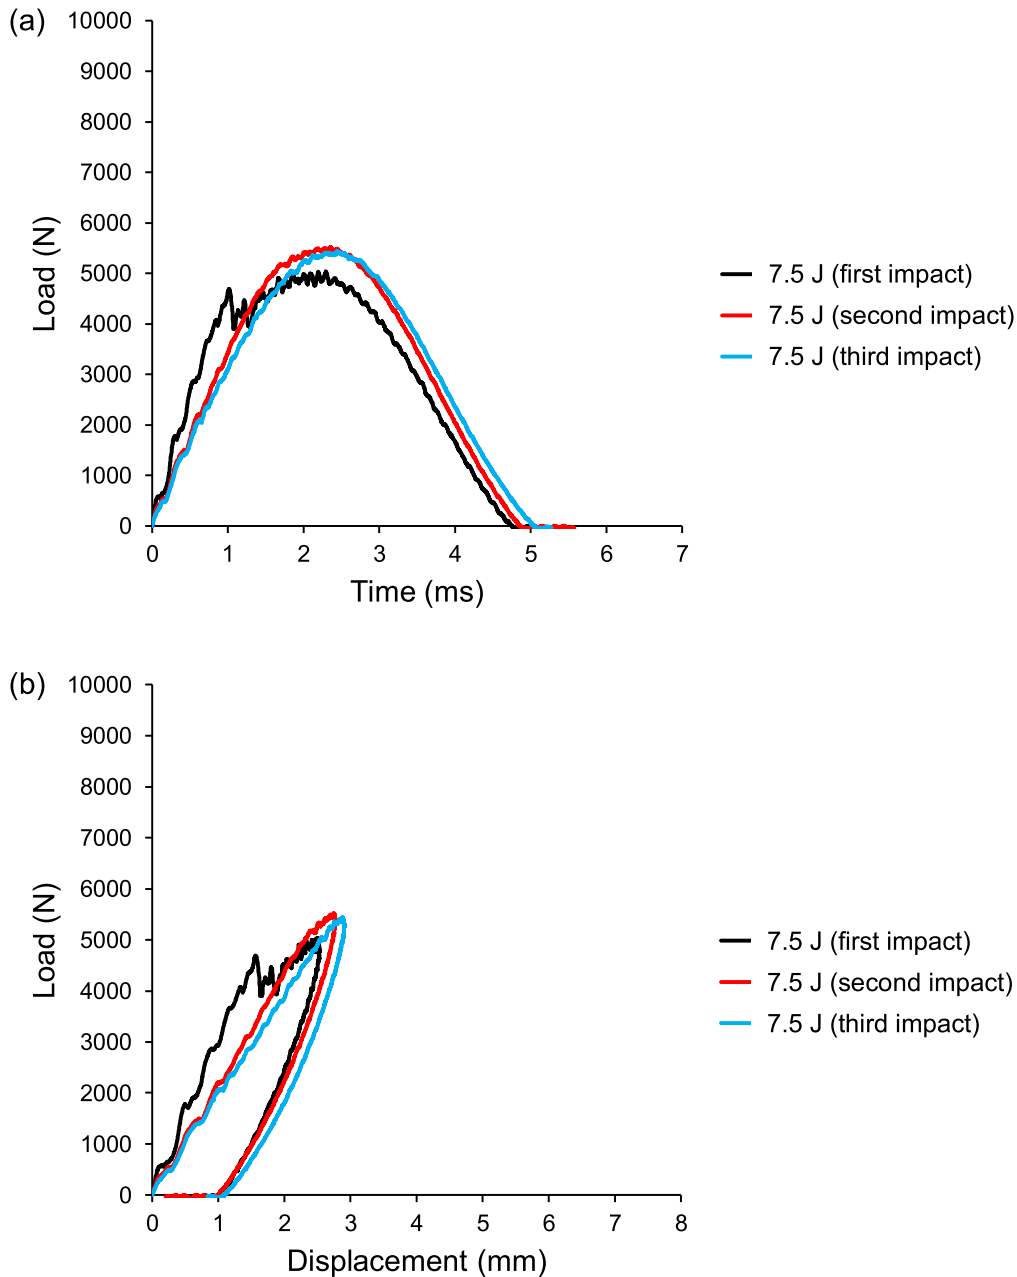
Fig. 5. Load traces for repeated, i.e. multiple, impacts on a pristine CFRP panel at 7.5 J: (a) load versus time traces and (b) load versus displacement traces.

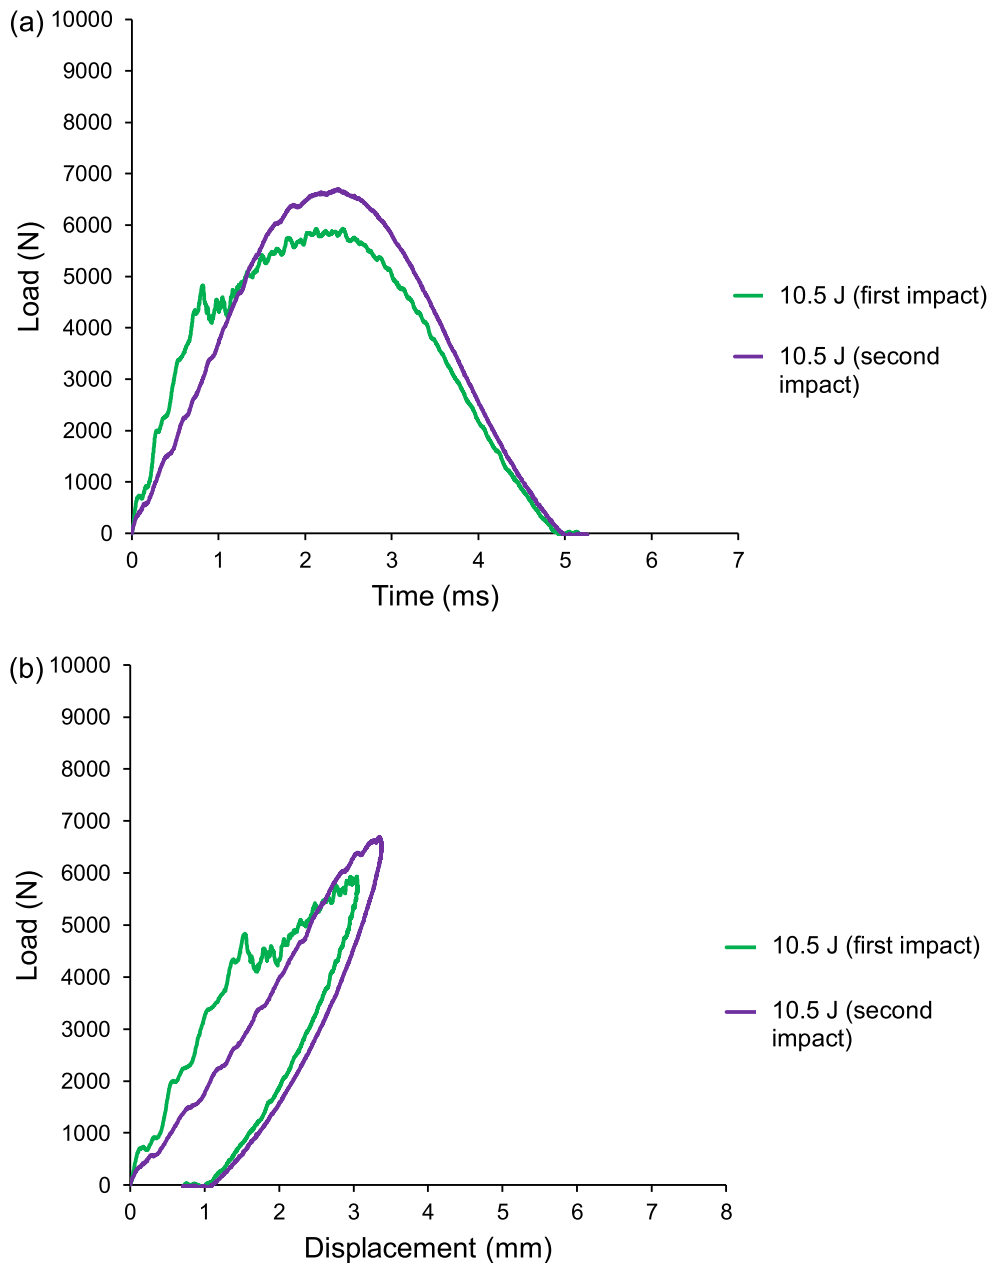
Fig. 6. Load traces for repeated, i.e. multiple, impacts on a pristine CFRP panel at 10.5 J: (a) load versus time traces and (b) load versus displacement traces.

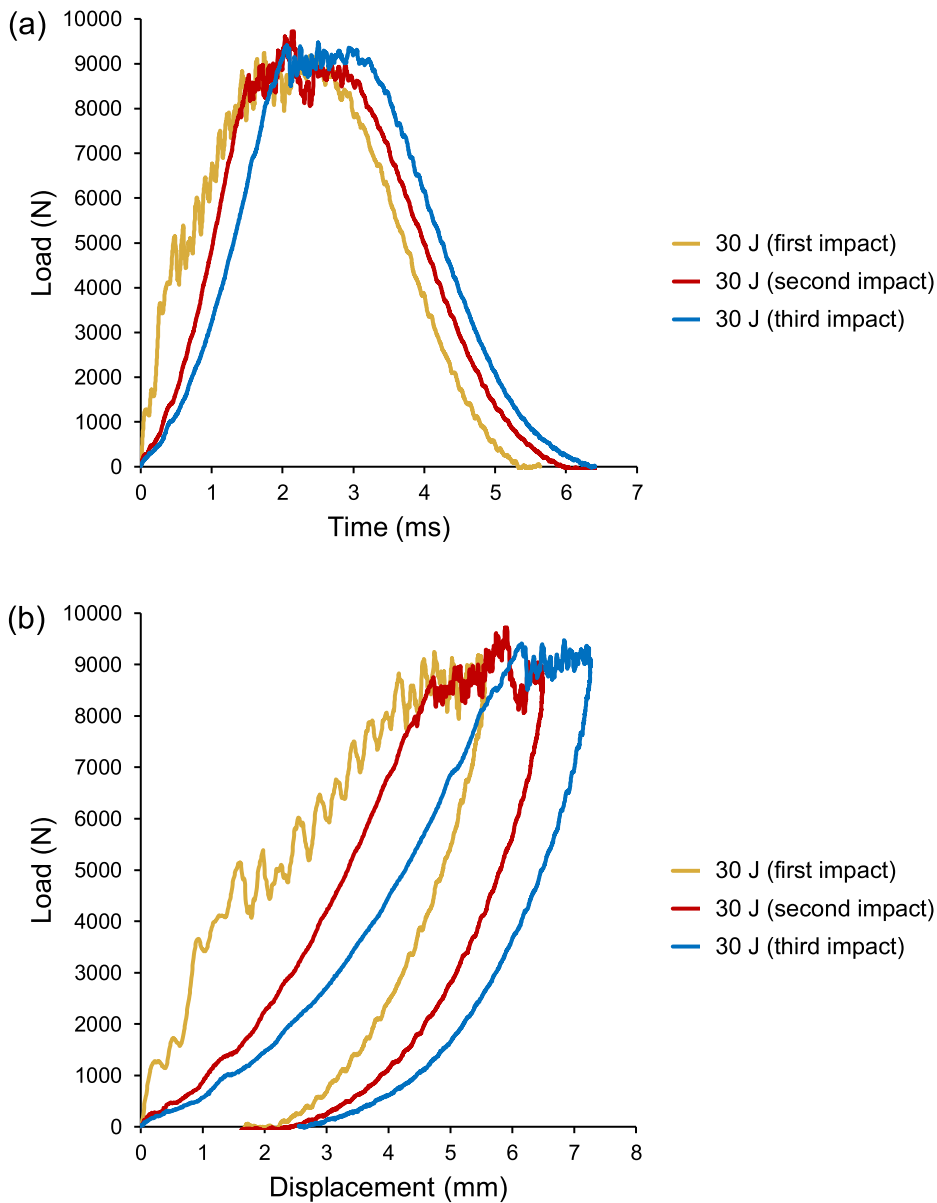
Fig. 7. Load traces for repeated, i.e. multiple, impacts on a pristine CFRP panel at 30 J: (a) load versus time traces and (b) load versus displacement traces.

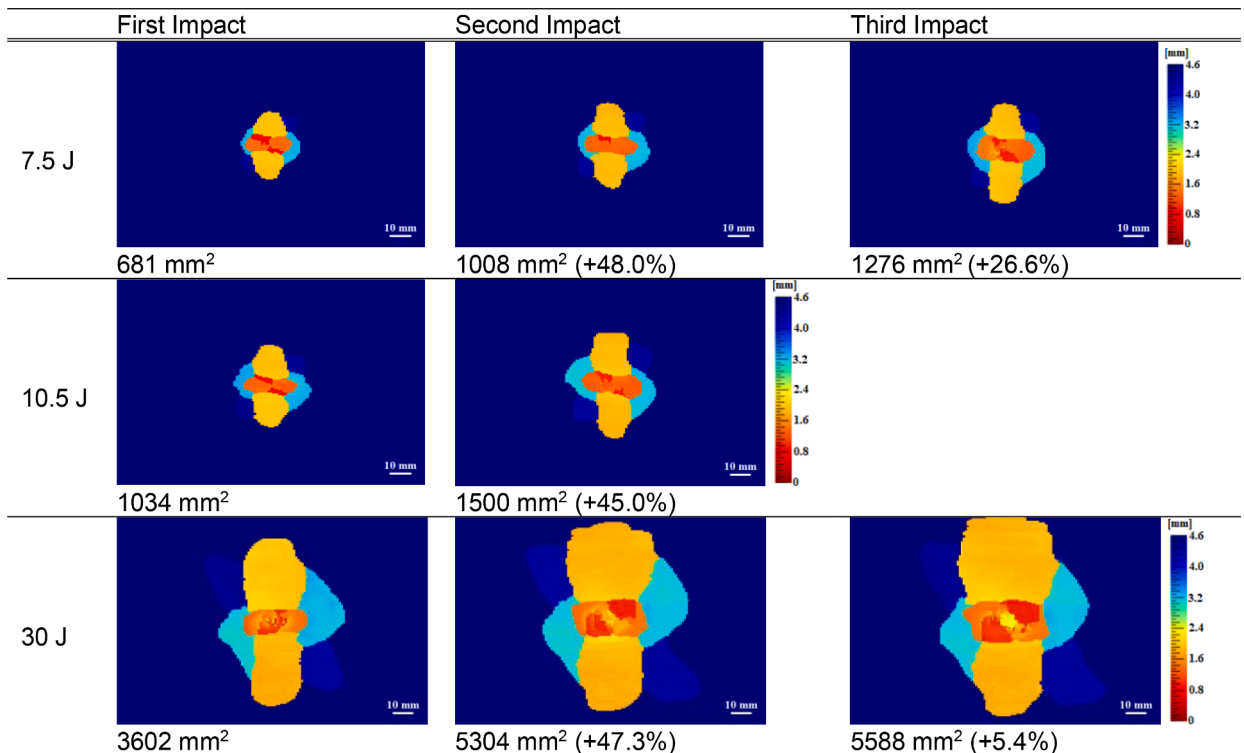
Fig. 8. C-scan images taken from the top (impacted) surface for repeated, i.e. multiple, impacts on pristine CFRP panels at various impact energies. (The scales show the depth of the different locations of the interlaminar damage. The percentage value, in brackets, is relative to the preceding impact.).

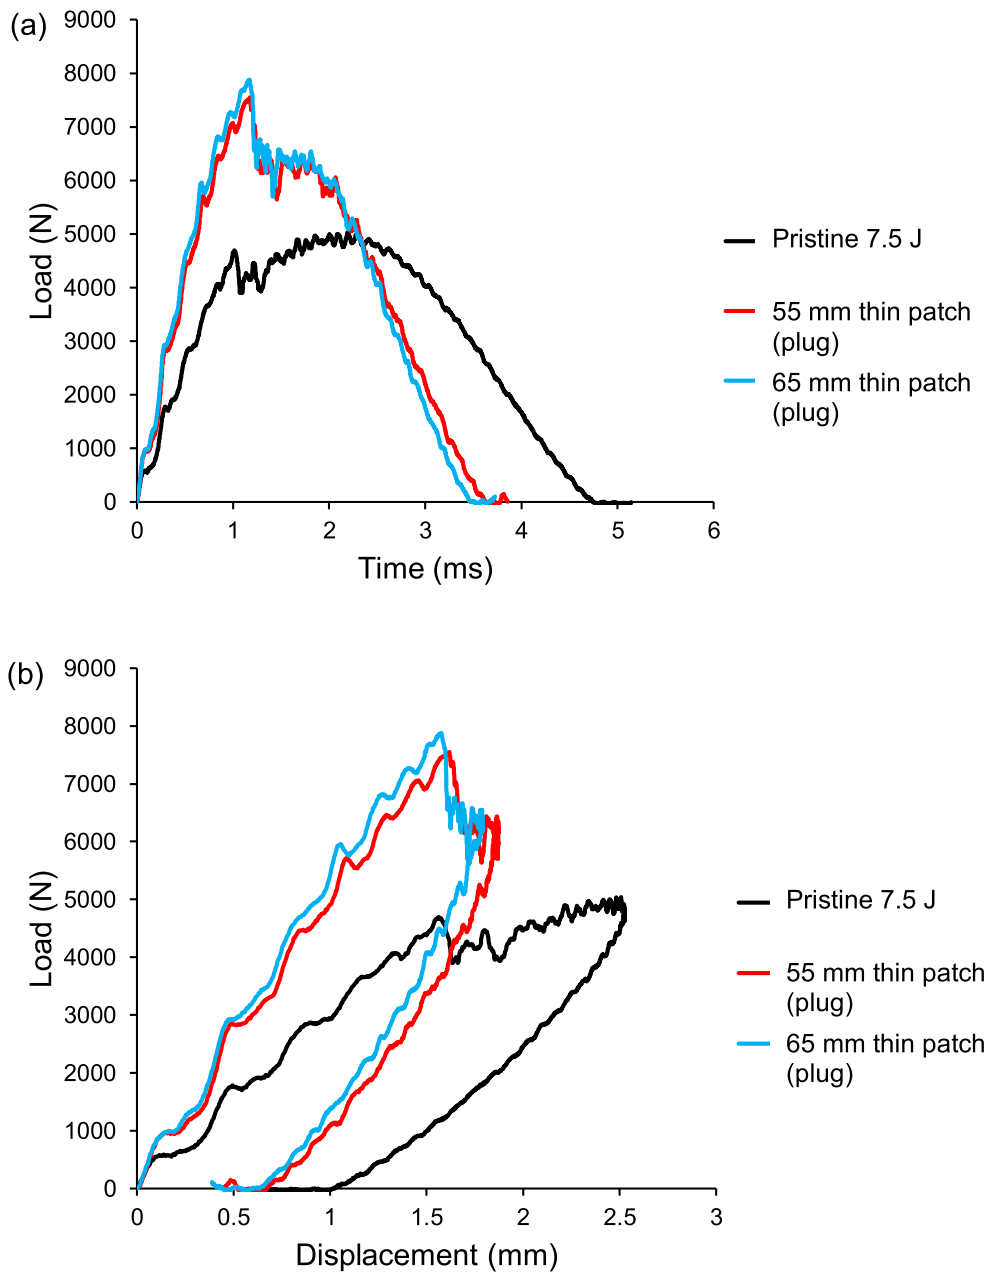
Fig. 9. Load traces for a pristine CFRP panel and 55 mm diameter and 65 mm patch-repair panels, with a CFRP plug, impacted at 7.5 J. The thickness, t , of the parent and the plug CFRP was 4.58 mm and the thickness, $0.5 t$, of the patch was 2.29 mm. Shown are the: (a) load versus time traces and (b) load versus displacement traces.

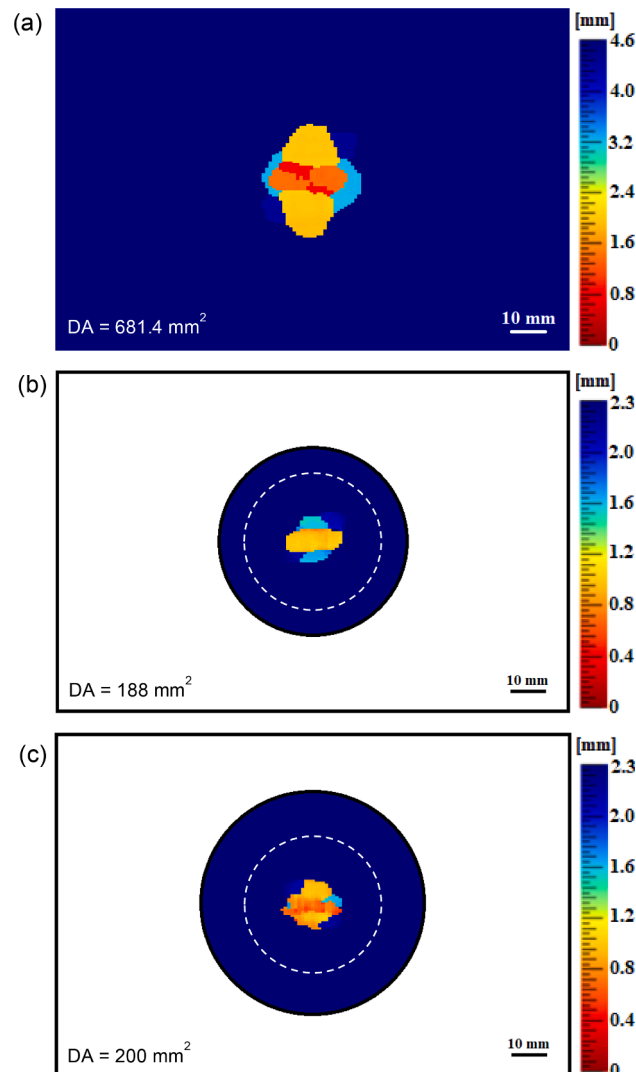
Fig. 10. C-scan images taken from the top (impacted) face after a 7.5 J impact for: (a) the pristine CFRP panel (of thickness, t , of 4.58 mm), (b) the 55 mm patch-repair CFRP panel (of patch thickness, $0.5 t$, of 2.29 mm, with a plug) and (c) the 65 mm patch-repair CFRP panel (of patch thickness, $0.5 t$, 2.29 mm, with a plug). The plug was 4.58 mm thick, i.e. the same thickness as the parent CFRP. (The white-dashed line represents the 40 mm diameter hole that was initially cut out in the parent panel.)

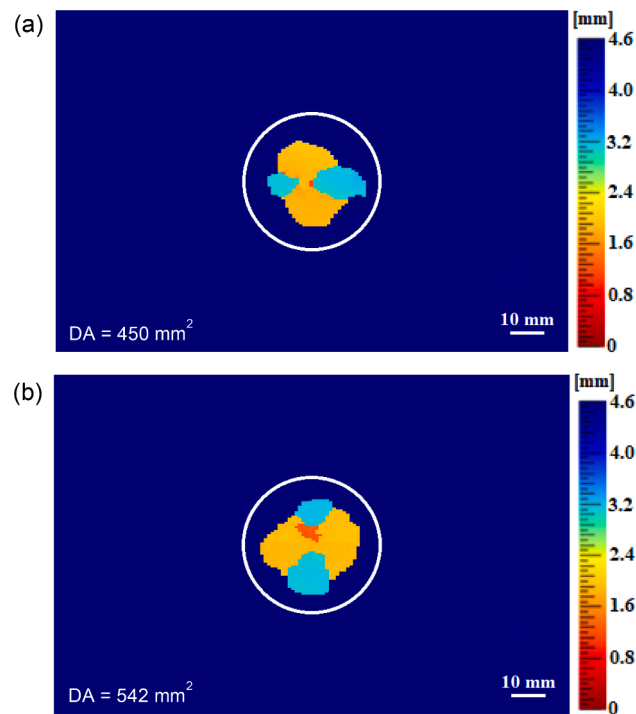
Fig. 11. C-scan images of the plug and surrounding parent composite taken from the rear (non-impacted) face of the panel after a 7.5 J impact of: (a) the 55 mm patch-repair panel (of thickness, 0.5 t, of 2.29 mm, with a plug) and (b) the 65 mm patch-repair panel (of thickness, 0.5 t, of 2.29 mm with a plug). The plug was 4.58 mm thick, i.e. the same thickness as the parent CFRP. (The solid-white line is 40 mm in diameter and represents the boundary between plug and the parent CFRP panel.)

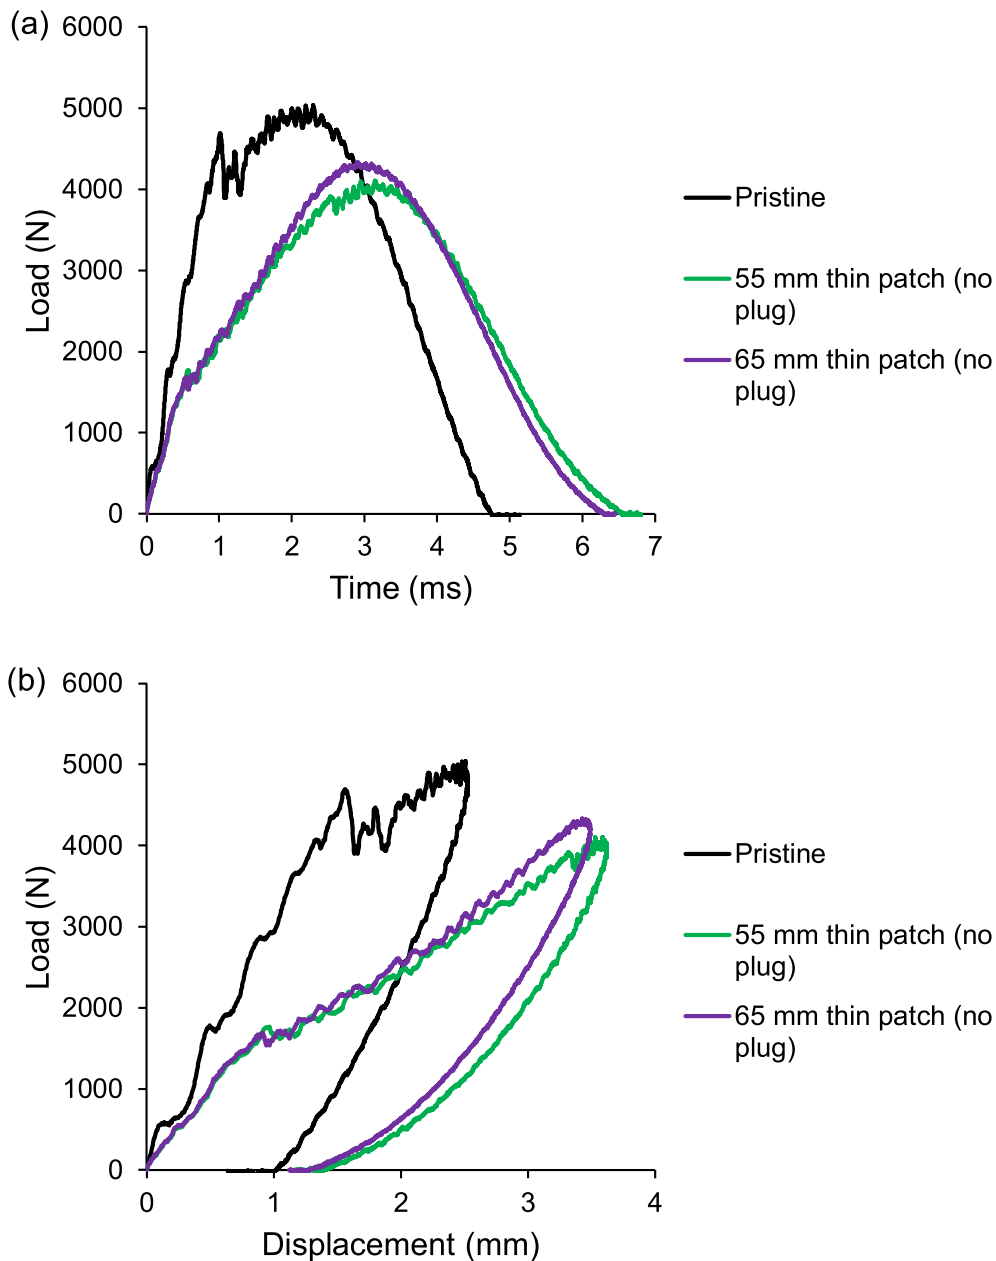
Fig. 12. Load traces for a pristine CFRP panel and 55 mm diameter and a 65 mm patch-repair panels, with no CFRP plug, impacted at 7.5 J. The thickness of the parent was 4.58 mm and the thickness of the patch was 2.29 mm. Shown are the: (a) load versus time traces and (b) load versus displacement traces.

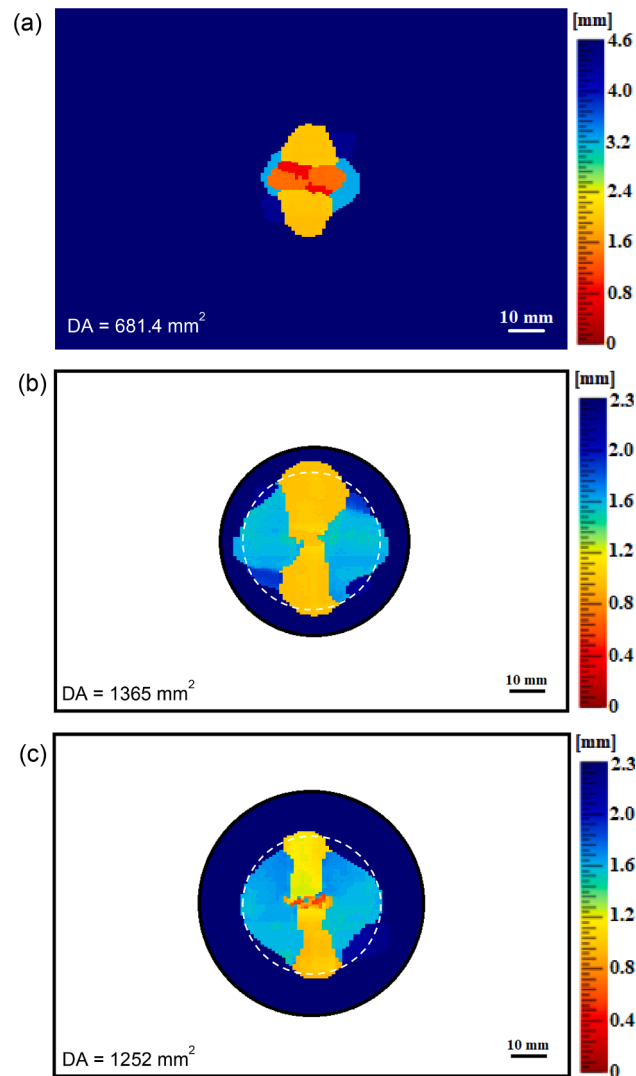
Fig. 13. C-scan images taken from the top (impacted) face after a 7.5 J impact for: (a) the pristine CFRP panel (of thickness, t , of 4.58 mm), (b) the 55 mm patch-repair panel (of patch thickness, 0.5 t , of 2.29 mm, with no plug) and (c) the 65 mm patch-repair CFRP panel (of patch thickness, 0.5 t , 2.29 mm, with no plug). The thickness, t , of the parent CFRP was 4.58 mm. (The white-dashed line represents the 40 mm diameter hole that was initially cut out in the parent panel.).

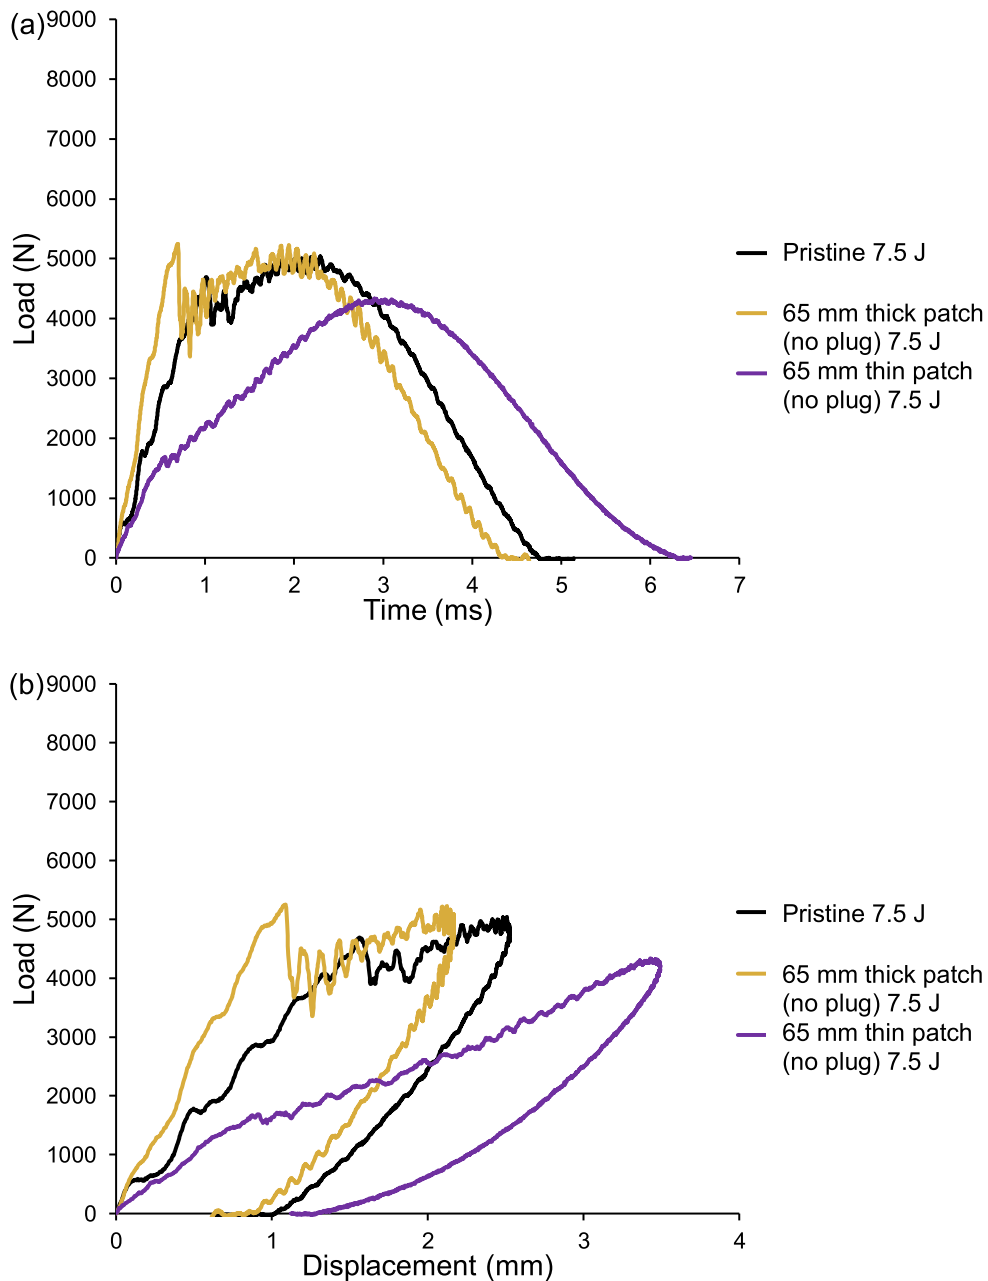
Fig. 14. Load traces for a pristine panel, a 65 mm patch-repair CFRP panel (of patch thickness, t , of 4.58 mm, with no plug) and a 65 mm patch-repair CFRP panel (of patch thickness, $0.5 t$, of 2.29 mm, with no plug). Both patch-repair panels were impacted at 7.5 J. Shown are the: (a) load versus time traces and (b) load versus displacement traces.

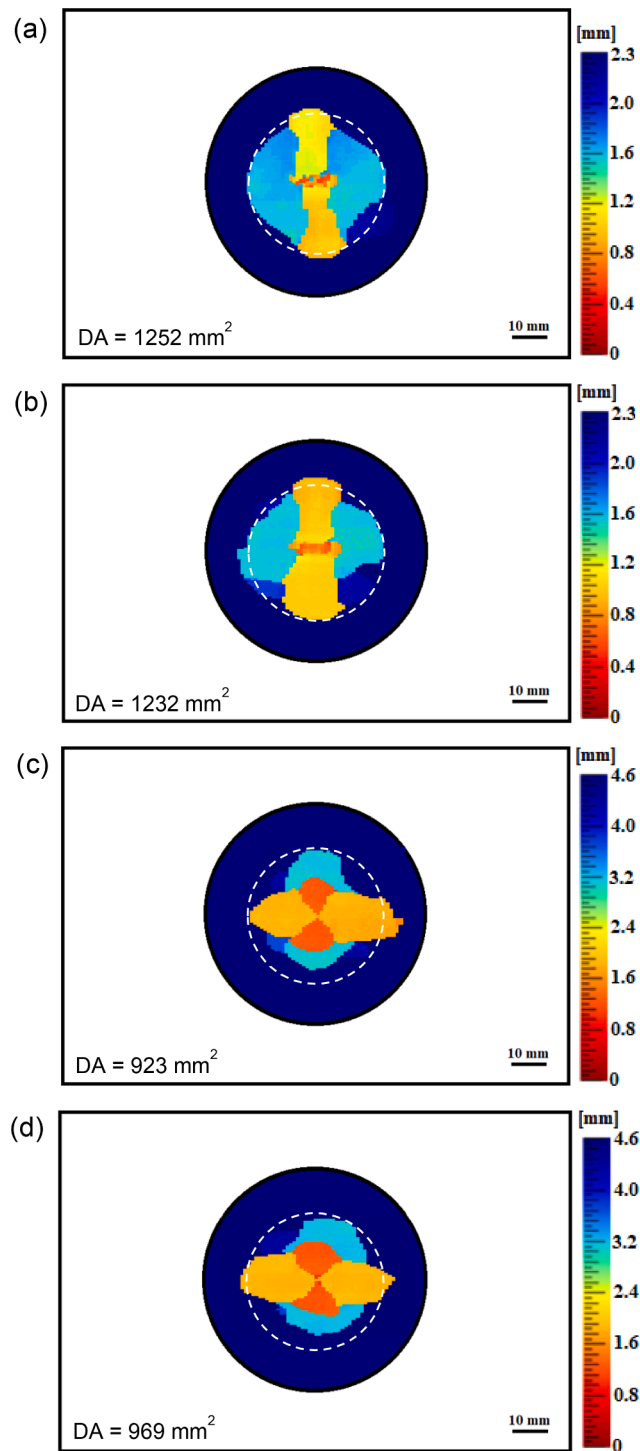
Fig. 15. C-scan images of patch-repair CFRP panels with no plugs taken from the top (impacted) face after a 7.5 J impact for: (a) the 65 mm thin ($0.5 t = 2.29$ mm) patch repair – Test 1, (b) the 65 mm thin ($0.5 t = 2.29$ mm) patch repair – Test 2, (c) the 65 mm thick ($t = 4.58$ mm) patch repair – Test 1, and (d) the 65 mm thick ($t = 4.58$ mm) patch repair – Test 2. (Tests 1 and 2 are duplicate tests. The white-dashed line represents the 40 mm diameter hole that was initially cut out in the parent panel.).

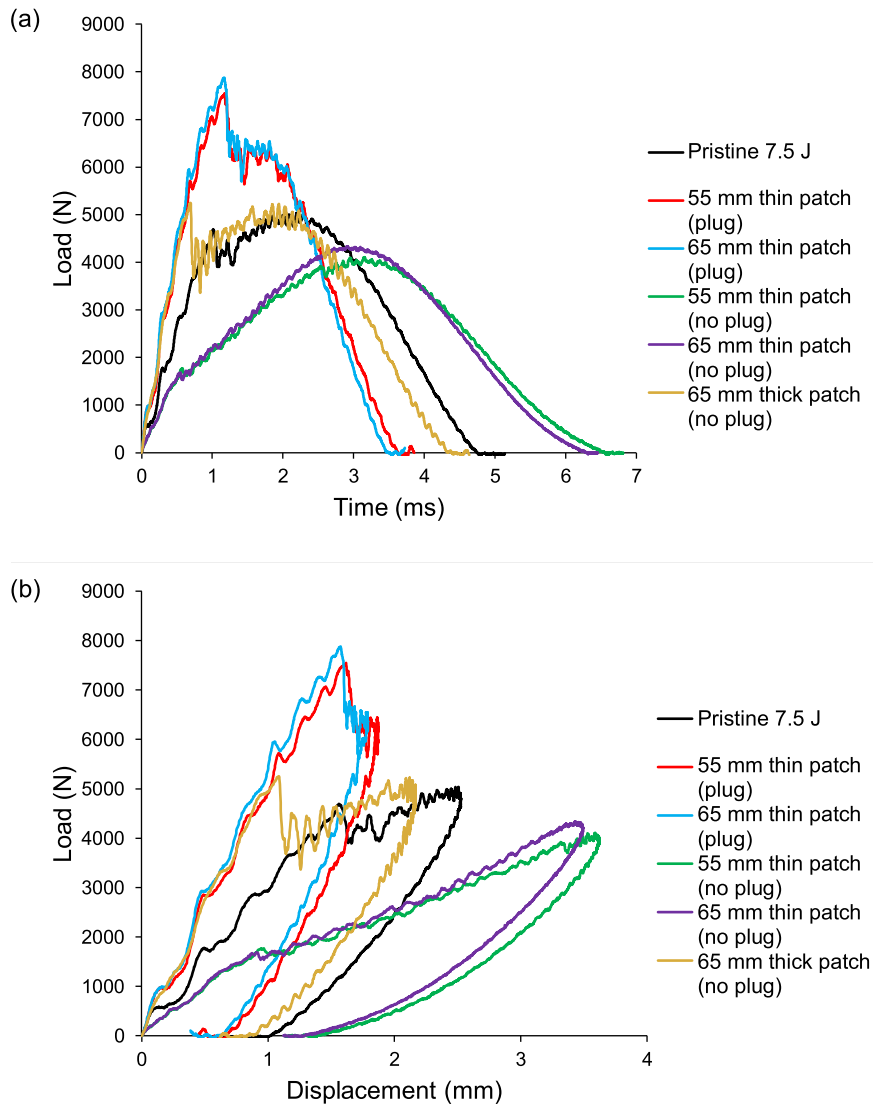
Fig. 16. Load traces for the pristine panel, the 55 mm diameter thin ($0.5 t = 2.29$ mm) patch-repair panel with a plug, the 65 mm diameter thin ($0.5 t = 2.29$ mm) patch-repair panel with a plug, the 55 mm thin ($t = 2.29$ mm) patch-repair panel with no plug, the 65 mm thin ($0.5 t = 2.29$ mm) patch-repair panel with no plug and the 65 mm thick ($t = 4.58$ mm) patch-repair panel with no plug. All impacted at 7.5 J: (a) load versus time traces and (b) load versus displacement traces.

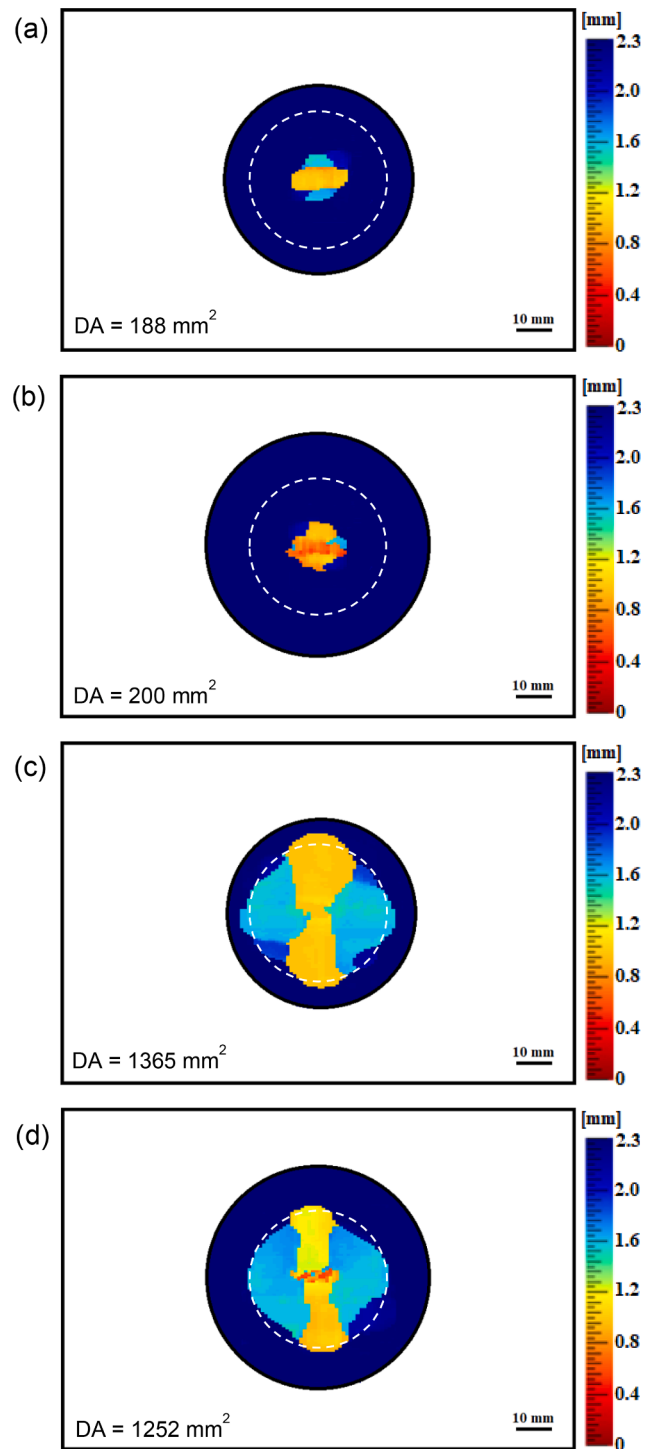
Fig. 17. C-scan images of patch-repair CFRP panels taken from the top (impacted) face after 7.5 J impact for: (a) the 55 mm diameter thin ($0.5 t = 2.29$ mm) patch-repair CFRP panel with a plug present, (b) the 65 mm diameter thin ($0.5 t = 2.29$ mm) patch-repair CFRP panel with a plug present, (c) the 55 mm diameter thin ($0.5 t = 2.29$ mm) patch-repair CFRP panel with no plug present and (d) the 65 mm diameter thin ($0.5 t = 2.29$ mm) patch-repair CFRP panel with no plug present. (The white-dashed line represents the 40 mm diameter hole that was initially cut out in the parent panel.).
