Performance of industrial buildings during the Emilia earthquakes in Northern Italy and recommendations for their strengthening

Dionysios A. Bournas · Paolo Negro · Fabio F. Taucer

Abstract A series of earthquakes, the highest of magnitude M_w 5.9, hit a portion of the Po Valley in Northern Italy, which was only recently classified as seismic. The paper reports the findings and the lessons learnt from a preliminary field survey which was conducted immediately after the second event. As a result of the economic attitude of the affected area, and possibly of the characteristics of the event, an unprecedented number of industrial precast buildings were affected, resulting into most of the casualties as well as in large economic losses. Whereas most of the damaged and collapsed buildings were designed for gravity loads only, evidence of poor behavior of some precast buildings designed according to seismic provisions were discovered. The paper provides a description of the performance of precast buildings, highlighting the deficiencies that led to their poor behavior as well as some preliminary recommendations.

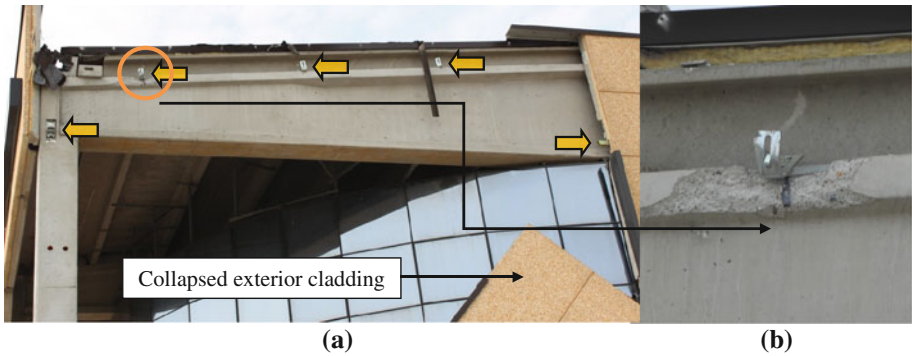
Figure 15a illustrates the in-plane detachment of an exterior cladding element after failure of the connections (Fig. 15b) with the main structure. Similarly, the excessive drifts which were experienced by the precast building in Fig. 16 exhausted the displacement capacity of the connections of the panels, leading to the development of high forces that led to failure of the connections and unseating of the horizontal panel.

Fig. 15 **a** Cladding panel collapse after failure of the connections with the main structure (*orange arrows* showing the location of connections of the collapsed exterior cladding); **b** detail showing failure of the mechanical connection

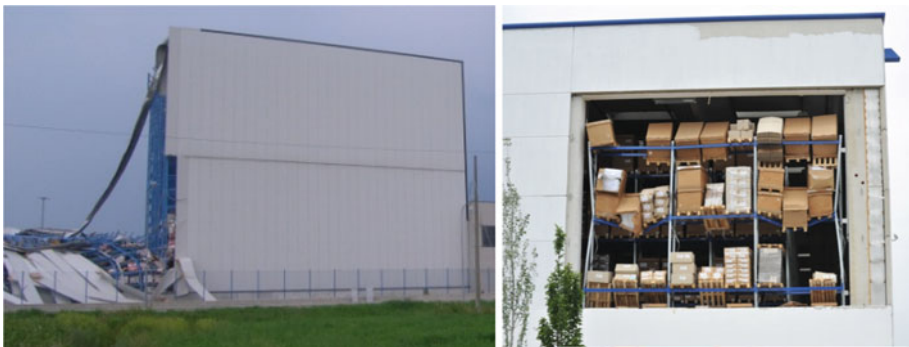
Finally, in some industrial buildings the failure of steel racking systems, especially very tall ones (in excess of 10 m), was observed, with important economic consequences. In some cases, their large mass and the resulting high inertia forces developed during the earthquake induced ramming and consequent collapse of exterior cladding (Fig. 19).

Fig. 19 Collapse and local failures attributed to the failure of rack systems

The field visit revealed that the large flexibility of tall storage racks led to hammering against the main structure and the concrete claddings, which ultimately caused their failure. The provisions for the design of a racking system should exclude the possibility of attaching the steel racks to the structure or to the claddings, and adequate clearances should be provided to exclude the likelihood of hammering.

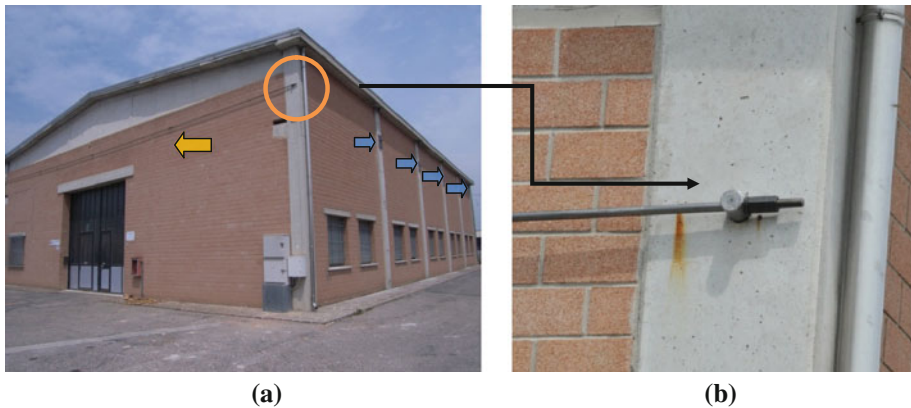
Fig. 20 **a** Steel ties anchorage system installed after the main event to stabilize the structure: *orange arrow* showing the external tie, *blue arrows* showing the internal ties. **b** Detail of the anchorage at the external tie

During the field visit the team inspected a precast industrial building that had been retrofitted following the first event (after information gathered from the building owner). The building corresponded to the typology with simply supported beams on columns designed for gravity loads only. The retrofit consisted in a series of steel ties in line and below the main girders, as shown in Fig. 20. The steel ties were anchored at the top of the columns in the transverse direction and might have prevented opening of the columns and loss of seating of the girder during the 29 May event.
