The May 25th 2011 Railroad Embankment Failure in Ann Arbor, Michigan, As a Means for Teaching Geotechnical Engineering

ABSTRACT: A 30-m long railroad embankment failure that occurred on May 25 2011 in the city of Ann Arbor, Michigan, is presented. Emphasis is given on the field observations of the failure, the characterization of the site conditions and the seepage and slope stability analyses, all of which represent important components of the training and practice of a geotechnical engineer. The failure occurred following a record wet season that resulted in ponding water against the embankment and high enough water pressures and exit gradients that resulted in instability of the railroad embankment. Detailed background material and the methodology for using the case history in geotechnical engineering education are presented.

International Journal of Geoengineering Case histories, Vol.3, Issue 4, p.234-245. doi: 10.4417/IJGCH-03-04-03

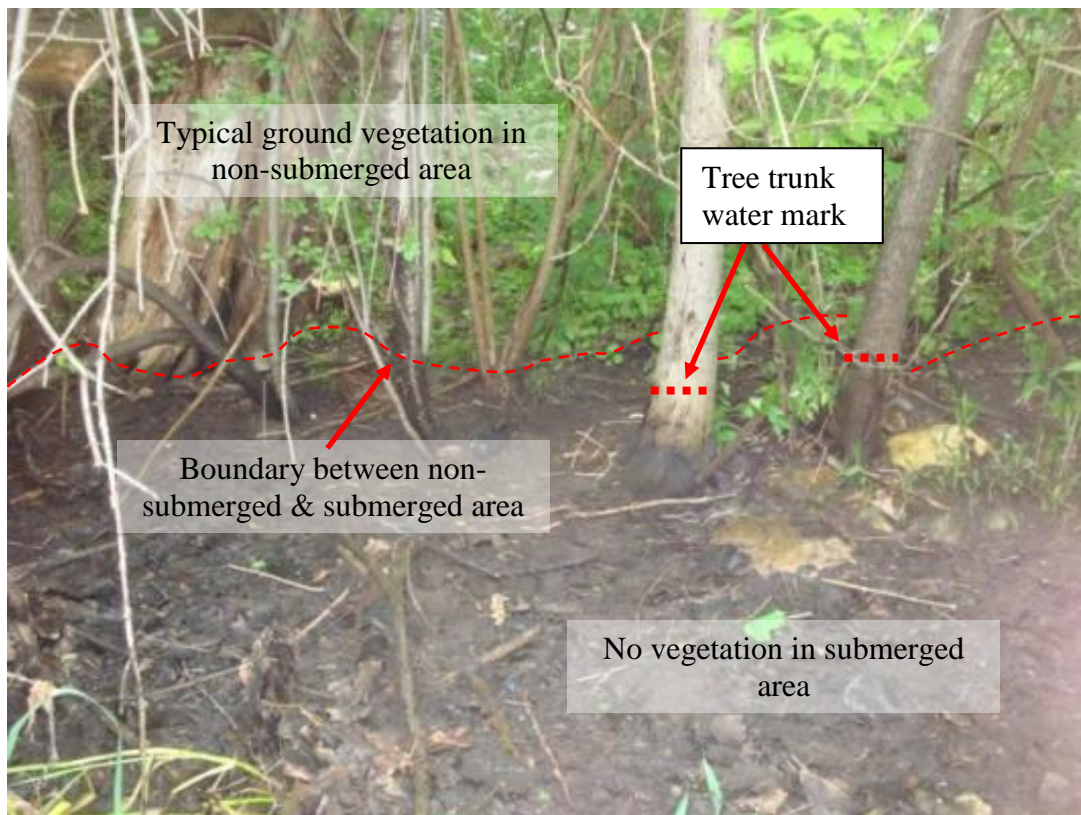
During the site visit, it was observed that the failure location was at a local natural depression that was receiving and accumulating surface water from a wider area. After careful inspection, the authors hypothesized the existence of seasonal ponding water. The surface soil on the uphill side of the embankment was very wet with vegetation that is typical of marshes, such as reeds. Next to the embankment where the water appeared to nearly permanently ponding and below trees there was no vegetation (see web-based supporting information titled “Photos and “Videos”). These conditions were found to be unique compared to other locations along the axis of the embankment. In addition, the level of water could be clearly seen as a watermark on the trunks of trees, as shown in Fig. 6. Based on these observations it was evaluated that the depth of the ponding water could have reached up to 120 cm. Local residents confirmed the existence of ponding water adjacent to the embankment. In fact, it appears that a neighbor used to feed visiting ducks at that location. Retention of ponding water was not part of the original embankment design. It is important to note that ponding water existed for at least some

period of time prior to failure. However, the spring of 2011 was particularly wet and probably more water accumulated compared to previous years. It is also not entirely clear whether a clogged storm drain existed in that location.

Figure 6. Area previously covered by ponding water and water mark on tree trunks.

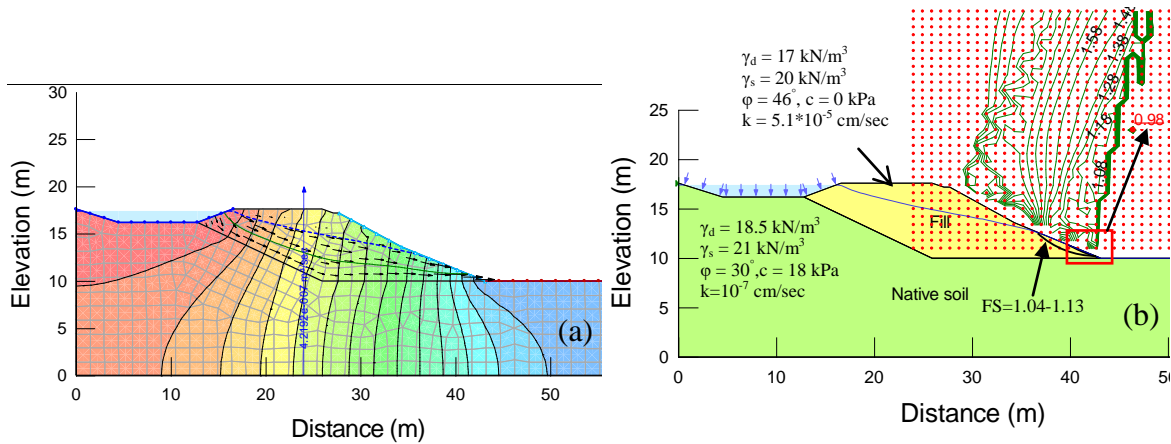
Subsequently, seepage analyses were conducted using the estimated hydraulic conductivities. As described earlier, the natural soil has significantly lower hydraulic conductivity than the embankment soils. Thus, the analyses indicate that when the ponding water depth increases, the exit gradients at the toe of the embankment become high, and vary between 0.48 and 0.78, which are dangerously high and close to critical gradients (~ 0.9). The stability analyses using the calculated hydraulic pressures, indicate failure of the embankment with factors of safety around one, as shown in Fig. 12. Note that this is not surprising as the seepage analysis gives a more realistic pore pressure profile (Fig. 12a) than that of an arbitrarily assumed piezometric surface (e.g., Fig. 11) with the flow concentrating more on the higher hydraulic conductivity soil. The results, indicate that the failure is caused by the high pore pressures that may even cause piping. The numerical results, are supported by the following interesting field observation: The reeds in the ponding water area adjacent to the embankment were found to be bent sideways and positioned horizontally with a direction that was pointing with great accuracy to the exact location where the ponding water initially drained quickly, as shown in Fig. 12.

Figure 12. Indicative results of combined (a) seepage and (b) stability analyses using seepage analyses results

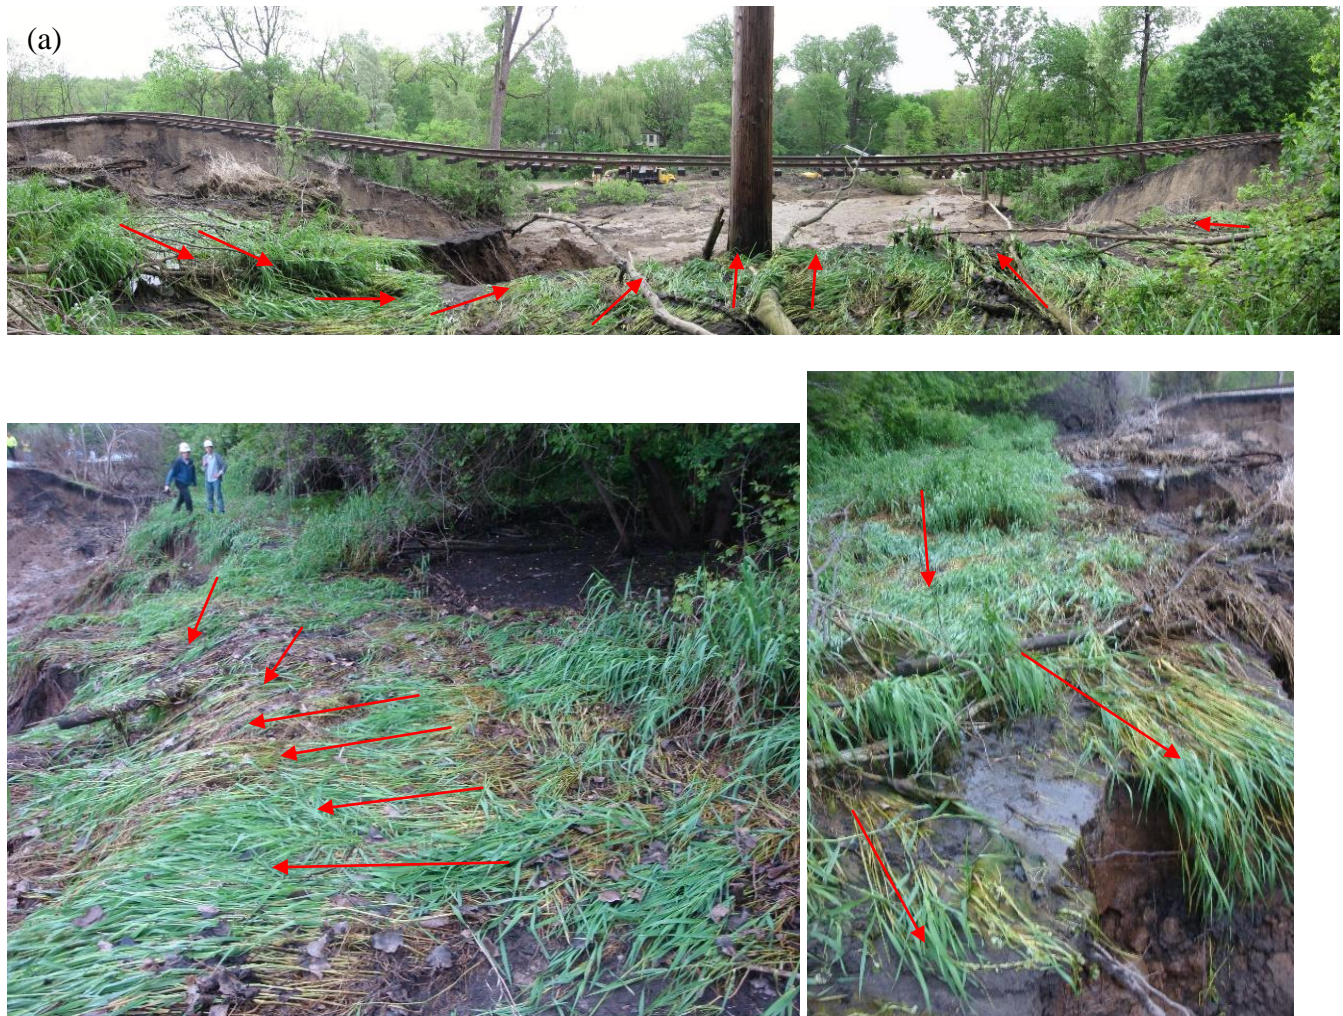
Figure 13. View of the failure and the reeds uphill of the embankment. The arrows are parallel to the direction of the fallen reeds that bent and broke during the abrupt emptying of the ponding water and fell on the ground with their orientation pointing to the initiation point of failure. (Fig. 13a by Karl Jansen, ceephotos.com)
