Analysis of the tribological interaction of a polytetrafluoroethylene-lined radial lip oil seal, shaft and lubricant sample

Proc IMechE Part J:
J Engineering Tribology
1–21
© IMechE 2021

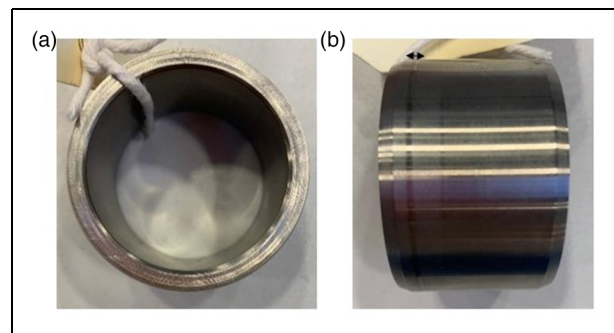
Figure 2. Dimensions of sleeve is inner diameter = 42 mm, outer diameter = 52 mm: (a) case-hardened sleeve top view and (b) case-hardened sleeve with visible wear track (marked with a black arrow).

Surface topography of sleeve. In Figure 2(b), the wear band of the sleeve is clearly visible, indicating that this was where the seal was mounted. The measured surface topography covers an area of $1.56 \text{ mm} \times 11 \text{ mm}$ across the sleeve surface (Figure 9(a)). Figure 9(b) shows the surface topography after removing the best-fit cylindrical form from the original surface topography. An S-filter with a nesting index of $2.5 \mu\text{m}$ and an L-filter with a nesting index of $800 \mu\text{m}$ are applied²⁶ before calculating the surface texture parameters.

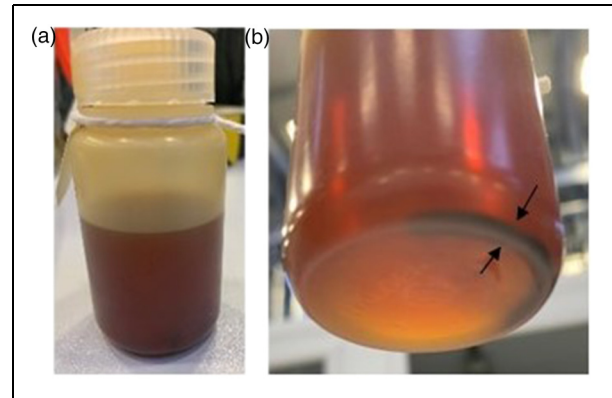
Figure 6. (a) Lubricant sample extracted from test and (b) debris present in lubricant sample settled at the bottom marked with black arrows.

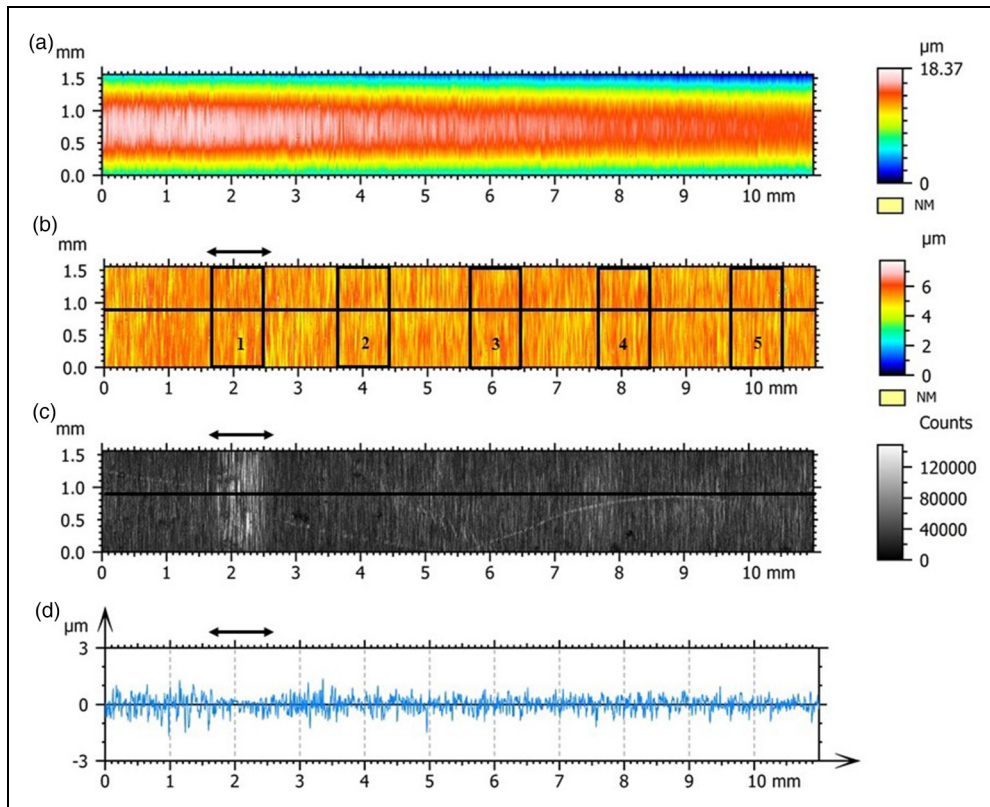
The corresponding optical microscopic image shown in Figure 9(c) is where the greyscale corresponds to light intensity. A shiny area is visible and it is the wear band that is 'polished in' by the seal mounted in place

A surface profile is extracted from the filtered areal topographic map. Qualitatively, it can be seen that the region marked with an arrow in Figure 9(b) to (d) from 1.5 to 2.5 mm is less rough than the rest of the sleeve. The asperities of the surface texture have worn away, resulting in a polished and 'smoother' surface.

Figure 9. (a) Measured surface topography 1.56 mm × 11 mm, (b) filtered surface topography (S-filter with a nesting index of 2.5 μm and an L-filter with a nesting index of 800 μm). The locations of the extracted surface profile and areas are highlighted, (c) optical microscope image in greyscale corresponding to light intensity and (d) extracted surface profile from the line marked in Figure 7(b) and (c).

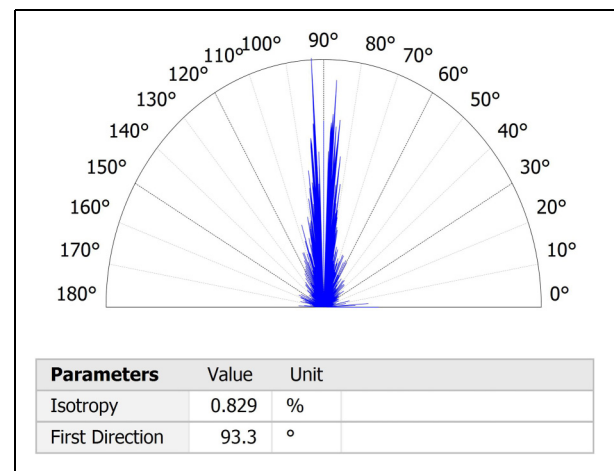
This experiment reveals axial movement of the string towards the free end for clockwise shaft direction and axial movement towards the fixed end for anti-clockwise shaft rotation. Thus, this concludes the presence of right-hand lead on the sleeve surface. In this long-term endurance experiment, shaft rotation was in the clockwise direction. This will result in transportation of oil towards the airside, and eventually result in leakage. The profiling method helps quantify and measure the lead angle on the sleeve surface.

Hence, the reverse pumping effect, if present at all, might be too little to counterbalance the leakage of oil occurring in this system. Instead, we find right-hand lead present on the sleeve surface. This lead, along with clockwise shaft rotation will result in leakage of the

Figure 10. Sleeve texture direction for lead angle.

lubricant from the oil side to the airside. It is detrimental to the sealing system and explains the leakage observed in this case over the duration of the test.

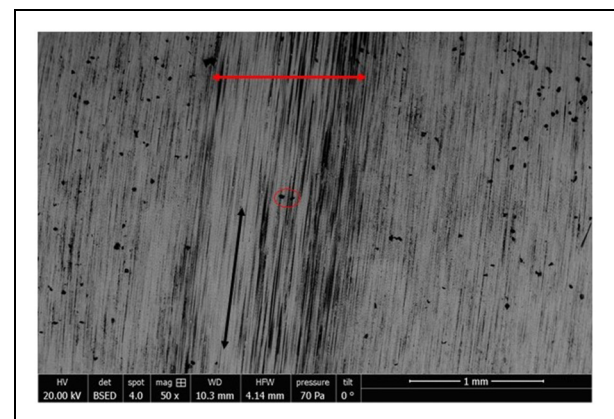
Figure 11. Environmental scanning electron microscopy (ESEM) image of wear track marked with a red arrow horizontally, sliding direction shown with a black arrow and magnification area of Figure 9 marked with a red circle.

Material transfer on sleeve surface. Figure 11 shows the wear track on the sleeve, ~ 1 mm across, marked with a red arrow. At this point, it is important to note that the seal lip is $123.3\ \mu\text{m}$ in width at first, but as it wears during the test, the lip width extends to $918.5\ \mu\text{m}$ (for detailed analysis, refer to ‘Wear of the PTFE-lined lip’ section). The worn seal lip of ~ 1 mm explains the reason for the wear band on the sleeve being 1 mm in width as well.

Additionally, there are many visible black spots outside the wear band, along with very few remaining within the wear band (e.g. circled in red in Figure 11). However, the image reveals that these spots are located all over the sleeve surface and are primarily missing from the area marked as the wear band. Evidenced by this, the seal sliding on the sleeve at that spot has resulted in their removal. This further enforces the conclusion that the sleeve has experienced polish and wear by the seal lip.

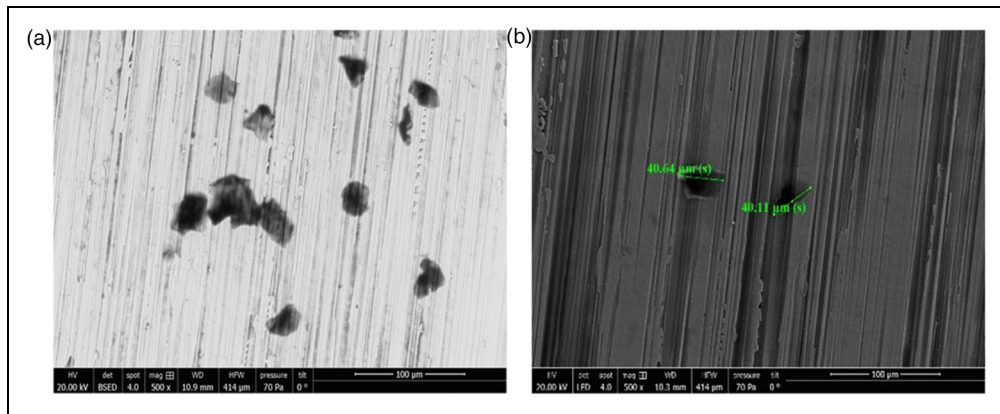
Figure 12. (a) Several deposits on the sleeve surface and (b) measurement of two deposits observed on the sleeve surface.

Figure 12(a), shows the magnified appearance of deposits present outside the wear track on the lighter grey substrate and Figure 12(b) shows the magnified appearance of a few of the deposits present within the wear band (this is marked with a red circle in Figure 11). Quantitatively, Figure 12(b) shows the measurement of two such deposits ranging from 40.64 to 40.11 μm across to present an idea of the size of these deposits.

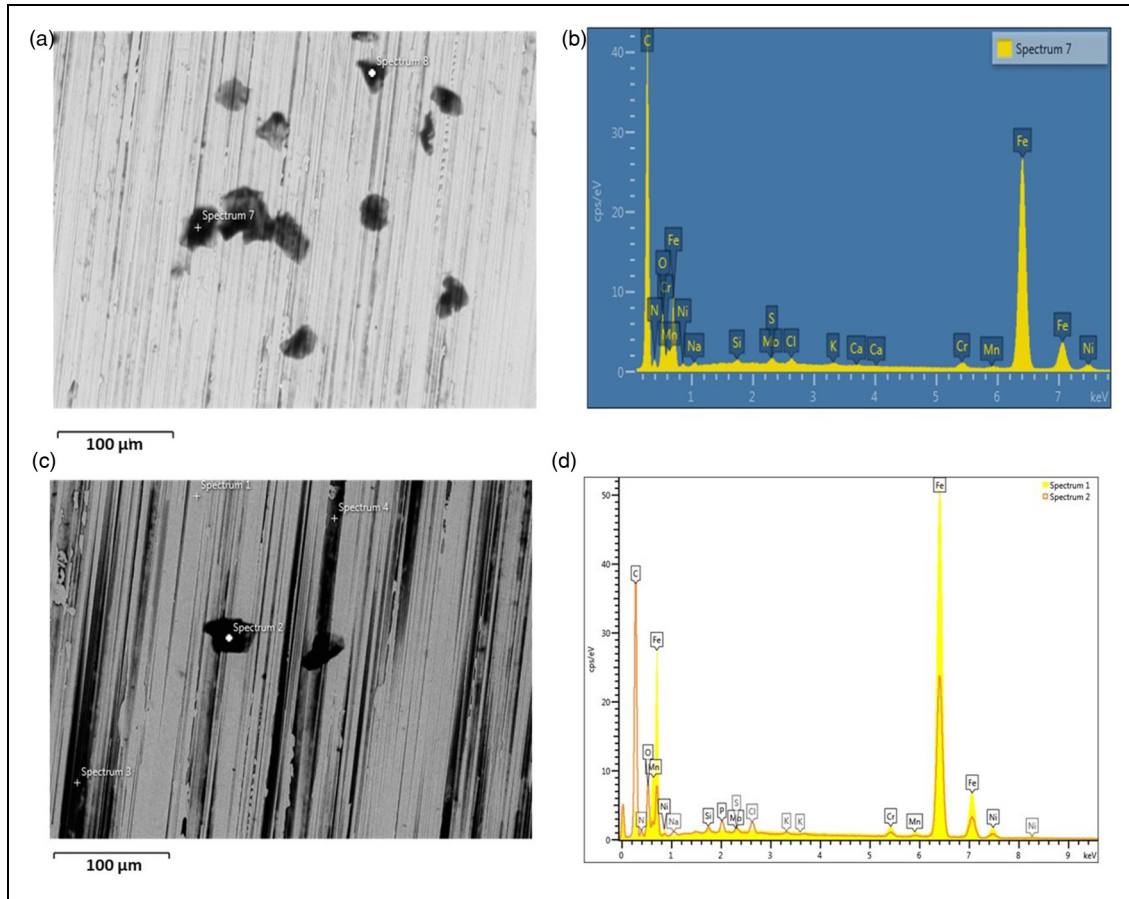
Figure 13. (a) Spectrum 7 selected for energy dispersive spectroscopy (EDS) analysis on sleeve surface deposits outside wear band, (b) plot of EDS analysis showing spectrum 7 with a higher carbon count, similar to deposits in spectrum 2, (c) spectra 1, 2, 3 and 4 identified for EDS analysis of visible black spots on sleeve surface within wear band and (d) comparison plot of EDS analysis showing spectrum 1 (light grey substrate) with higher iron count as the sleeve surface and spectrum 2 (darker deposits) with a higher carbon count.

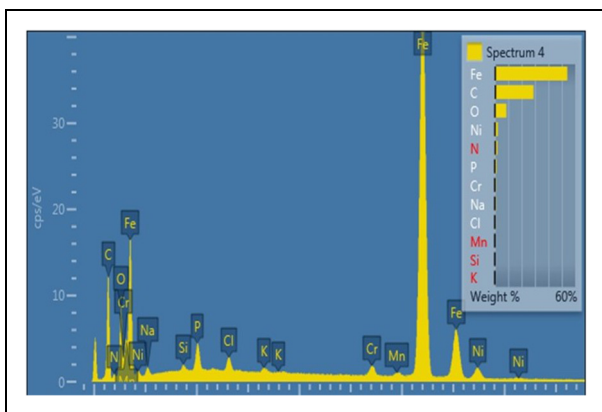
Figure 14. Energy dispersive spectroscopy (EDS) analysis for spectrum 4 displaying one of the darker lines on the wear band, with a composition different from spectrum 1, which is the bulk iron substrate. It is also different from spectra 2 and 7, which are the circular deposits seen across the sleeve sample, apart from where they have been removed on the wear band.

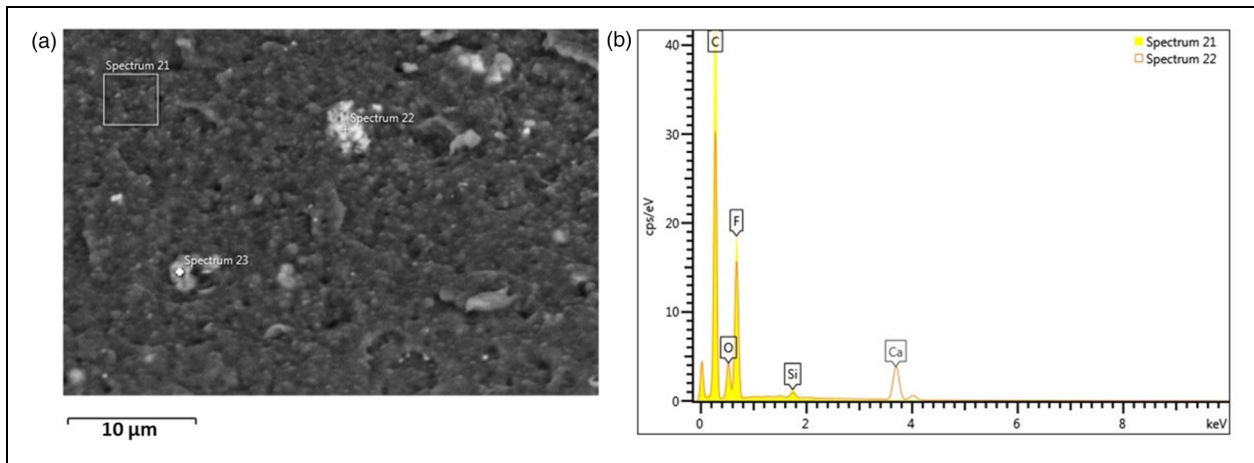
Figure 15(b) shows high carbon content present in the darker areas in the ESEM image of the seal specimen (spectrum 21).

Figure 15. Seal top surface: (a) energy dispersive spectroscopy (EDS) image identifying spectra 21 (dark substrate), 22 (brighter particles) and 23 (bright particles) and (b) comparison plot between spectra 21 and 22 showing calcium present in spectrum 22.

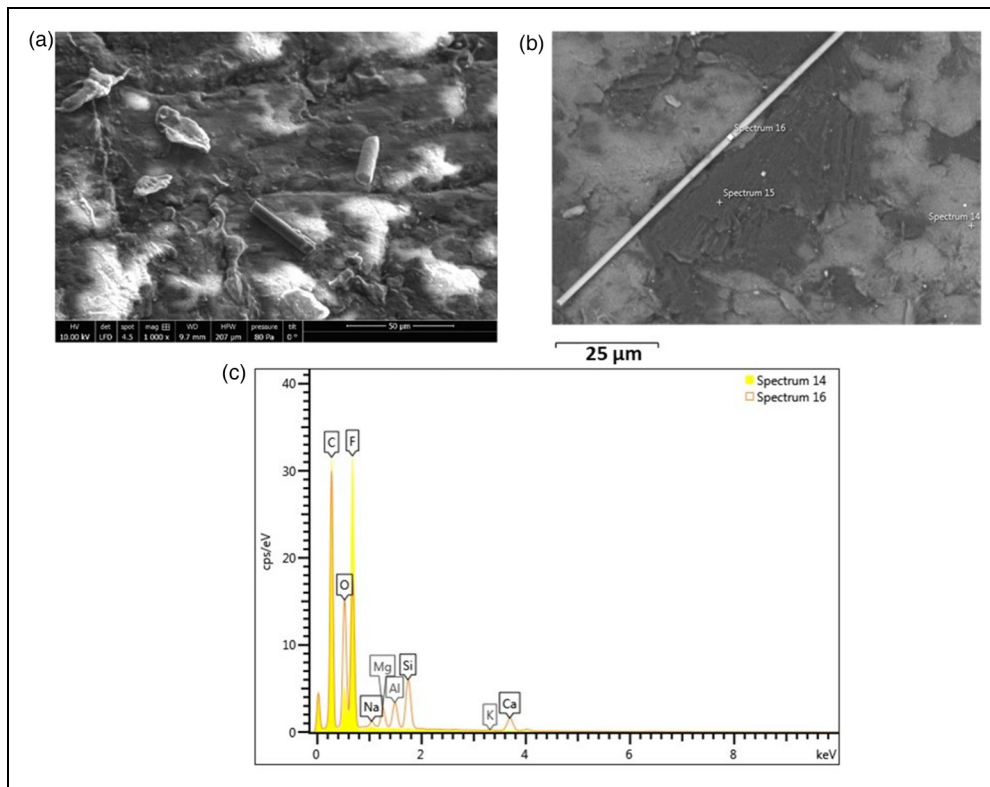
Figure 16. Seal top surface: (a) ESEM image of glass fibres in filled PTFE, (b) spectrum 14 (light grey bulk substrate), 15 (darker carbon patch) and 16 (glass fibre) selected for analysis and (c) comparison plot of spectra 14 and 16 showing Silica in spectrum 16 and higher Fluorine and Oxygen count in spectrum 14.

Figure 16(a) displays an image of the particles believed to be the glass fibre fillers identified in the polymer matrix. They are similar in appearance to glass fibres identified in other recent research.³² Quantitatively, Figure 16(b) displays a glass fibre particle, 132 μm in length. Figure 16(b) shows spectra 14, 15 and 16 selected for EDS analysis and the comparison plots in Figure 16(c) show that spectrum 14 has a higher fluorine count while spectrum 16 has a higher silica and oxygen count. Traces of aluminium and magnesium are also

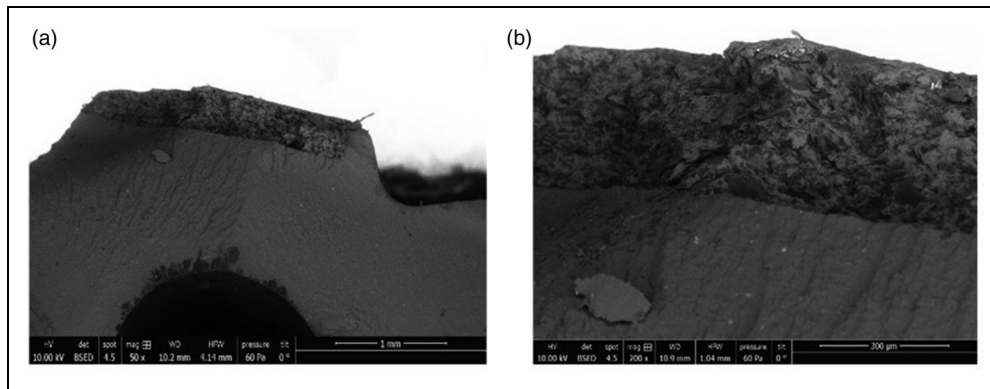
Figure 17. Tested seal fracture surface: (a) ESEM image of fracture surface of the seal cross-section showing a distinct PTFE layer on the seal lip and (b) close up of the same distinct layer measuring 300 μm thickness. ESEM: environmental scanning electron microscopy; PTFE: polytetrafluoroethylene.

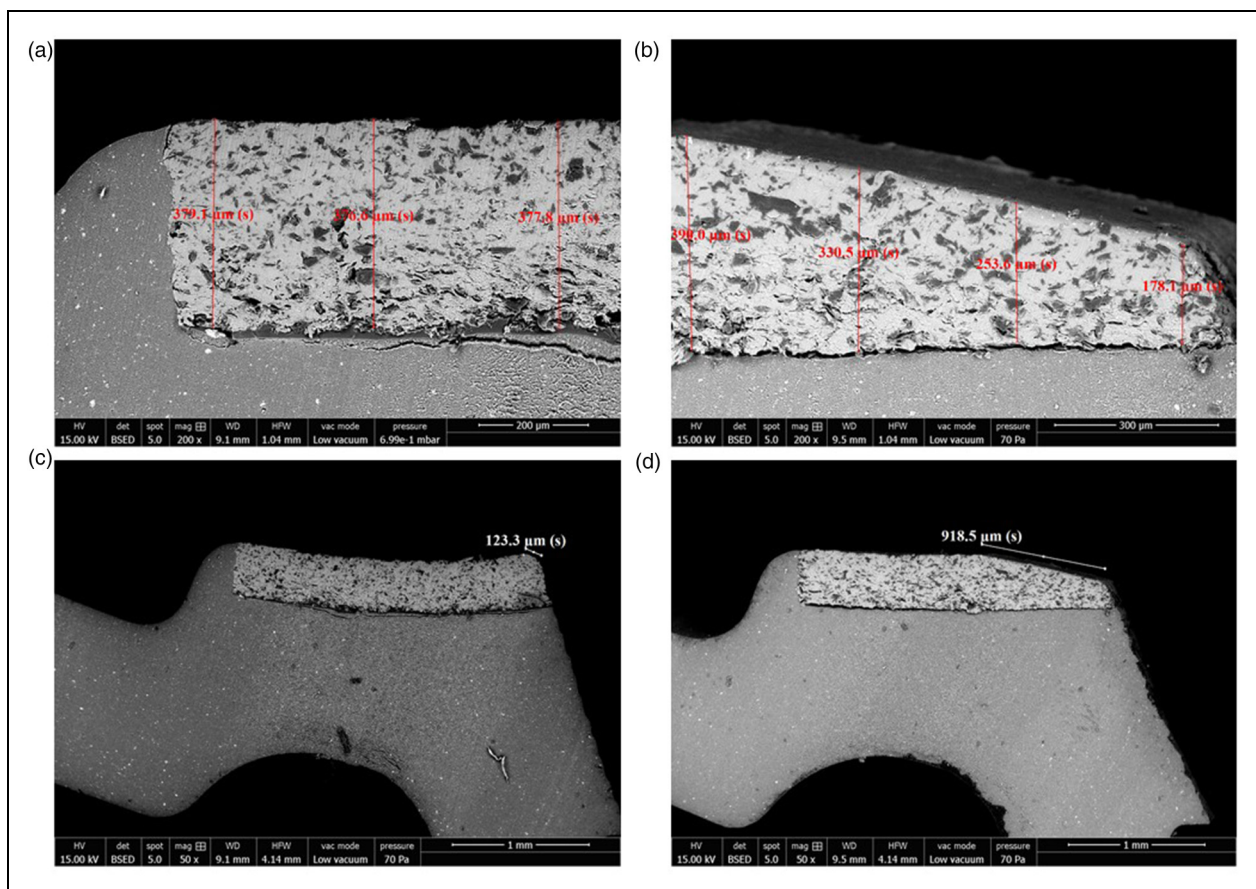
Figure 21. Cross-section of new and used seal surface with varying magnifications: (a) new seal lip mag. 200 \times . Measurements from left to right (μm): 379.1, 376.6 and 377.8, (b) used seal lip mag. 200 \times . Measurements from left to right (μm): 390.0, 330.5, 253.6 and 178.1, (c) new seal lip mag. 50 \times . Lip contact band 123.3 μm and (d) used seal lip mag. 50 \times . Lip contact band 918.5 μm .

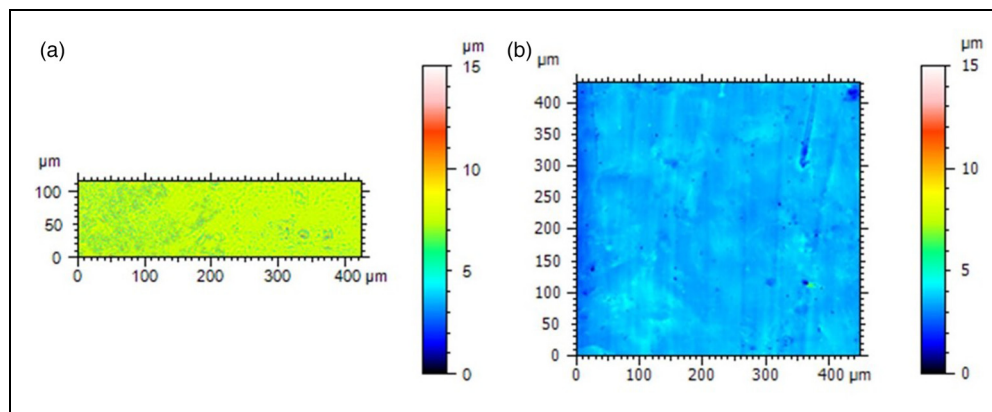
Figure 23. Surface topography of the lip region of the new and used seal. They are levelled and have an S-filter with a nesting index of 2.5 μm and an L-filter with a nesting index of 250 μm : (a) new seal lip and (b) used seal lip extracted from the position marked in Figure 22b.

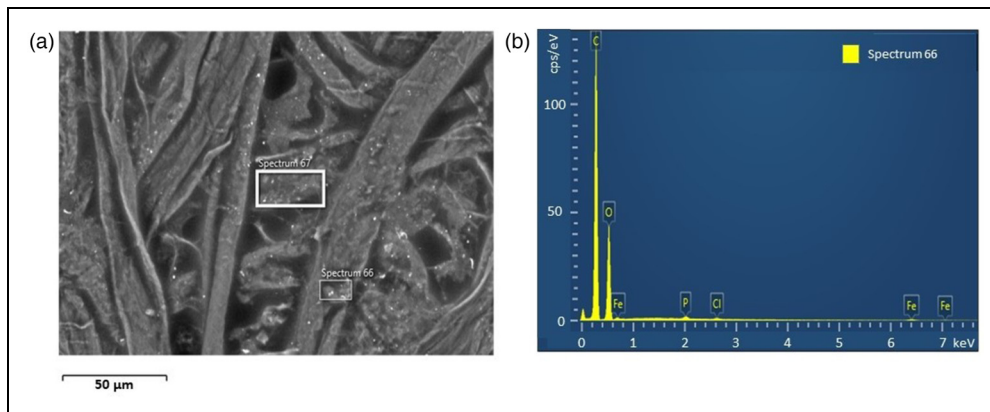
Figure 25. Filter paper with lubricant analysis: (a) ESEM image and (b) EDS analysis showing iron present in addition to carbon and oxygen present. ESEM: environmental scanning electron microscopy; EDS: energy dispersive spectroscopy.

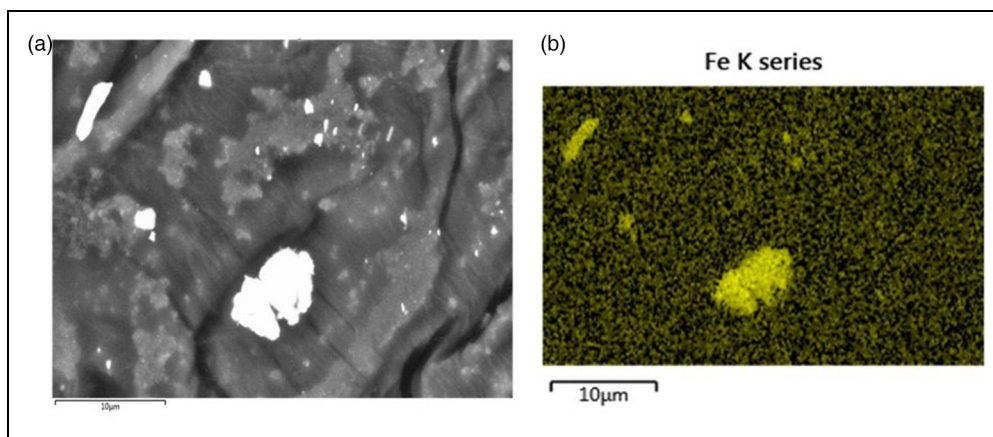
Figure 26. (a) ESEM image of iron deposits in the lubricant sample. (b) EDS dot map analysis of image. ESEM: environmental scanning electron microscopy; EDS: energy dispersive spectroscopy.

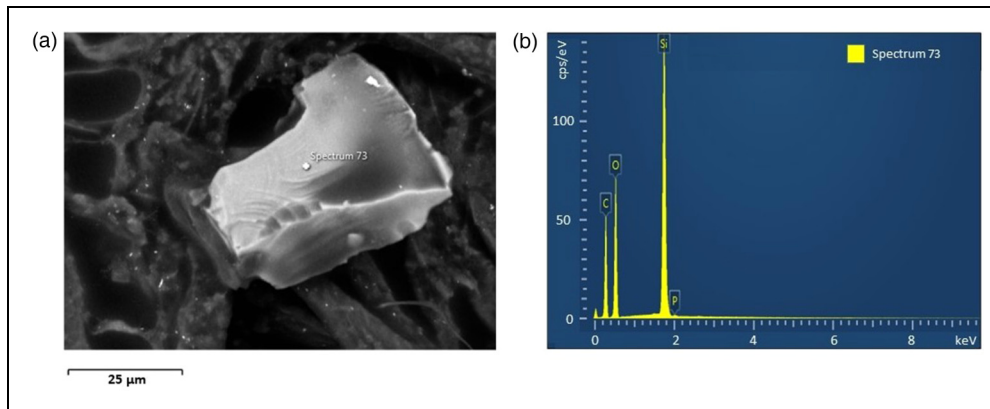
Figure 27. (a) ESEM image of glass fibres in the lubricant sample and (b) EDS analysis of spectrum 73 showing deposit to be silica rich. ESEM: environmental scanning electron microscopy; EDS: energy dispersive spectroscopy.
