# Effect of non-structural masonry brick infill walls on the robustness of a RC framed building severely damaged due to a landslide

In this paper, the robustness of framed RC buildings is analysed by comparing the reliability of the damaged structure with that of the original structure and considering (or not) the contribution of the masonry infill walls. To validate the adopted methodology, this is tested on a residential RC building severely damaged due to a landslide, herein considered as case-study. A numerical model of the original, as well as, of the damaged structure is defined using force-based finite elements with distributed plasticity. Masonry infill walls are modelled as equivalent internal struts. Monte Carlo simulation and FORM coupled with artificial neural networks and response surface polynomials are used in parallel to perform the reliability analyses of both original and damaged structures. Obtained results show that the masonry infill walls are fundamental to contain damage progression after the failure of a couple of columns. In fact, without these non-structural elements, the structure would lack in robustness, and the probability of failure would be above 99

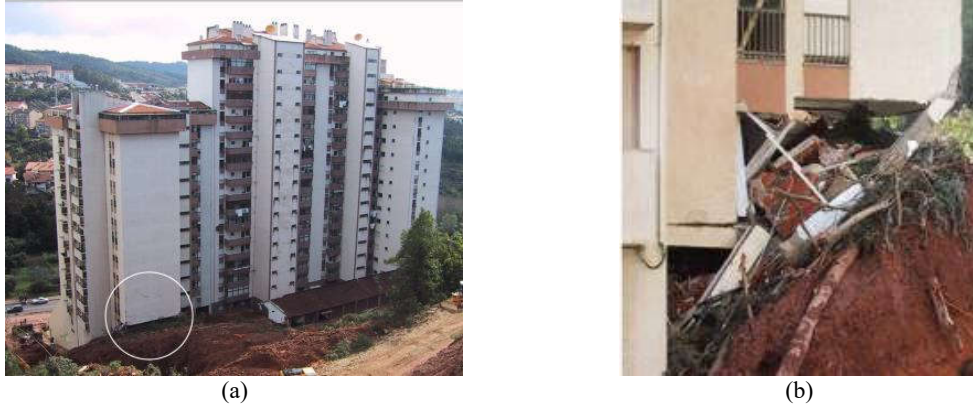
Figure 1 –Severely damaged RC residential building after a land slide: (a) rear façade; (b) collapse of the outer columns of the rear body of building.

In 2000, in Coimbra, Portugal, a landslide caused severe damage to the RC structure of a 16 stories residential building (Figure 1). The first two levels of three exterior columns were destroyed and the rear body of the building supported by these, with a dimension in plant of  $9.5 \times 6.7 \text{ m}^2$ , became a 7.0 m span cantilever with 12 stories above (Figure 1 (b)). Unlike what would be expected, no significant anomalies were identified, other than cracks on the masonry infill walls with a maximum width of 2 mm, located

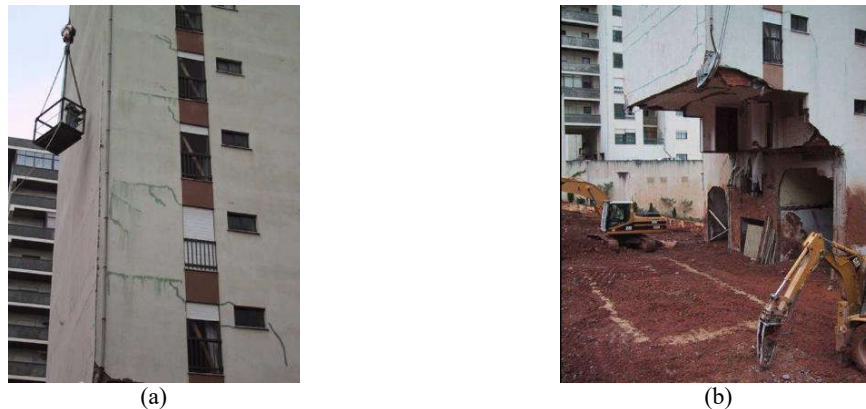
Figure 2 –Details of the accident: (a) cracks along the façade masonry infill walls; (b) removal of debris from the accident site.

140 predominantly at the openings' corners (Figure 2 (a)). After the inspection, the damaged part of the  
141 structure was consolidated using external prestress, the debris was removed, and the retrofitting works  
142 started (Figure 2 (b)).

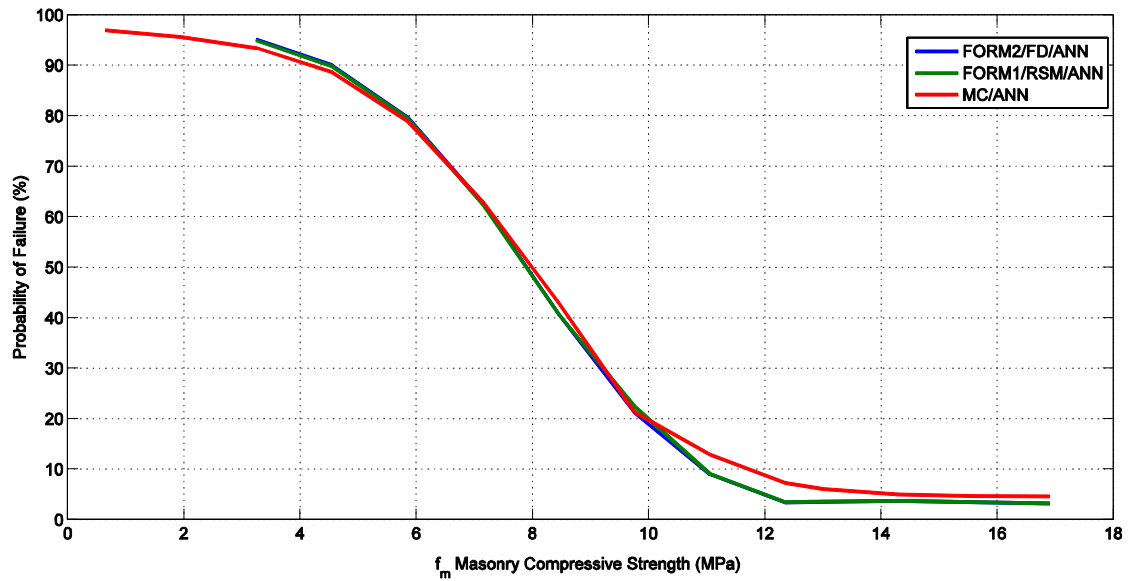
Figure 9 – Effects of the mean value of the masonry compressive strength to the damaged building probability of failure.

To highlight the role played by the masonry infill walls in the safety of the damaged structure, Figure 9 and Figure 10 show the influence of the mean value of the masonry compressive strength, on the probability of failure and reliability index, respectively. Calculations were performed using both the simulation (MC/ANN) and the gradient-based approaches (FORM1/RSM/ANN and FORM2/FD+ANN).
