Metallic fabric jackets: an innovative method for seismic retrofitting of substandard RC prismatic members

By G.E Thermou¹and S.J. Pantazopoulou²

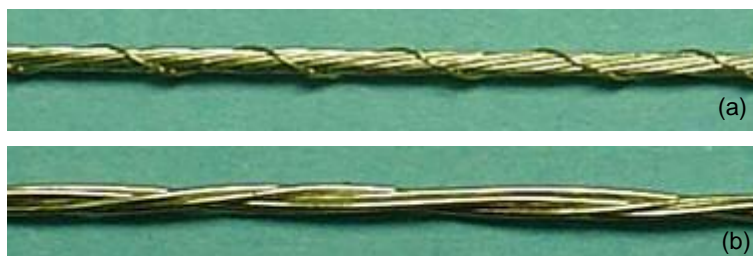
Figure 3 Steel cords (a) 12X; (b) 3X2

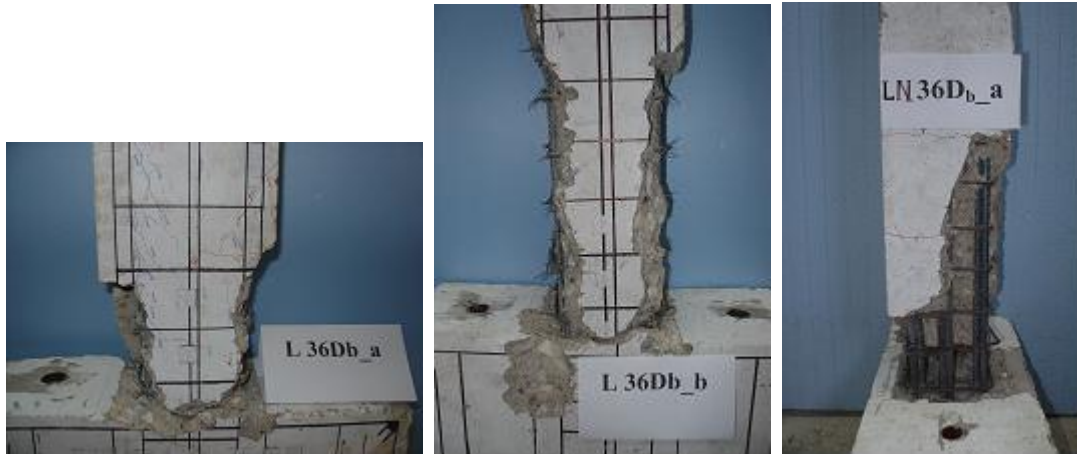
Figure 6 Specimens with lap-splices after removing the loose concrete fragments

After the first phase of loading, the loose concrete fragments were removed by hand using chisel and hammer. In specimens L36D_{b_b}, L36D_{b_a} and LN36D_{b_a}, the concrete core was preserved as shown in Figure 6. However, in specimens FN_a and FN_b, concrete had spalled and disintegrated completely in the damaged area due to the extended crack patterns, and for this reason it was entirely removed (Fig. 7). Success of this phase was critical for the next steps of retrofitting and required caution to avoid damaging the healthy concrete parts and the longitudinal reinforcement and persistence to progress systematically through the complex crack system.

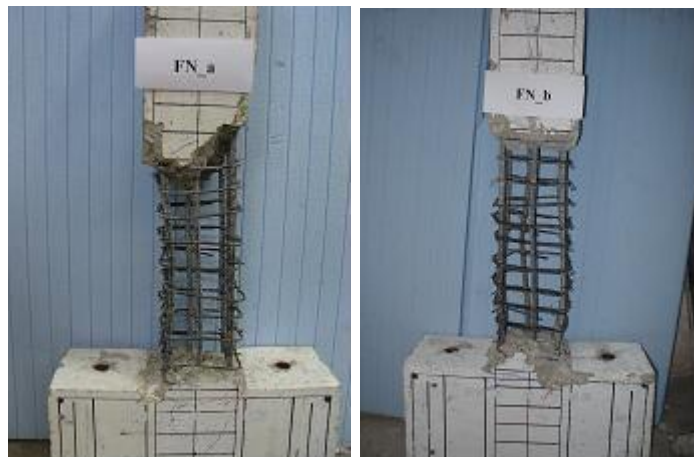
Figure 7 Specimens FN_a and FN_b after removal of damaged and fragmented concrete

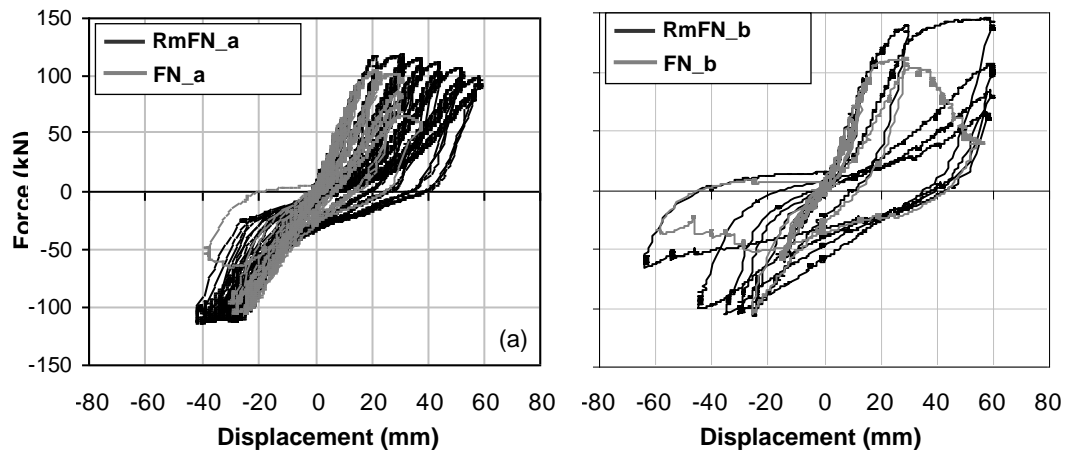
Figure 14 Load-displacement diagrams for the system of specimens RmFN_a and RmFN_b
