Aging of lime-based TRM composites under natural environmental conditions

Ali Dalalbashi¹, Bahman Ghiassi², Daniel V. Oliveira³

ABSTRACT

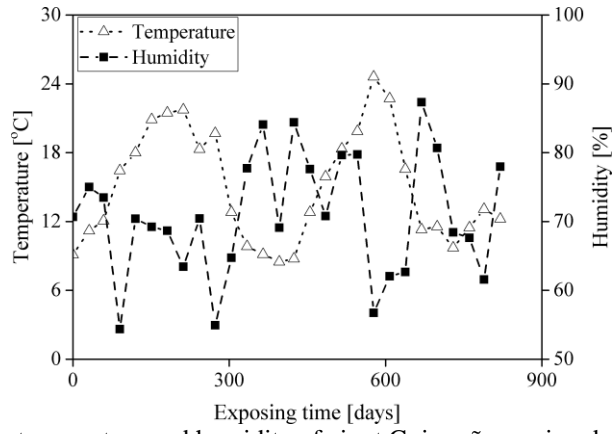
3
4 Fig. 1. Changes of the temperature and humidity of air at Guimarães region during outdoor exposure
5 conditions.
6
7
8

7 The experimental campaign investigates the changes in materials properties (compressive and
8 flexural strength), textile-to-mortar bond behavior, and the tensile response of TRM
9 composites with time under indoor and outdoor environmental conditions. The details of the
10 experimental plan are shown in Table 1. To address this aim, a set of samples (sample details
11 are presented in section 2.1 to 2.4) were placed in the laboratory conditions (20°C, 60 % RH)
12 for 920 days to replicate indoor conditions. Another set was placed outside under direct
13 exposure of rain and sun at the site of the University of Minho to simulate outdoor conditions.
14 The outdoor aged specimens, after initial curing of 90 days in the laboratory, were transported
15 to the outside of the laboratory since January 2017 for 830 days. Fig. 1 shows the changes in
16 mean temperature and humidity of air in the location of samples during the outdoor exposure.

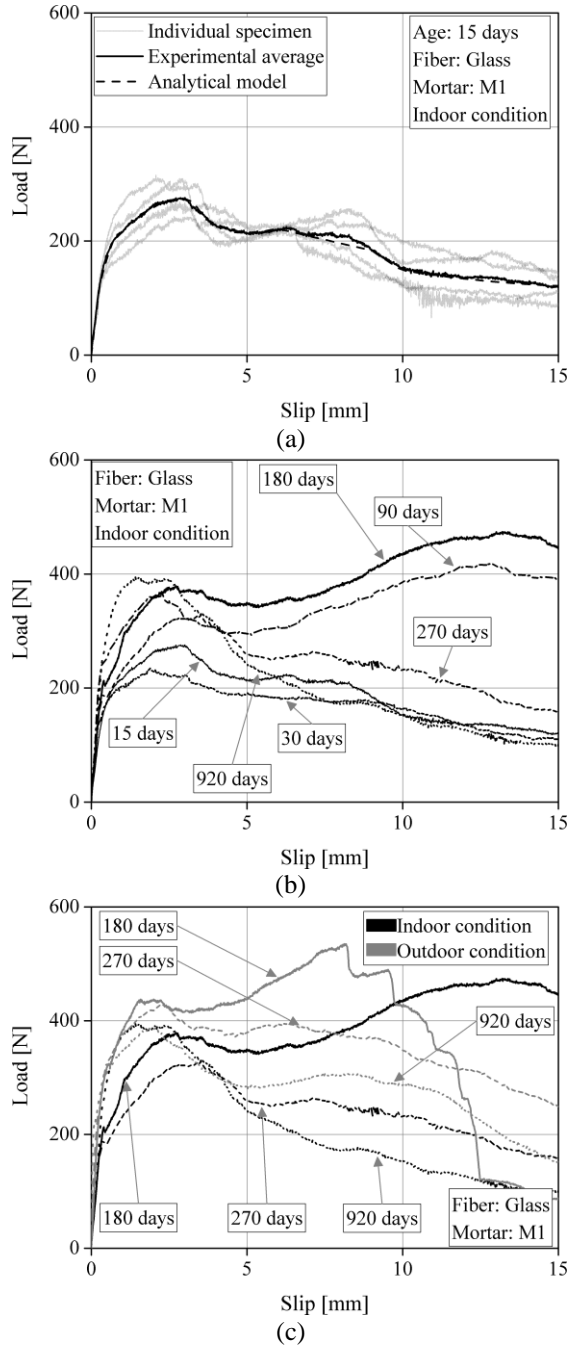
Fig. 10. Pull-out behavior of the glass-based TRM: (a) typical pull-out behavior; (b) effect of the mortar age; (c) effect of environmental conditions.

4 The pull-out curves of the individual samples, the experimental average, and the analytical
5 curves of the glass-based TRM are presented in Fig. 10. These specimens, in contrast to steel-
6 based TRMs, do not show a sudden load drop after the peak load; thus, the transition from the
7 progressive debonding to the dynamic stage is smooth. This behavior can be due to the
8 insufficient curing condition of the M1 mortar, followed by the weak bond at the fiber-to-
9 mortar interface. Comparing the pull-out curves tested at different ages and under indoor
10 conditions (Fig. 10b) shows that at early and late ages (until 30 days and after 270 days), the
11 slip hardening is followed by a softening in the pull-out curves. However, at 90 and 180 days,
12 the slip hardening is followed by a second slip hardening effect leading to significant
13 absorption of energy. This change of final slip softening at early ages to slip hardening seems

14 to be a result of further hydration of the mortar. Nevertheless, at later ages, it seems that a sort
15 of bond deterioration or mortar shrinkage by forming micro-cracks at the bond interface has
16 occurred, which led to a slip softening behavior.

17 Comparison of the indoor and outdoor aged samples indicates again that generally, outdoor
18 aged samples show a better bond performance compared to indoor aged samples, see Fig. 10c.
19 This behavior is in line with what is observed for the M1 mortar changes at indoor and outdoor
20 conditions. As also observed in indoor aged samples, a degradation of the bond performance
21 can also be observed in the samples aged under outdoor conditions at later ages.

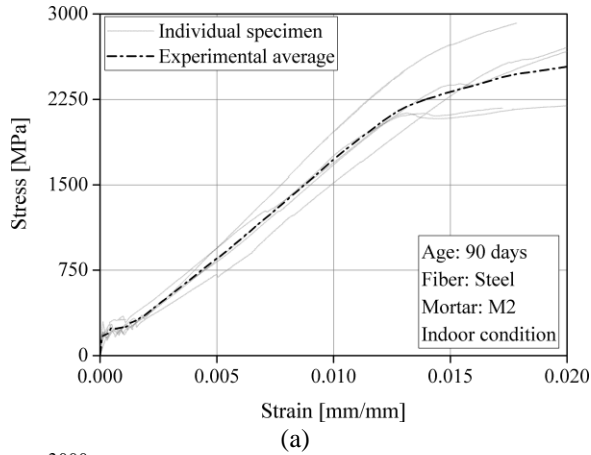
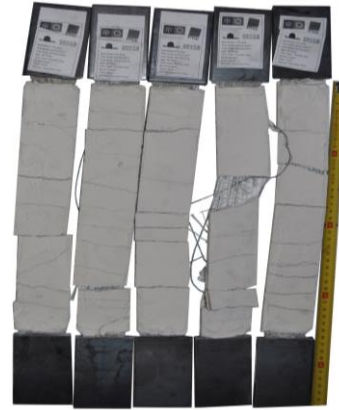
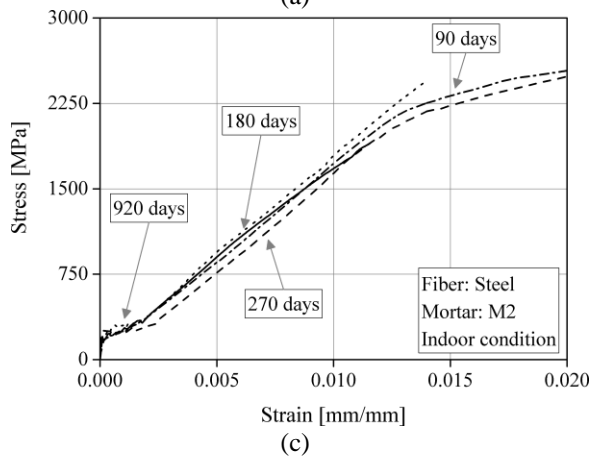
1 Fig. 14. Tensile response of the steel-based TRM: (a) typical tensile behavior; (b) saturated cracking stage at 90
 2 days (indoor aged); (c) effect of the mortar age under indoor conditions; (d) effect of mortar age under outdoor
 3 conditions.
 4
 5

11 The typical tensile stress-strain response of individual steel-based TRMs at 90 days, together
12 with their experimental average curves, are presented in Fig. 14a. In all the specimens, fiber
13 rupture was the governing failure mode. In addition to the three typical stages of the tensile
14 response, explained previously, a final softening stage can be observed in the stress-strain
15 curves. This final softening is probably due to the non-uniform distribution of the stresses
16 among the cords or the step-by-step failure of wires. Cracking of the mortar can be clearly
17 observed in the samples Fig. 14b. Many cracks have formed, showing the balance between the
18 bond and mortar strength and suitable textile-to-mortar bond behavior in these samples.

19 At first glance, no significant change is observed in the tensile response of samples aged under
20 indoor conditions, Fig. 14c, or the samples aged under outdoor conditions (despite the final
21 tension strength), Fig. 14d, with time. However, looking at the changes in the main
22 characteristics of the tensile response, Fig. 15, shows interesting trends. Only a slight increase
23 can be observed in the first cracking stress, σ_1 , with time in indoor aged samples. However,

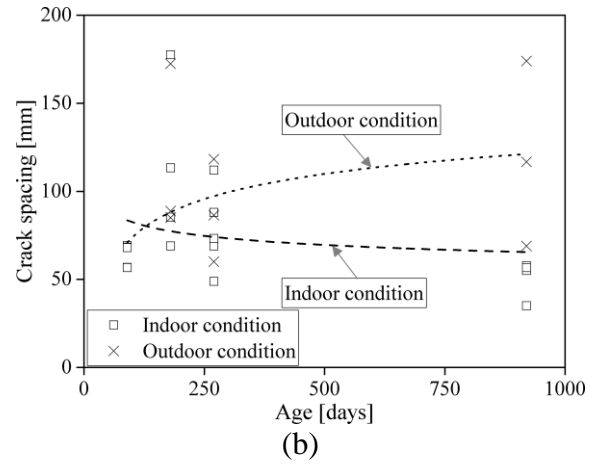
Fig. 16. Crack spacing under tensile test: (a) the steel-based TRM; (b) the glass-based TRM.

1 the cracking strength is increased until 270 days and then decreased until the end of the tests
2 in the outdoor aged samples. At all times, however, outdoor samples show higher cracking
3 stress than the indoor samples, which can be again attributed to a higher hydration degree of
4 the mortar. These observations are in line with the observed changes in the mechanical
5 properties of the mortars reported in previous sections. The stress corresponding to the end of
6 stage II, σ_2 , increases notably with time in both indoor and outdoor aged samples. Again,
7 outdoor aged samples show a higher σ_2 than indoor aged samples. In contrast, σ_3 , shows an
8 initial decrease and then an increase in both cases. As for stiffness, E_1 is increased initially and
9 then decreased, E_2 , increases, and E_3 does not show any significant changes with time. The
10 saturation crack spacing of the samples gradually decreases over time, Fig. 16a. The mean

1 steel-based TRM, the first cracking stress, σ_1 , decreases with time. This decrease is
2 significantly higher in outdoor aged specimens in the first 270 days, which is then recovered
3 to some extent until the end of the tests. The stress corresponding to the end of stage II, σ_2 ,
4 increases with time in indoor aged samples but decreases in outdoor aged samples. σ_3 , shows
5 a slight decrease in indoor aged samples and a significant one in outdoor aged samples. This
6 observation shows the sensitivity of the glass yarns to outdoor environmental conditions,
7 which has led to their mechanical degradation. As for stiffness, E_1 increases with time for
8 indoor aged samples and decreases for outdoor aged samples, E_2 increases in indoor aged
9 samples but shows a decrease after 270 days in outdoor aged samples and E_3 decreases in both
10 cases. In contrast to Steel-based TRM, the crack spacing is decreased in indoor aged but

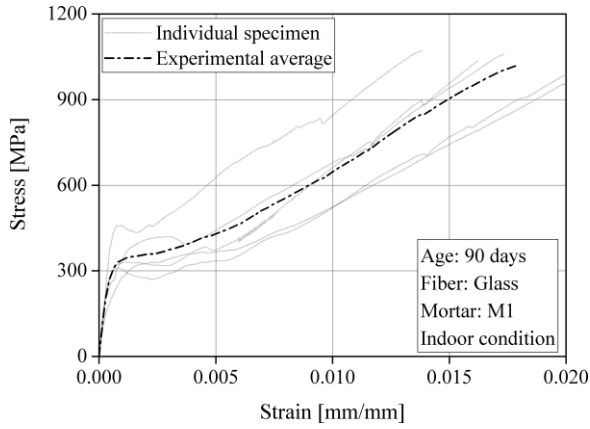
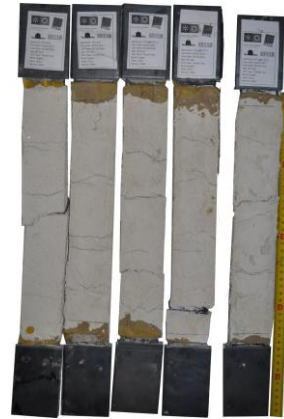
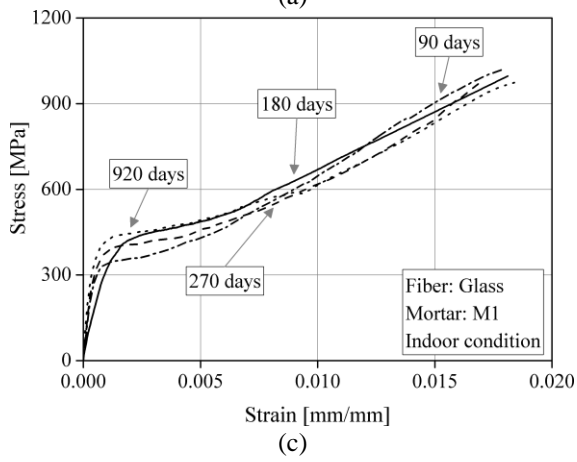
Fig. 17. Tensile response of the glass-based TRM: (a) typical tensile behavior; (b) saturated cracking stage at 90 days (indoor aged); (c) effect of the mortar age under indoor conditions; (d) effect of mortar age under outdoor conditions.

13 The typical tensile stress-strain response of individual glass-based TRMs (at 90 days), together
14 with their experimental average curves, are presented in Fig. 17a. In all the specimens, again,
15 fiber rupture was the governing failure mode. Although the three stages of the tensile response
16 are identified in the curves, no fluctuation in the crack developing stage can be observed,
17 which is due to the small number of cracks formed in these samples and/ or the low tensile
18 strength of the glass fibers (Fig. 17b).

19 No significant change is observed in the tensile response of samples aged under indoor
20 conditions, Fig. 17c, though the samples aged under outdoor conditions, show the tensile
21 behavior declines by increasing the exposure, as presented in Fig. 17d. However, an in-depth
22 look at the changes in the main characteristics of the tensile response (Fig. 18) shows some
23 differences between the samples aged under indoor and outdoor conditions. As opposed to
