Title: The effect of frequency on both the debris and the development of the tribologically transformed structure during fretting wear of a high strength steel

Article Type: Research Paper

Keywords: fretting wear; TTS; debris; damage

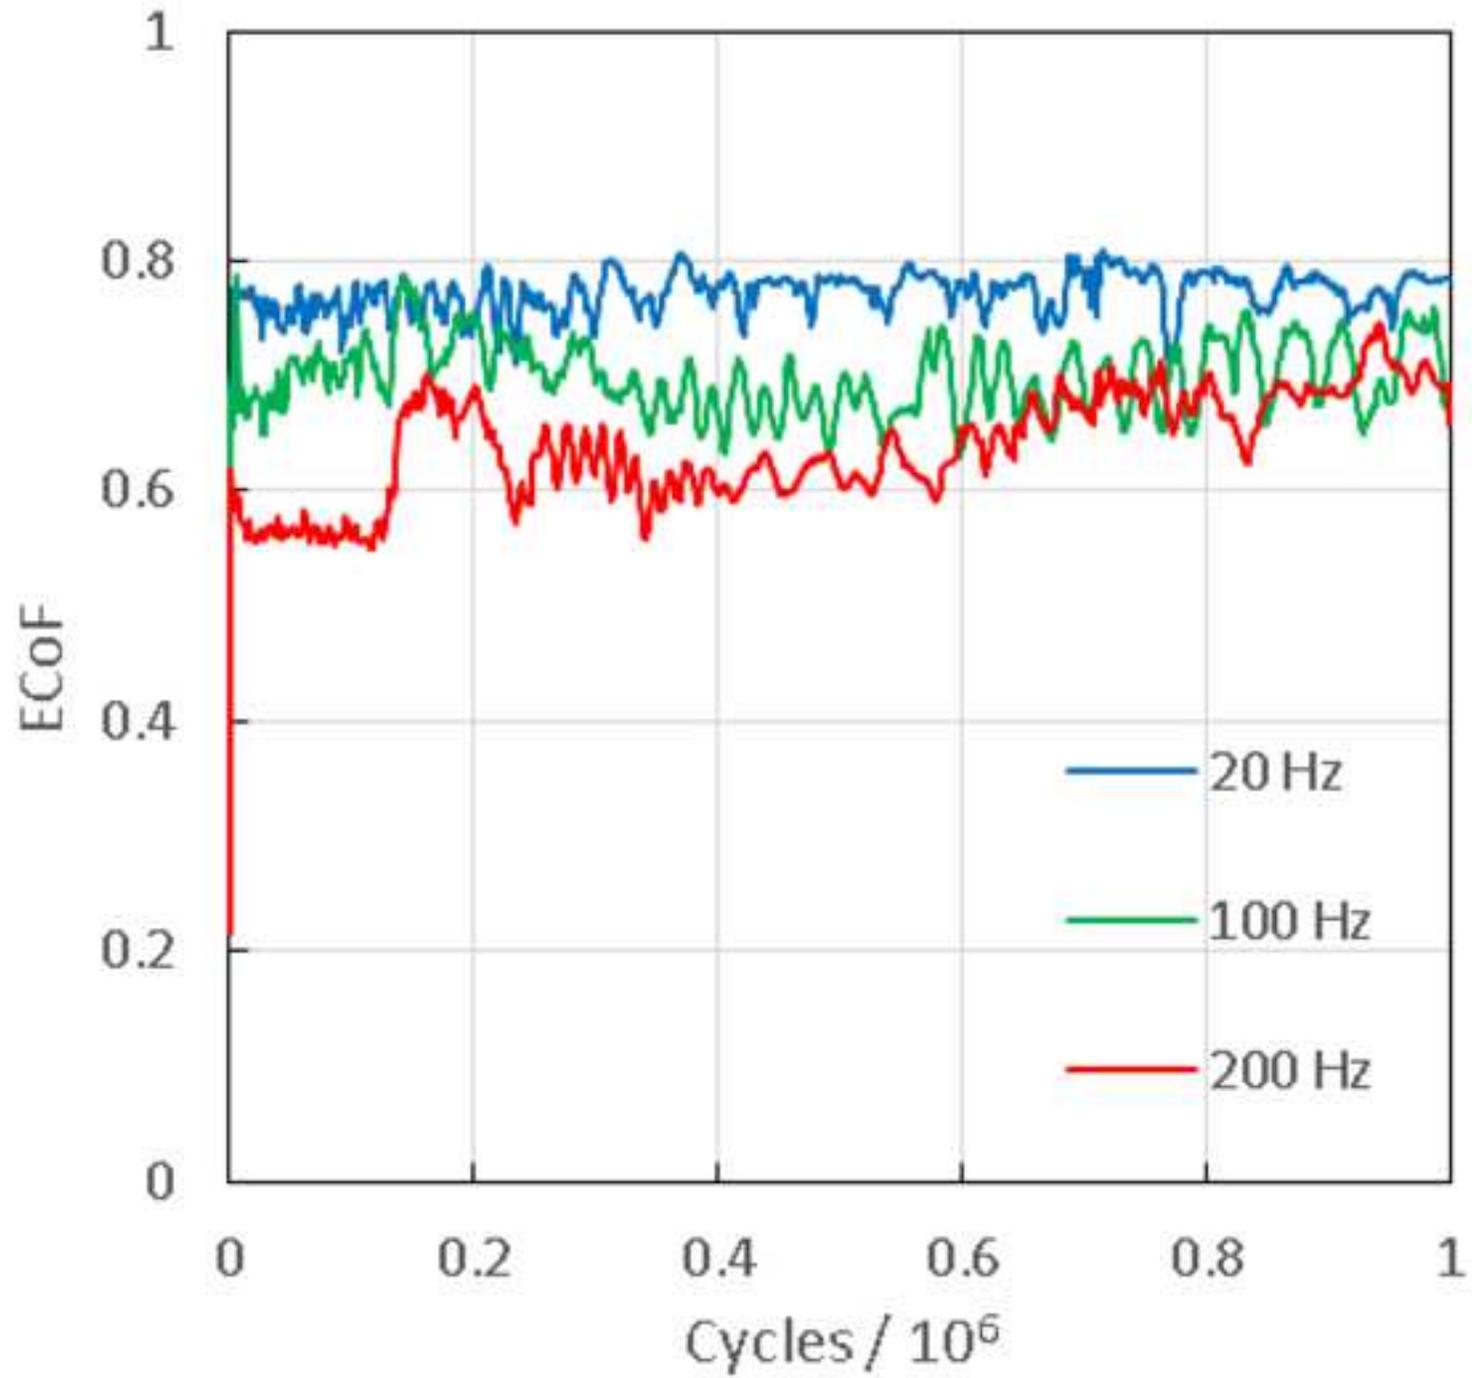
Figure 3
[Click here to download high resolution image](#)

Plots of the energy coefficient of friction (ECoF) plotted as a function of number of cycles (Figure 3) show that under the conditions employed, the coefficient of friction decreased with increasing fretting frequency, with values at all three frequencies at the end of the tests being in the range ~ 0.7 to ~ 0.8. The coefficient of friction remained broadly steady over the duration for tests conducted at 20 Hz and 100 Hz; however, at the highest fretting frequency of 200 Hz, ECoF was observed to increase from ~ 0.6 to ~ 0.7 over the duration of the tests.

Despite the differences in the nature of oxide coverage across the wearing surfaces as observed in Figure 5, it is notable that the ECoF is not strongly dependent upon the fretting frequency (Figure 3). In contrast, the rate of wear is strongly dependent upon the fretting frequency, with the wear volume following fretting at 200 Hz being less than 40% of that observed following fretting at 20 Hz.

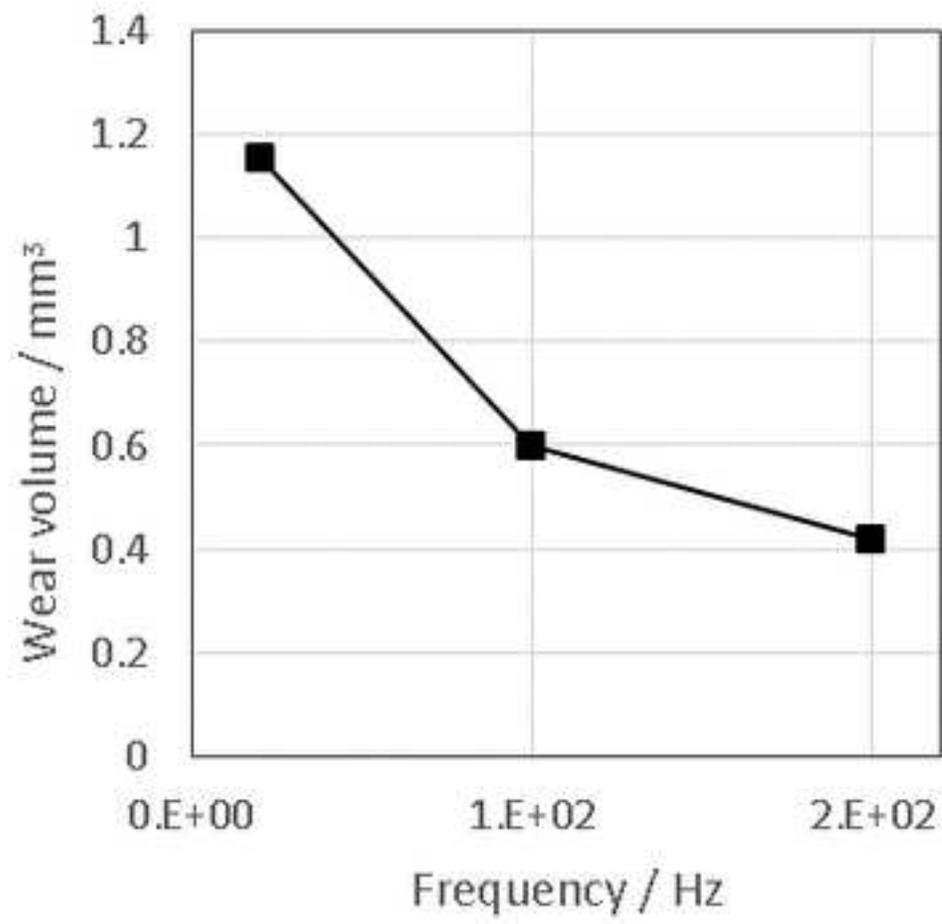
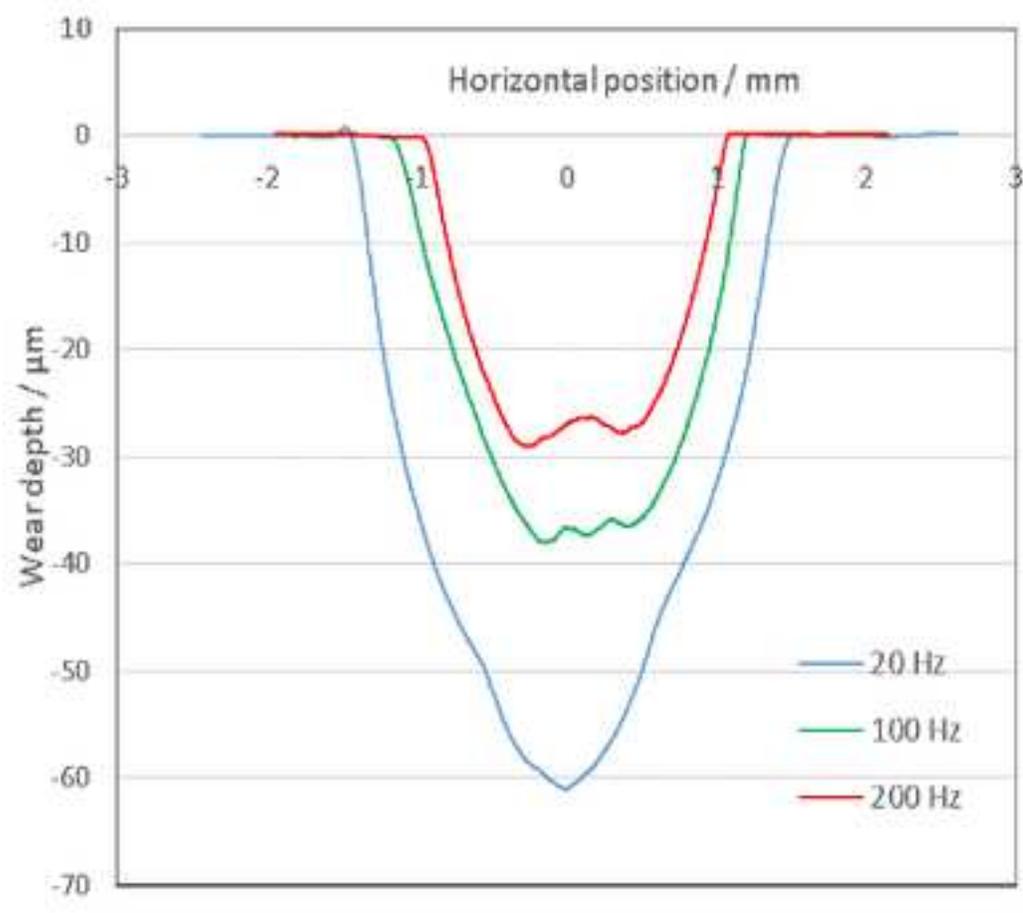
Figure 4

The extent of wear following 10⁶ fretting cycles at the three different frequencies tested, expressed in terms of the total volume of material removed from both specimens, is shown in Figure 4a. It can be seen that increasing frequency results in a significant reduction in material removal from wear, in line with observations of previous studies of frequency effects in fretting [26-28]; here, the wear volume following testing at 200 Hz is less than 40% of that following testing at 20 Hz. Average profiles of the wear scars of the flat specimens were calculated from profilometry data and are shown in Figure 4b. Both the depth and width of the wear scars is seen to decrease with increasing frequency, in accordance with the lower volume of material removal; testing at 20 Hz results in an average wear depth at the centre of ~ 60 μ m, more than twice that of the wear depth for the test conducted at 200 Hz. It can also be seen that wear profiles associated with the higher frequency tests have a raised region at the centre, resulting in a W-shaped scar, rather than the U-shaped scar exhibited at the lower frequency.

Figure 4. (a) Net total wear volume as a function of fretting frequency for the tests conducted in this study (b) average profiles of the resulting wear scars on the flat specimens from the pairs.

Figure 4b, it can be seen that the wear scar width decreases with increasing fretting frequency. Moreover, there is a more complete coverage of oxide (the darker grey areas in the BSE image) across the wear scar at the lowest frequency; as the fretting frequency increases, more patches of light grey are observed within the wear scar, indicating that the surface material is metal rather than oxide. Following fretting at 100 Hz and 200 Hz, the wear scars exhibit bright patches of metallic debris located centrally in the wear scars; these regions were observed from profilometry data to be raised compared to the surrounding material.

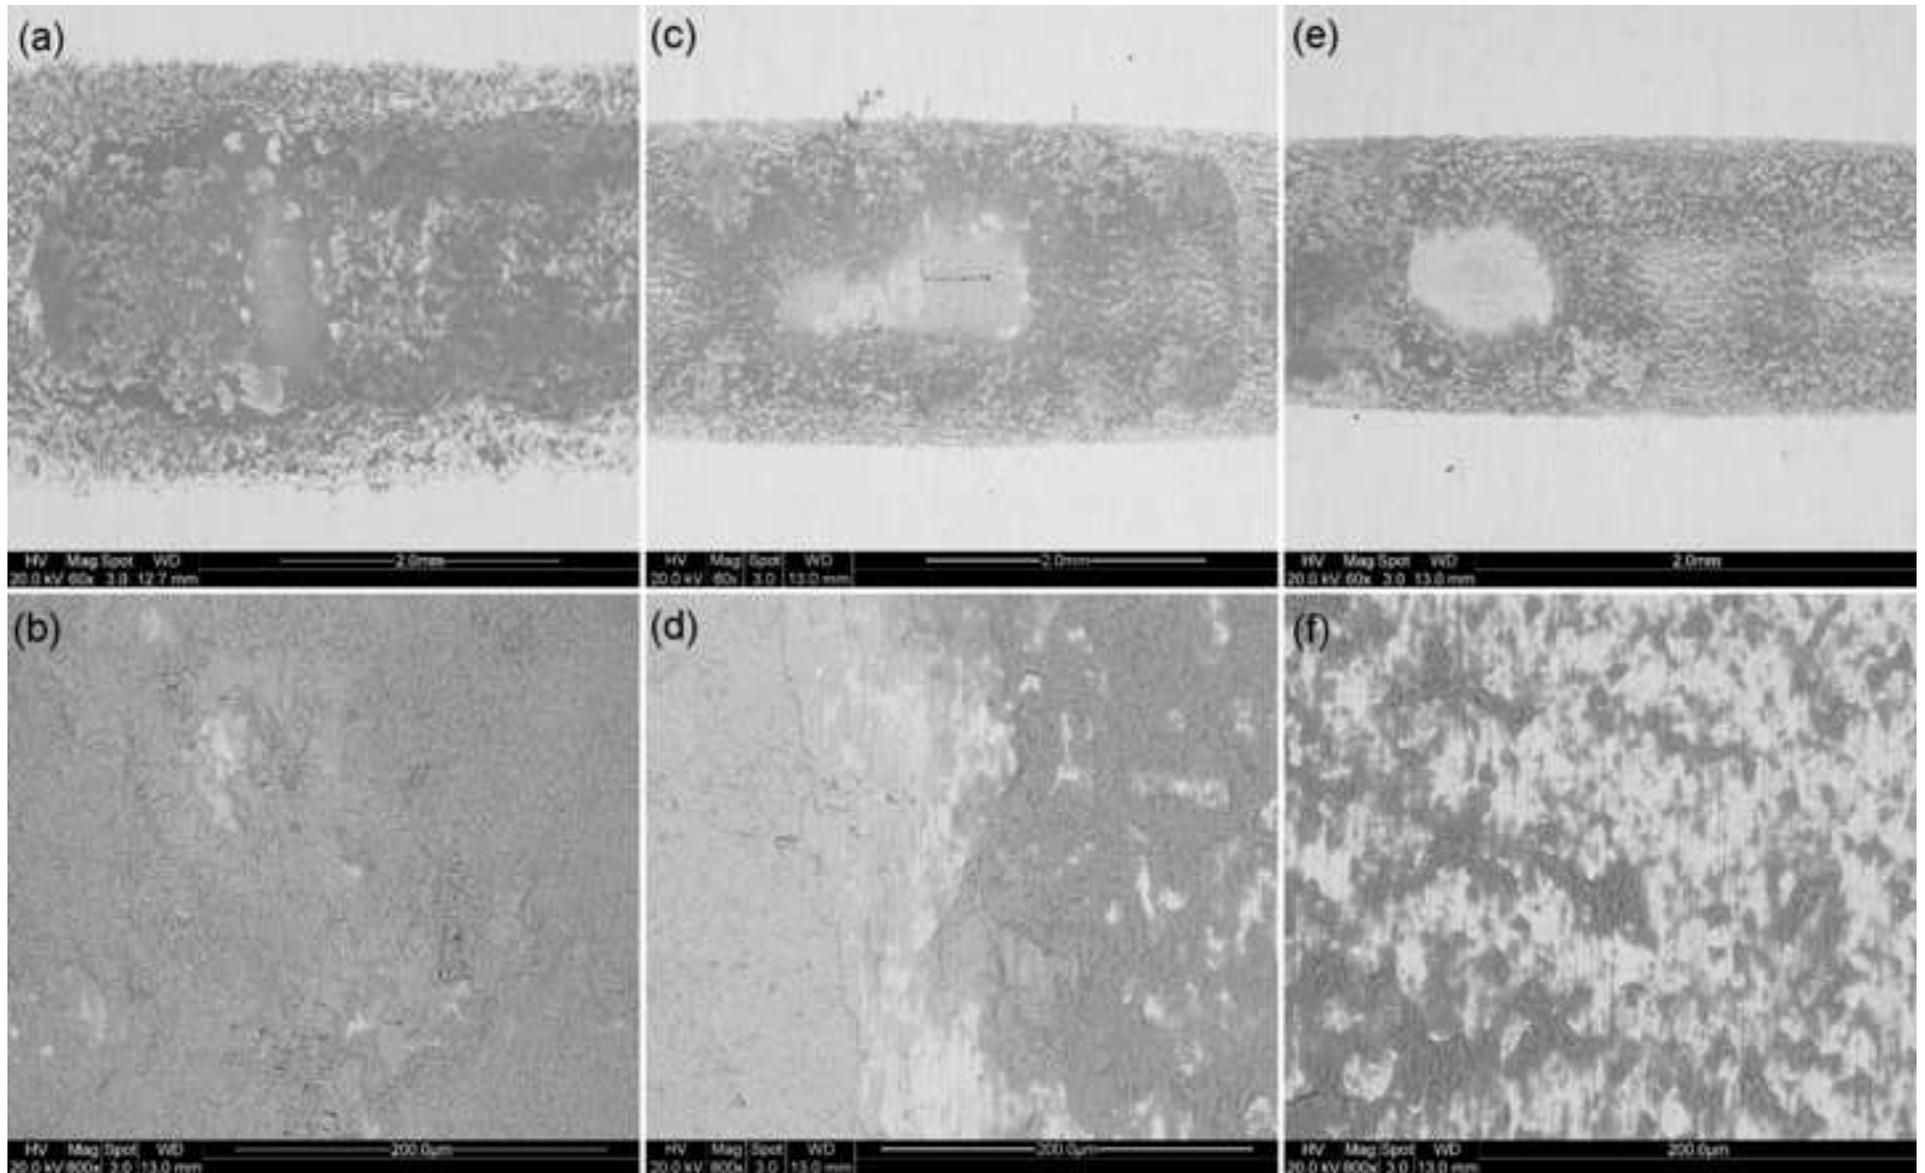
Figure 5
[Click here to download high resolution image](#)

Plan-view BSE SEM images showing the wear scars on the flat specimens from the fretting pairs are shown in Figure 5 following tests at all three frequencies. In accord with the profiles presented in

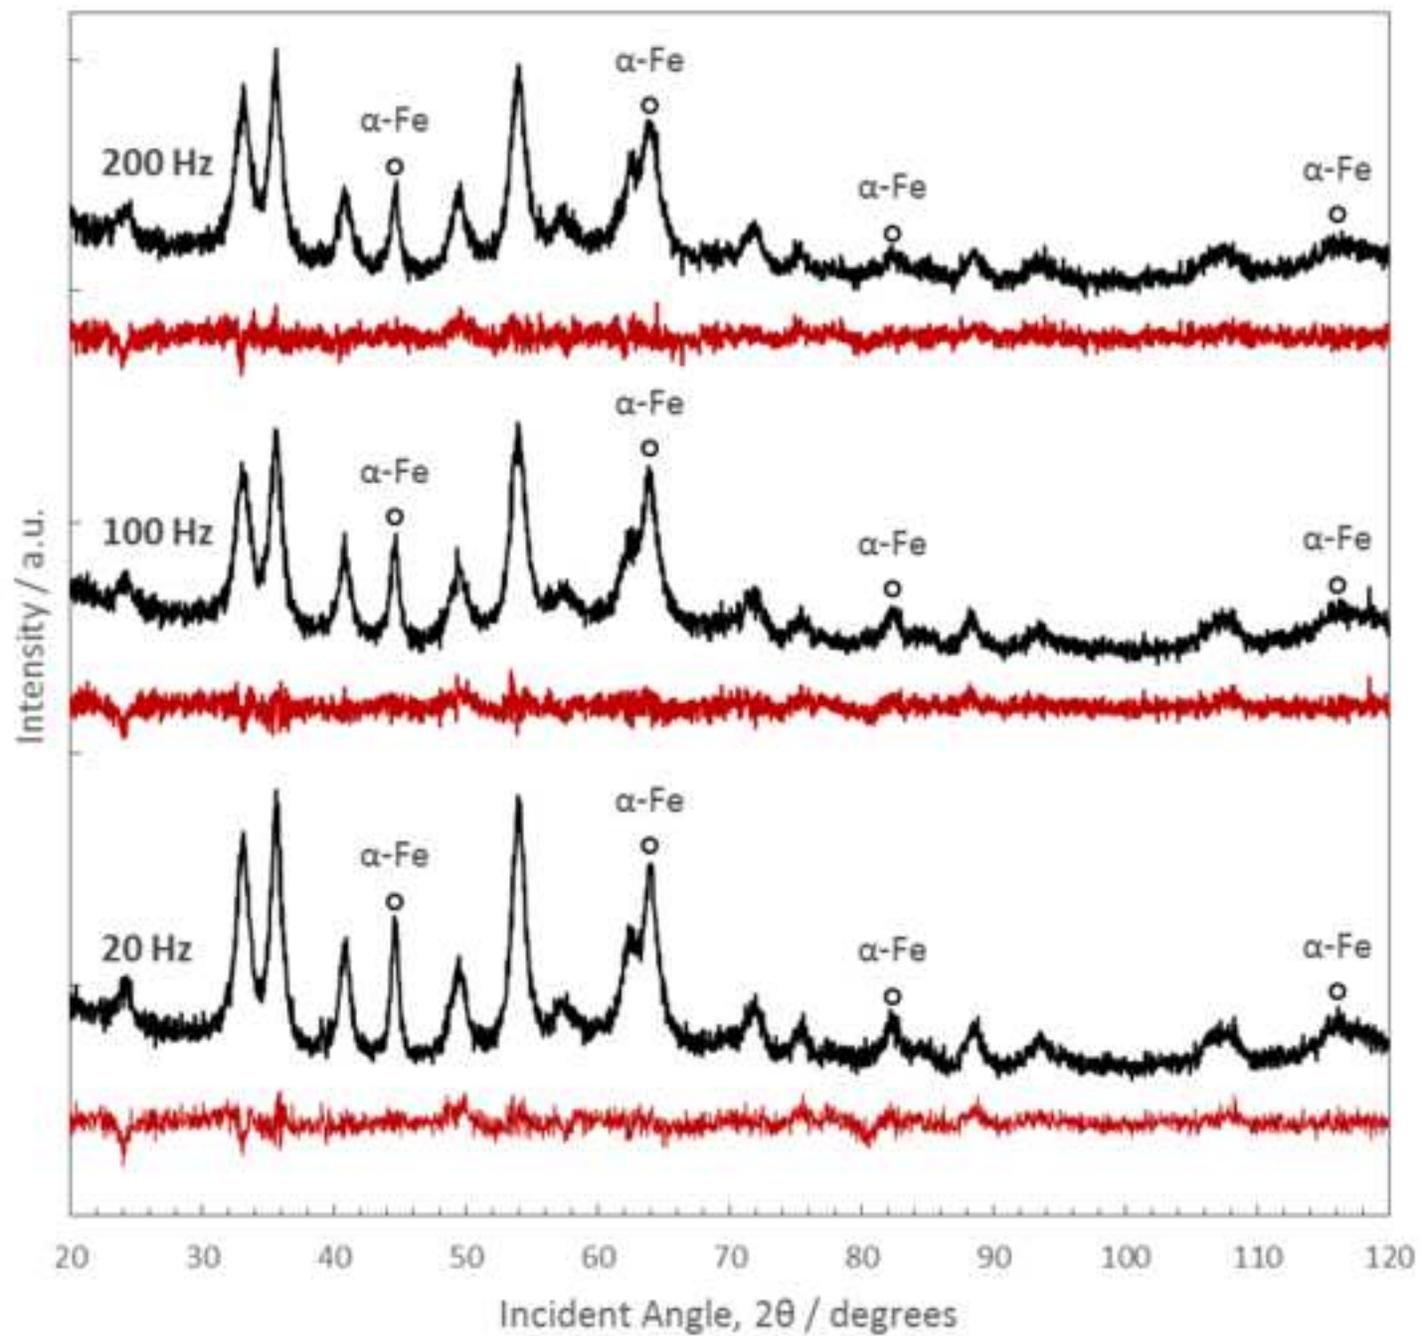
Figure 6
[Click here to download high resolution image](#)

X-ray diffraction data obtained for samples of ejected debris are shown in Figure 6, with the experimentally obtained diffraction pattern plotted with a black line and the fit with the corresponding calculated pattern obtained from Rietveld refinements performed on the data plotted directly below the experimental data in red; in all cases, the Rietveld refinement was observed to provide a good fit across the whole measured data range.

For the debris obtained from the tests conducted at all three fretting frequencies, the only phases found to be present in the ejected debris were haematite, $\alpha\text{-Fe}_2\text{O}_3$, and ferrite, $\alpha\text{-Fe}$. For clarity, only the peaks corresponding to ferrite have been marked on the diffraction patterns; the remaining peaks correspond to haematite.

The debris which is expelled from the contacts was found to consist primarily of oxide with a small fraction of metal (Figure 6), with the proportion of metal in the debris falling slightly with an increase in fretting frequency (Figure 7). Also, the debris particle size distribution was not strongly dependent upon fretting frequency, although there is some indication that higher fretting frequencies resulted in a smaller particle size distribution. Together, these observations regarding the composition and size of the ejected debris suggest that there is no fundamental difference in the mechanism of generation of the expelled debris with fretting frequency. Accordingly, it is proposed that wear (i.e. material removal) of the fretting contact is primarily controlled by oxide formation within the contact and its subsequent removal as fine debris particles, and that the reduction in oxide formation with increasing fretting frequency (due to the reduction in time between contact of asperities in which the oxide forms) is the cause of the reduced rate of wear.

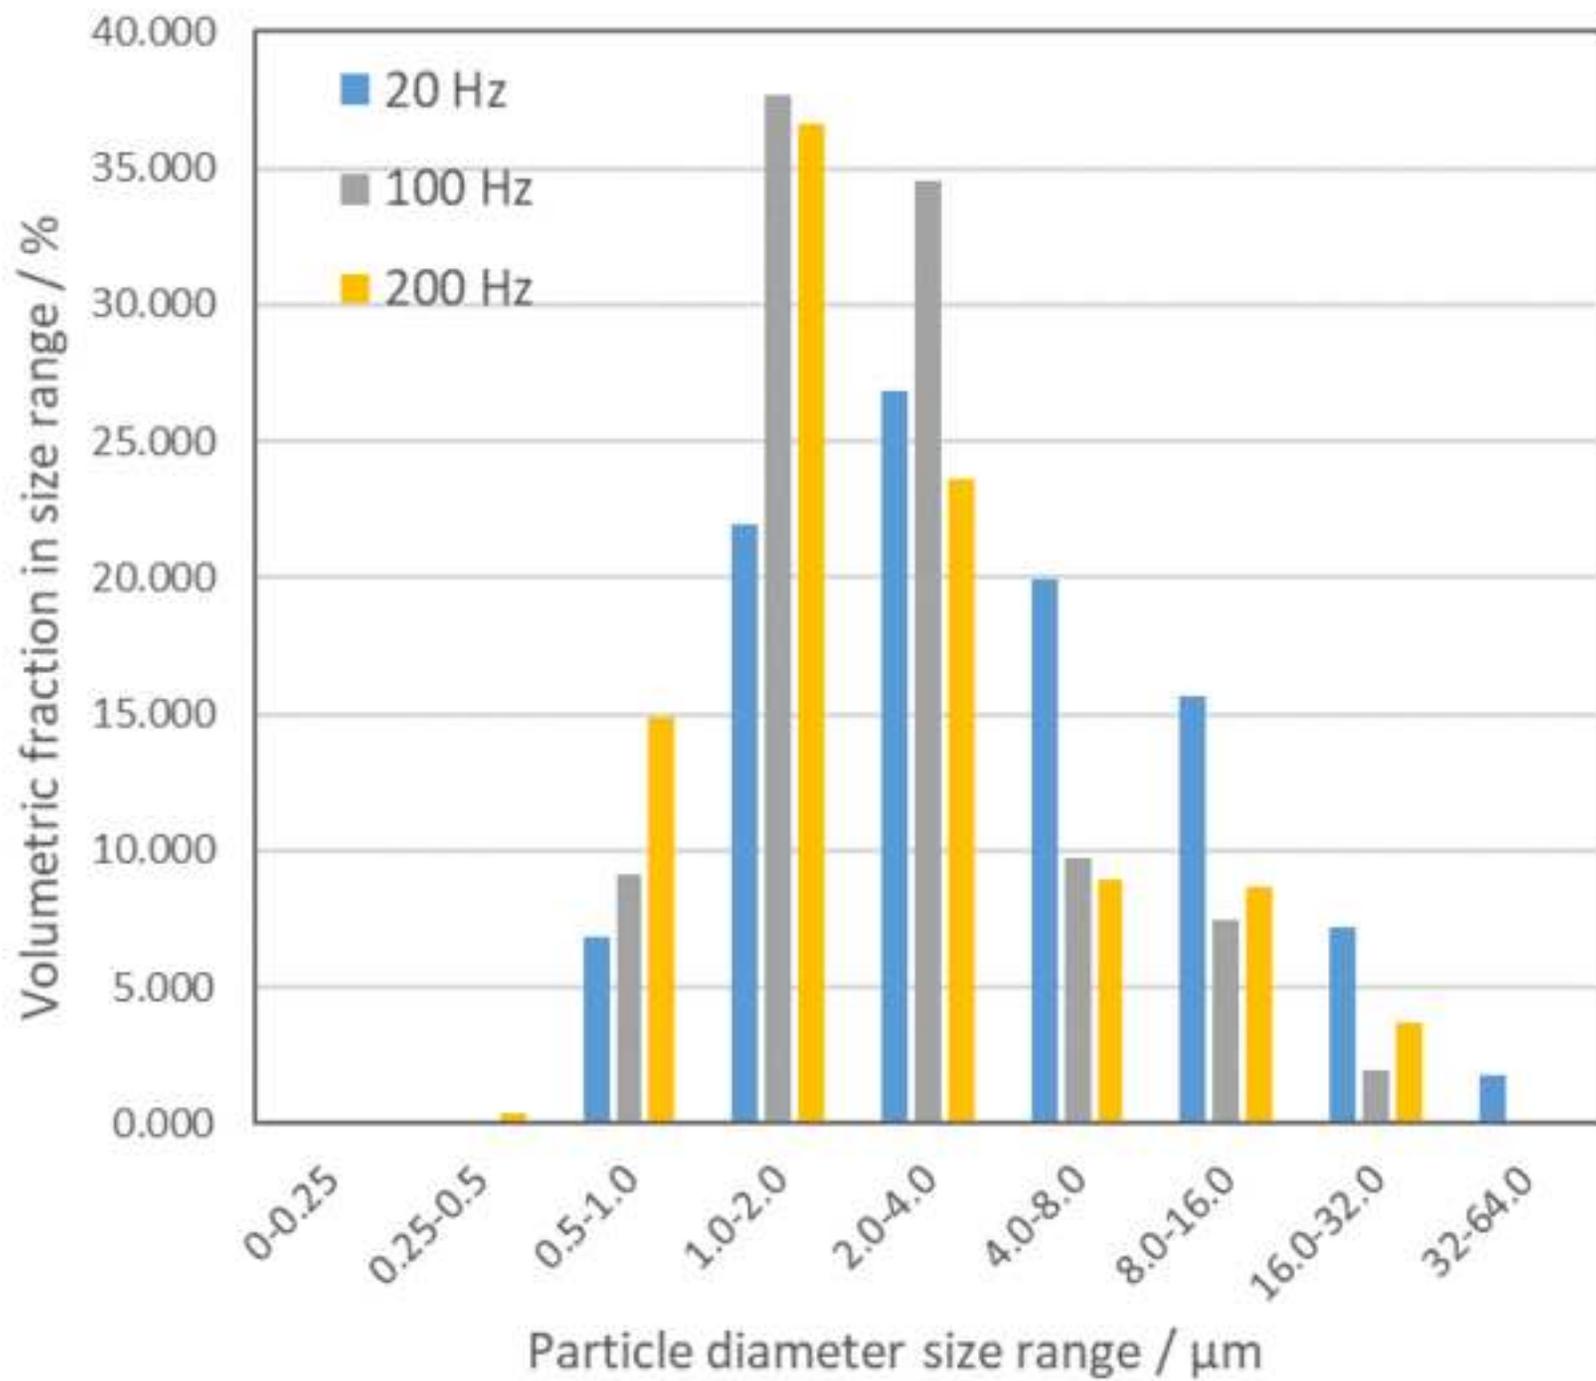
Figure 8
[Click here to download high resolution image](#)

Investigations into the particle size distribution of the ejected debris showed debris particles falling within a size range of $\sim 0.4 - 50 \mu\text{m}$ in equivalent spherical diameter (see Figure 8). The equipment used to measure particle size has a measurable range down to $0.0375 \mu\text{m}$, but no particles were observed in the measurable range below $\sim 0.4 \mu\text{m}$.

It was found that increasing fretting frequency resulted in a decrease in the maximum size of ejected particles, with no particles being observed in the $32 - 64 \mu\text{m}$ range for the 100 Hz and 200 Hz tests,

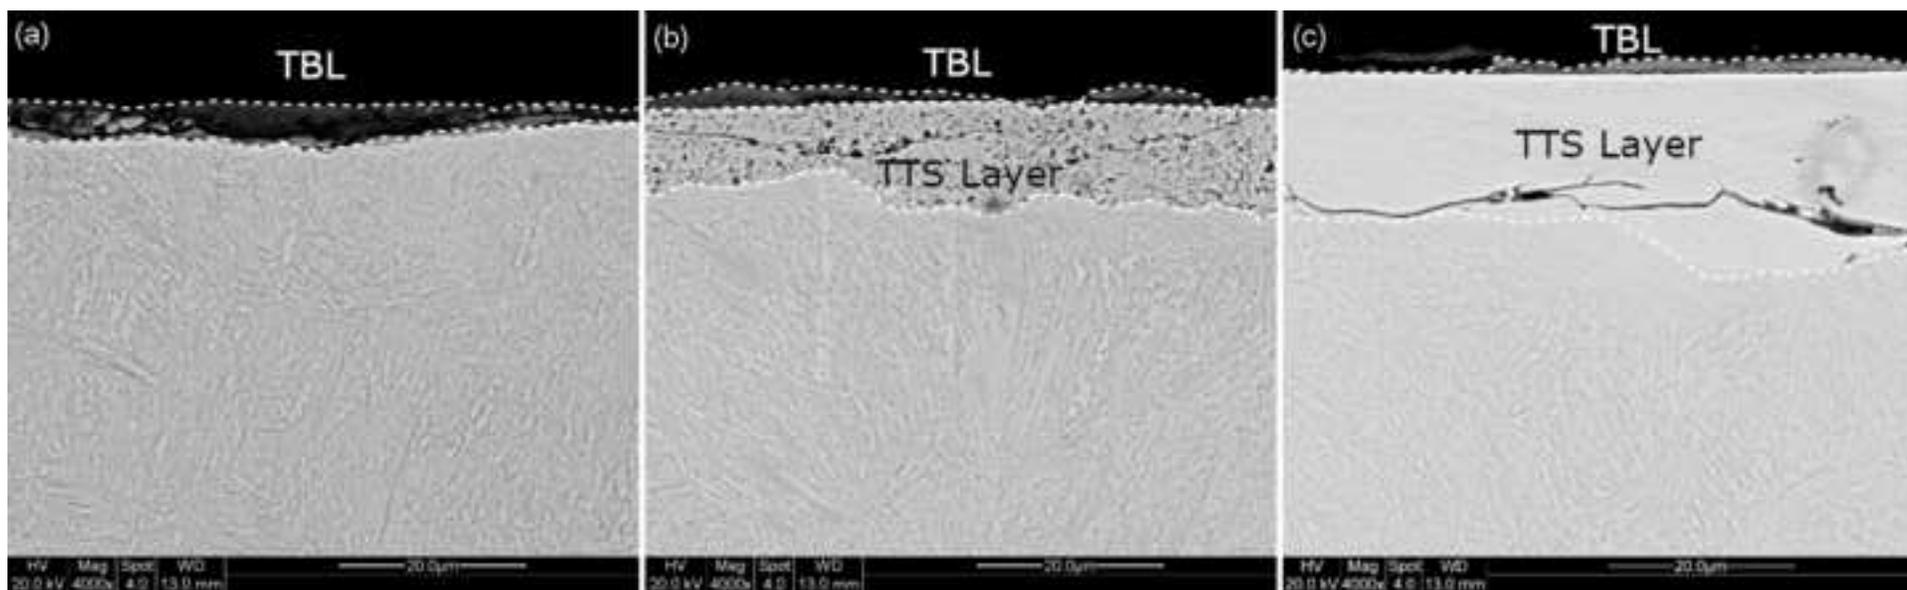
Figure 9
[Click here to download high resolution image](#)

Backscattered electron SEM images of etched specimen cross sections showing central regions of the wear scars of cylindrical specimens following fretting tests (Figure 9) show a marked difference in the appearance of the subsurface region as a function of fretting frequency. The third body layer (TBL) and TTS layers have been marked for clarity. Under each set of conditions, the general appearance of sub-surface damage was consistent over repeat tests.

Following fretting at 20 Hz (Figure 9a), there is complete coverage of the scar by an approximately 5 μm thick layer of oxide debris, identifiable as such from the dark contrast of the layer relative to the bulk metal. This layer was confirmed as iron oxide by qualitative EDX analysis. This oxide layer was observed to span the width of the scar and to be broadly uniform in thickness. This is in line with the plan-view SEM images (Figure 5) showing the corresponding flat specimen, from which oxide can be seen to cover a large proportion of the surface of the scar.

Following fretting at 100 Hz (Figure 9b), oxide coverage of the wear scar is not as complete as for the specimen tested at 20 Hz, although an oxide layer up to 2 μm in thickness is clearly visible at the scar surface. The material beneath the oxide layer, however, is significantly different in appearance at this higher frequency, appearing highly porous and severely cracked. The BSE contrast of the porous layer is much closer to that of the metallic substrate than the oxide debris layer atop it, indicating that this is a layer of metallic material rather than oxide debris. This was confirmed by qualitative EDX mapping, which showed only a slight increase in oxygen concentration in this layer relative to the bulk metal, and that this concentration was significantly lower than that of the oxide layer at the surface. A clear boundary between the porous layer and the substrate suggests that the porous layer may consist of transferred material, detached from the first bodies and then reattached to the first body (rather than being formed from material directly beneath it). Moreover, the porous metallic layer was found to extend to a width of approximately 300 μm in the wear scar, and so is only present over a small proportion of the scar which was found to be greater than 2 mm in total width (Figure 4b).

After fretting at 200 Hz (Figure 9c), the wear scar does not exhibit the porous layer visible after fretting at 100 Hz (Figure 9b). Instead, in this case, beneath a thin oxide layer on the surface, a smooth metallic layer is observed, extending to approximately 20 μm beneath the fretted surface with a crack broadly marking the boundary with the material below. Cracks can also be seen to propagate within the layer itself, although no cracks have been observed to enter into the bulk material from this layer. This smooth, cracked region was found to extend across a central region of the wear scar approximately 300 μm in width, the width and depth of the region being similar to that of the porous layer exhibited by the specimen fretted at 100 Hz (Figure 9b). Qualitative EDX mapping of this region indicated that there was no significant difference in composition (including oxygen concentration) between the highly deformed and fractured layer and the bulk material.

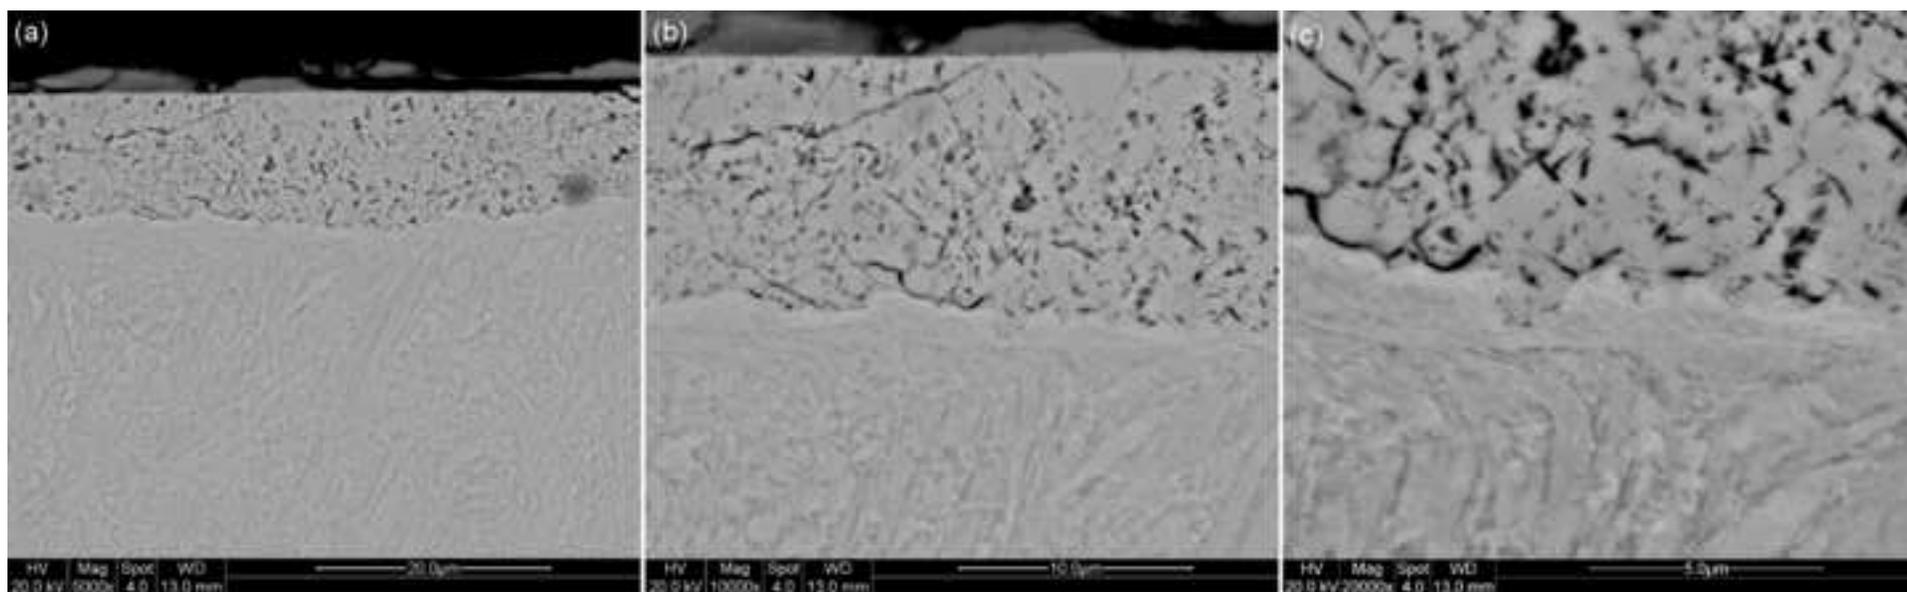
Figure 10
[Click here to download high resolution image](#)

In order to better understand the formation of the TTS, the specimens fretted at 100 Hz and 200 Hz (where the porous and cracked layers were observed respectively) were imaged at higher magnifications. Such images of the porous layer following fretting at 100 Hz are presented in Figure 10 which highlight the sharp boundary between the porous layer and the substrate. The layer appears to consist of a highly fragmented metallic structure; many of these fragments are of the order of 0.5 – 1 μm in size, but some exist which are much larger. A distinct interface between the darker transformed material and the lighter bulk material is clearly evident. Also, between the porous layer and the undeformed martensitic structure of the bulk material exists a highly sheared layer (of the order of 1 – 2 μm in thickness) which is distinct from the porous material layer and has clearly been formed by shear of the underlying material (Figure 10c).

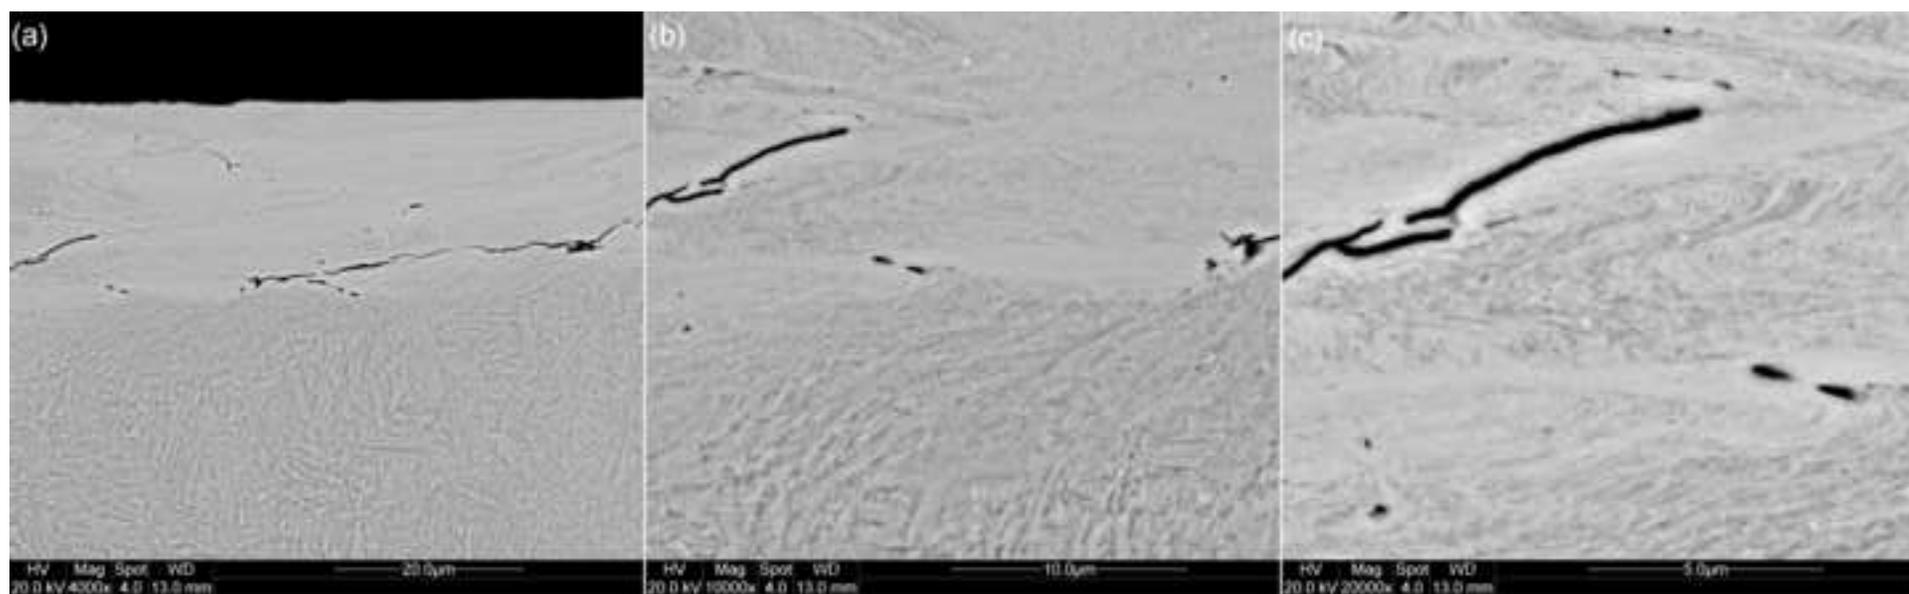
Figure 11
[Click here to download high resolution image](#)

Similar high magnification images are shown for the cylindrical specimen of a pair fretted at 200 Hz in Figure 11, in this case highlighting the extensive plastic deformation in the TTS region. Plastic shear deformation of the grains in the TTS is apparent from the difference in microstructure to that observed in the bulk of the specimen below (as clearly revealed by etching); there is clearly a general lateral texture in the TTS associated with the fretting motion, but it is also clear that there is significant microstructural variation across the TTS, with some regions showing the vestiges of the martensitic structure of the base material whilst other regions appear to exhibit much higher levels of plastic deformation (and thus etch more lightly). Cracking (with a small amount of porosity) is seen within this layer, with this being generally confined to the lightest-etching (most highly deformed) regions.

The dominant layer in the TTS in the sample fretted at 200 Hz exhibits rather different characteristics; here, vestiges of the original martensitic structure remain (Figure 11b&c) in bands, whereas in other bands this appears to have been eliminated; these latter bands are clearly more highly damaged since any cracking in this layer is confined to these regions. The microstructural features in this layer indicate that it has been heavily sheared. Moreover, this layer exhibits no increase in the oxygen level over that observed in the bulk material. As such, it is proposed that this layer does not result from any material transfer process between the two specimens in the pair, and has simply been formed by severe plastic deformation of the original subsurface bulk material.

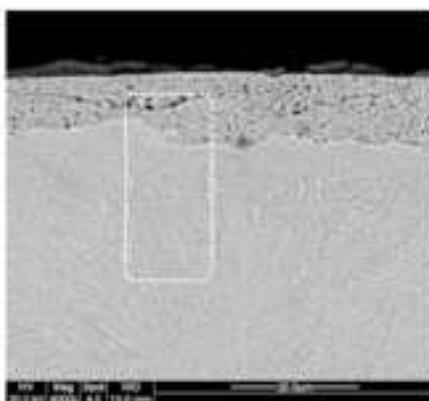
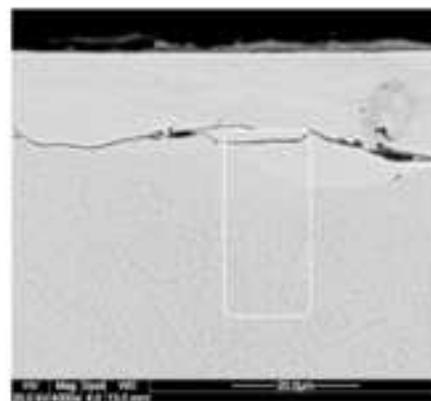
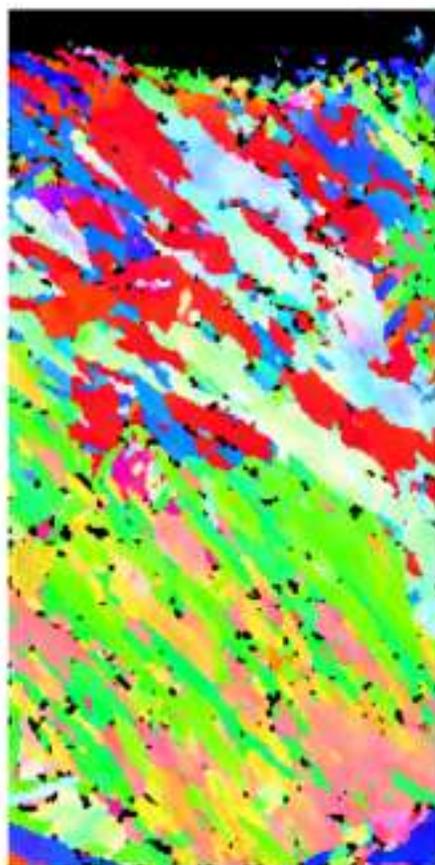
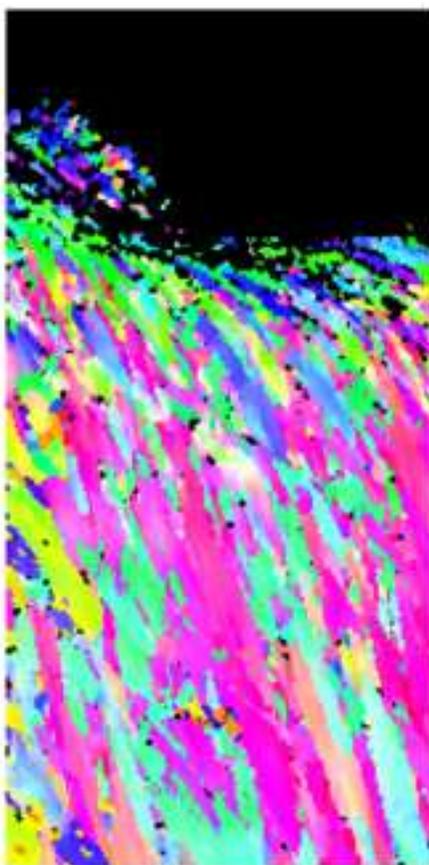
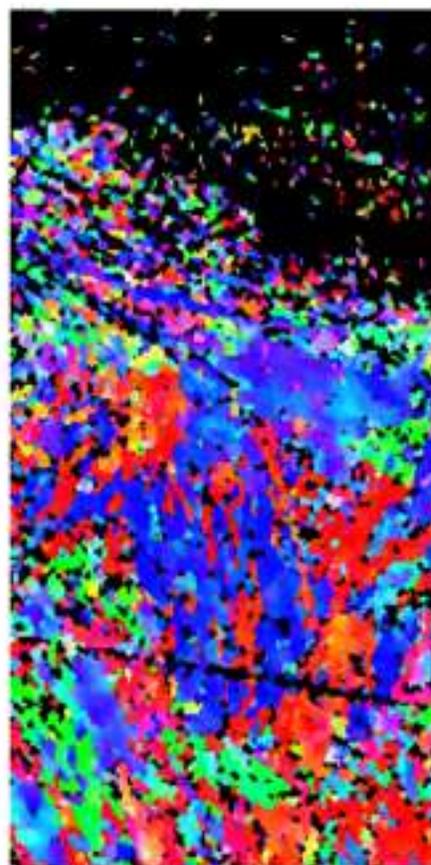
Figure 12
[Click here to download high resolution image](#)

In line with the appearance of the same specimens BSE imaged in the SEM as presented in Figure 9 - Figure 11, significant differences in microstructure of the TTS are observed for the three fretting frequencies examined. Following fretting at 20 Hz, there is very little evidence of grain deformation or refinement below the fretting surface, with the typical martensitic lath structure being visible across the whole surface, and with no clear evidence of any reorientation of the laths even very close to the fretted surface. Following fretting at 100 Hz, the EBSD image indicates that the grain structure in the bulk material exhibits shear close to the boundary between the porous layer and the bulk material (to a depth of less than 5 μm) along with a small amount of grain refinement. The black (unindexed) region at the top of the EBSD inverse pole figure represents the porous layer itself (as observed in Figure 10); the fact that this region could not be indexed in EBSD indicates a very high level of microstructural deformation and damage in this region.

Following fretting at 200 Hz, there is more evidence of deformation of laths in the martensitic structure as the TTS is approached. In the region of the TTS closest to the relatively undeformed bulk material, significant refinement of the grain structure is observed. However, within the distinct fractured layer itself, the levels of deformation are clearly very high (as observed in Figure 11), but it is notable that much more of this region is indexable in EBSD (the region towards the top of Figure 12c where, whilst mainly unindexable, there are numbers of coloured pixels where the diffraction has been indexable).

Figure 12. EBSD inverse pole figure images in central regions of the wear scars of cylindrical specimen for all frequencies tested. For the specimens fretted at 100 Hz and 200 Hz, the exact location from which the image was taken with respect to the BSE SEM images presented in Figure 9 is marked. The scale bar for the EBSD images is different to that for the BSE SEM images.

The majority of the TTS in the samples fretted at 100 Hz and 200 Hz was a layer which was distinct from the bulk material. In both cases, it was clear from the EBSD that this layer was heavily damaged microstructurally (Figure 12) and that it contained cracks and defects (Figure 10c and Figure 11c). However, the layers formed at the two frequencies are very different from each other. The damaged TTS layer in the sample fretted at 100 Hz exhibits a very fine crack pattern across the sample with no evidence of the original martensitic lath structure retained; it also exhibits a slightly higher oxygen concentration than the bulk material. It is suggested that the higher oxygen concentration indicates that this layer is (at least in part) made up of transferred material, and during this process of material transfer, some surface oxide has been incorporated into the structure. The structure has been heavily mechanically worked, which has resulted in the annihilation of the original martensitic structure; the fine crack pattern that is observed may be associated either with the agglomeration of fragments of metal into the TTS layer, or with fracture of the layer due to the high levels of damage sustained in the process of fretting for a million cycles.

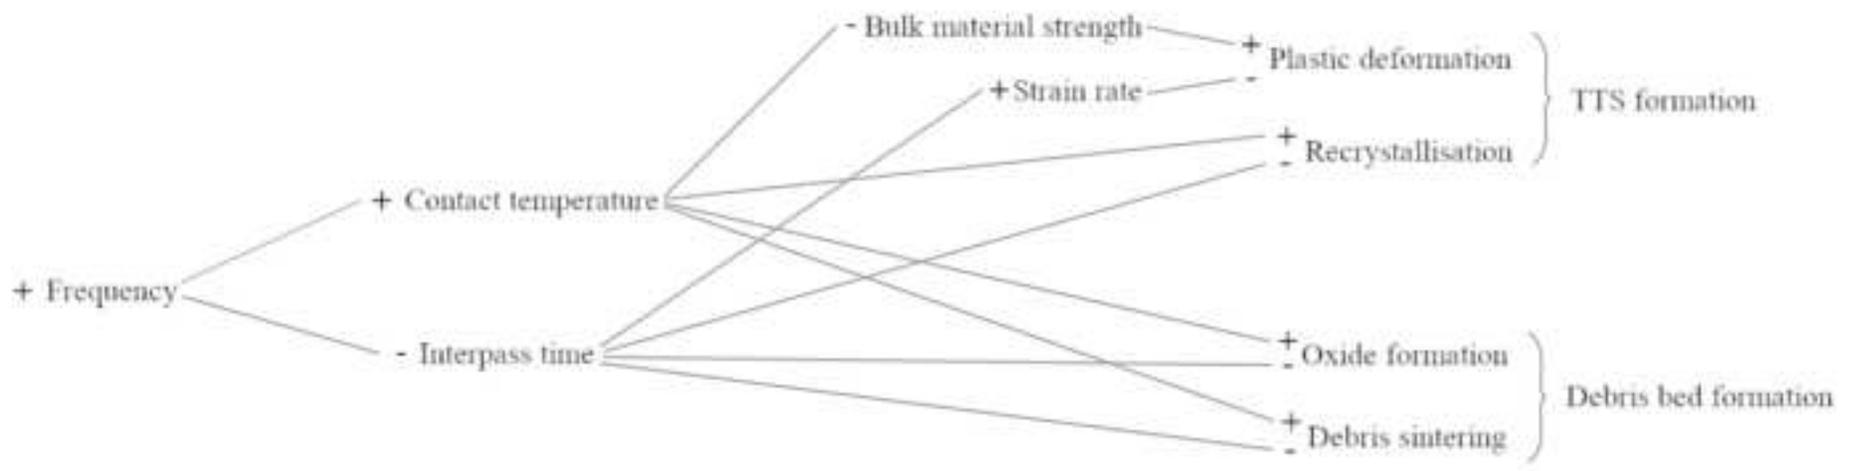
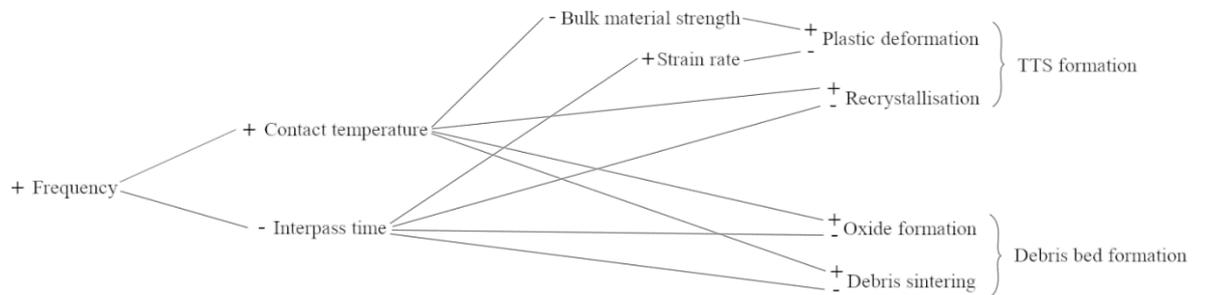
Figure 13
[Click here to download high resolution image](#)

"Given the complex interactions between physical processes brought about by changes in fretting frequency, an interaction diagram (Figure 13) has been developed to describe important relationships between key physical processes relating changes in frequency to processes affecting the development of both the TTS and the debris bed (noting that changes in the formation of the debris bed will in turn affect the development of the TTS). The symbols (+) and (-) employed indicate either a positive or negative change related to a feature of the system, with the lines indicating the links between these; for example, a

positive change (increase) in frequency results in a positive change (increase) in contact temperature and a negative change (decrease) in the interpass time.

Figure 13 - Interaction diagram representing relationships between changes in factors affecting TTS formation and debris bed formation as a result of changes in frequency.

increase in frequency causes an increase in contact temperature due to increased frictional power dissipation at the interface, promoting an increase in the rate of oxide formation, while the same increase in frequency reduces the time in which oxide can form, which leads to a decrease in the rate of oxide formation. The complex interactions between physical processes as a result of changes in frequency indicate that further work is needed in order to better understand the dependence of these mechanisms on fretting frequency and thus identify which will dominate in a particular situation.
