Performance of industrial buildings during the Emilia earthquakes in Northern Italy and recommendations for their strengthening

Dionysios A. Bournas · Paolo Negro · Fabio F. Taucer

Abstract A series of earthquakes, the highest of magnitude M_w 5.9, hit a portion of the Po Valley in Northern Italy, which was only recently classified as seismic. The paper reports the findings and the lessons learnt from a preliminary field survey which was conducted immediately after the second event. As a result of the economic attitude of the affected area, and possibly of the characteristics of the event, an unprecedented number of industrial precast buildings were affected, resulting into most of the casualties as well as in large economic losses. Whereas most of the damaged and collapsed buildings were designed for gravity loads only, evidence of poor behavior of some precast buildings designed according to seismic provisions were discovered. The paper provides a description of the performance of precast buildings, highlighting the deficiencies that led to their poor behavior as well as some preliminary recommendations.

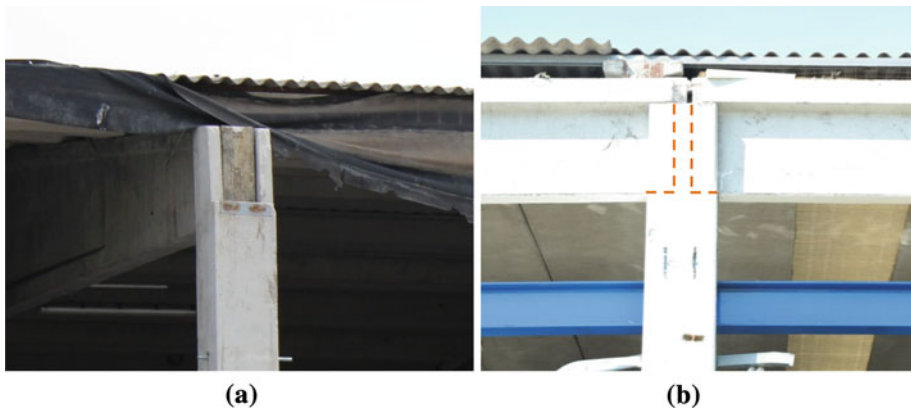
Fig. 7 **a** Seating of double slope precast beams showing the fork at the *top of the column*: seating at an *end column*. **b** Seating at an intermediate column of a “T” section beam (with *dashed lines* indicating the section of the beam at the seat pocket)

The weak link in the vast majority of the industrial buildings visited was the absence of mechanical connections between roof-girders and columns. The most common typology corresponded to double-slope beams, simply supported over special openings (forks) at the top of columns as shown in Fig. 7. This typology was used in Italy during the 60s and 70s for agricultural buildings, now being replaced by the more common flat-roof systems. In this connection typology, the capacity of transferring lateral loads depends entirely on the static coefficient of friction between the supporting surfaces of beam and column and on the length of the beam seating when the friction forces are exceeded by the earthquake force demands.

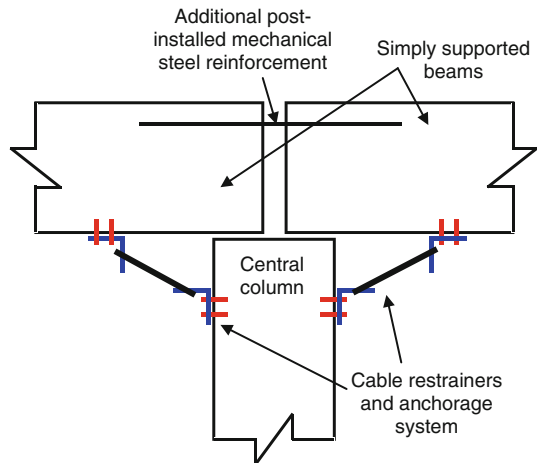
Fig. 21 General concept of a retrofit solution for industrial buildings with beams simply supported on the column top comprising seismic cable restrainers and possibly additional steel reinforcement

A proposal for the strengthening of existing industrial building consists in adopting a scheme which is used for the seismic retrofit of simply supported bridges: to reduce the likelihood of collapse due to unseating, cable restrainers are used between the girders and the piers/abutments of the bridge. Cable restrainers were first used in the United States after the collapse of several multi-frame bridges that collapsed due to unseating during the 1971 San Fernando earthquake in California (Jennings 1971). The performance of bridges in the 1989 Loma Prieta and 1994 Northridge earthquakes showed that cable restrainers were effective in limiting damage (Saïdi et al. 1993; Priestley et al. 1994; Moehle 1995). DesRoches et al. (2003) evaluated the force-displacement behavior of a cable restrainer assembly, used for the seismic retrofit of simply supported bridges. The cable restrainers were connected to the bridge pier using steel bent plates, angles, and undercut anchors embedded in the concrete as specified by typical bridge retrofit plans. The test results demonstrated that this strengthening configuration was effective in cases where seat widths were very small and relative displacements needed to be limited. The results of this study might form a good basis for future research on the use of cable restrainers for the retrofit of industrial buildings with beams simply supported at the top of columns (Fig. 21). The restrainers in such a system would be anchored at the column and beam ends, where the bending moment is minimum, with the advantage that their installation would not significantly disturb the functioning of the building.
