The May 25th 2011 Railroad Embankment Failure in Ann Arbor, Michigan, As a Means for Teaching Geotechnical Engineering

ABSTRACT: A 30-m long railroad embankment failure that occurred on May 25 2011 in the city of Ann Arbor, Michigan, is presented. Emphasis is given on the field observations of the failure, the characterization of the site conditions and the seepage and slope stability analyses, all of which represent important components of the training and practice of a geotechnical engineer. The failure occurred following a record wet season that resulted in ponding water against the embankment and high enough water pressures and exit gradients that resulted in instability of the railroad embankment. Detailed background material and the methodology for using the case history in geotechnical engineering education are presented.

International Journal of Geoengineering Case histories, Vol.3, Issue 4, p.234-245. doi: 10.4417/IJGCH-03-04-03

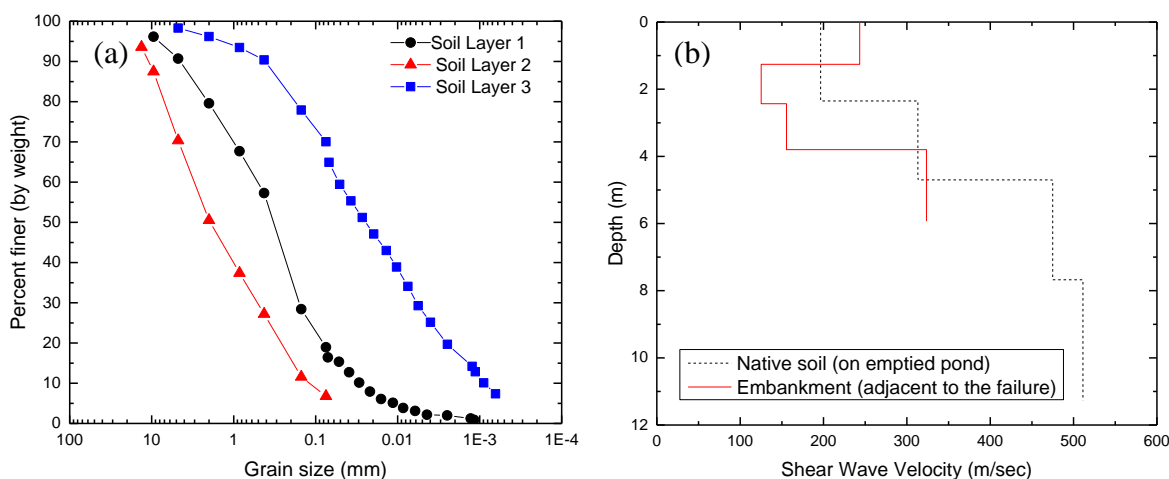
Soil Layer 1: This soil layer represents the main embankment layer, as shown in Fig. 5, and is classified per USCS as silty sand (SM). 18.9% of the material are non-plastic fines as shown in Fig. 8a. Since undisturbed samples were impossible to collect for the sandy fill, tests were conducted on reconstituted specimens at two different density states to evaluate the range of shear strengths expected for these materials. The direct shear tests were conducted in dry conditions. The shear strength of the material at a dense state was evaluated on the basis of direct shear testing, and the peak friction angle was found to be equal to 46° , whereas the post-peak was found to be equal to 38° without any cohesion, as shown in Fig. 9. The large-displacement friction angle at a dense state is approaching the peak friction angle of the soil at the loose state that was found to be equal to 35° . The hydraulic conductivity of the soil at a dry unit weight of 1.71 gr/cm^3 , was equal to $5.1 \cdot 10^{-5} \text{ cm/sec}$ based on a falling head hydraulic conductivity test conducted in the laboratory.

Figure 8. Results of (a) grain size distribution analyses and (b) in-situ shear wave velocity

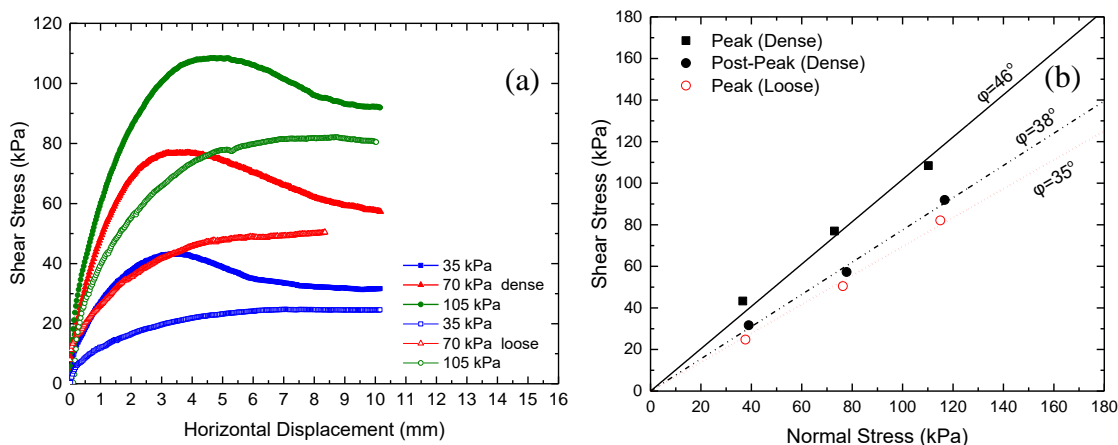
Figure 9. Direct shear results at nominal vertical stresses of 35 kPa, 70 kPa, and 105 kPa on reconstituted specimens of Soil Layer 1.
