Analysis of the tribological interaction of a polytetrafluoroethylene-lined radial lip oil seal, shaft and lubricant sample

Proc IMechE Part J:
J Engineering Tribology
1–21
© IMechE 2021

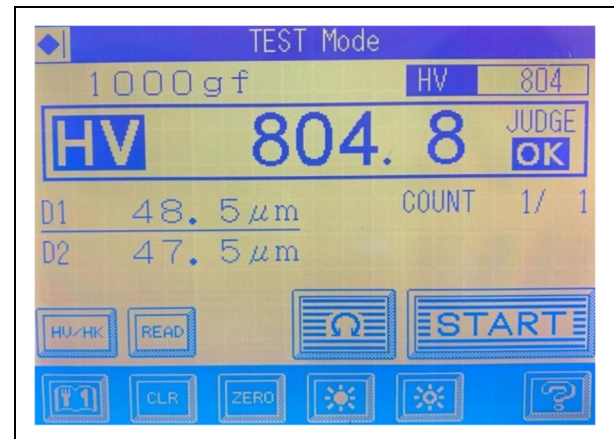
Figure 1. Micro-hardness test for sleeve indicating Vickers hardness of the specimen.

of 0.5 mm and hardness to be >55 HRC. According to DIN 3760/61, the sleeve must be hardened to at least 45 HRC, and as the running speeds increase, the HRC of the shaft must increase too. A micro-hardness test of this sleeve reveals that it has a hardness of 804.8 HV (Figure 1) which corresponds to 62 HRC. This is to cater to the high rotational speed of the test. It also specifies that the minimum depth of that hardness must be 0.3 mm. The sleeve has an inner diameter of 42 mm and an outer diameter of 52 mm. Figure 2(a) shows the top view of the sleeve and Figure 2(b) shows the surface of the seal with a wear track marked with an arrow, ~1 mm wide.

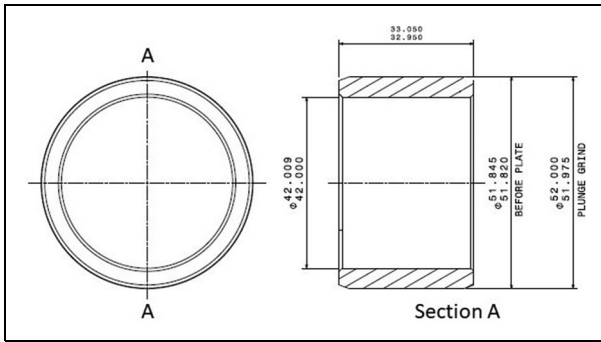
Figure 3. Engineering drawing of the sleeve showing surface plunge ground specifications.

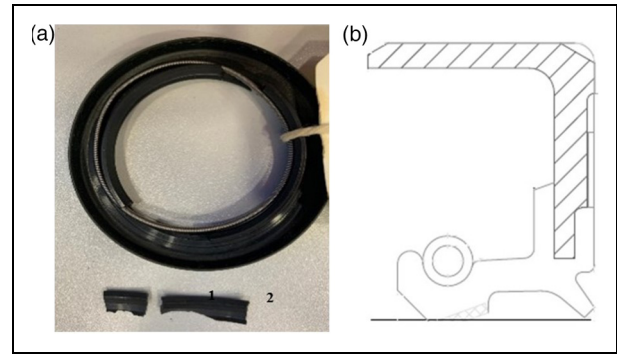
Figure 4. Dimensions of seals is inner diameter = 50 mm, outer diameter = 72 mm: (a) polytetrafluoroethylene (PTFE) radial lip seal top view (1 = 15 mm, 2 = 25 mm) and (b) drawing schematic of radial lip seal with garter spring and dust lip.

The inner diameter of the seal is 50 mm and the outer diameter is 72 mm. In Figure 4, two sections of the seal labelled 1 and 2 have been cut out for investigation. Section 1 is 15 mm in length and section 2 is 25 mm in length. Figure 4(b) is a schematic drawing of the radial lip seal. In total, three sections are analysed.

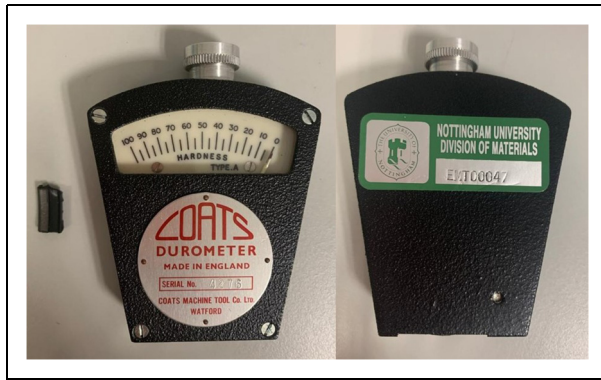
A durometer test measures the shore A of the seal elastomer using the handheld device presented in Figure 5. This test reveals that the base elastomer of the seal has a shore A of 70, which is a standard seal elastomer hardness. The seal manufacturer confirms the hardness of the base rubber of the seal as shore A 70 as well. To draw a comparison between the shore A of PTFE to this elastomer, the shore A of PTFE lies between shore A 90 and 100 (shore D, 50 and 60), but this seal is merely PTFE lined and is a very thin layer bonded onto an elastomer. Thus, the hardness of this seal is that of a standard elastomer rubber used in

Figure 5. Durometer shore A hardness for evaluating the hardness of the seal.

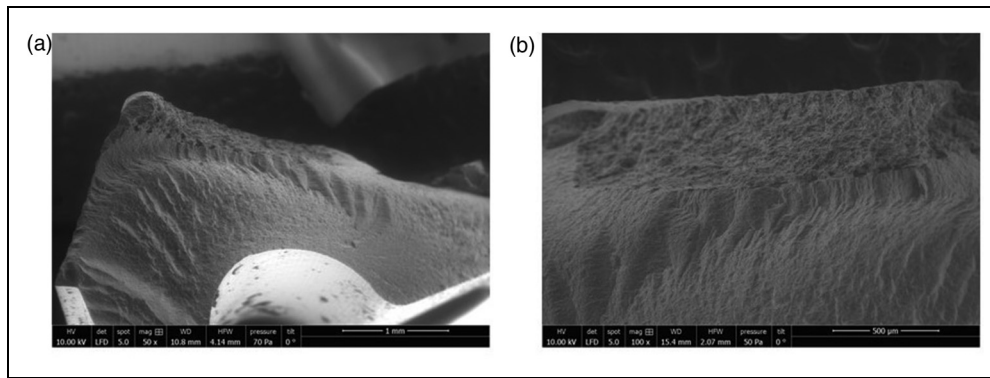
Figure 17 shows the tested seal lip, qualitatively displaying a clear line between the two textures. Figure 18 illustrates the same disparity in the new lip seal. There are two distinct layers of material present, separating the lip region from the rest of the seal. The layer on the lip is 300 μm in thickness (Figures 17(b) and 18(b)). Since the layers on the new and tested seal are identical in thickness and material, it is evident that the layer is a pre-existing surface coating of PTFE.

Figure 18. New seal fracture surface: (a) environmental scanning electron microscopy (ESEM) image of fracture surface of the seal cross-section showing a distinct layer of material coating on the seal lip and (b) magnified image of the same distinct layer measuring $\sim 300 \mu\text{m}$.

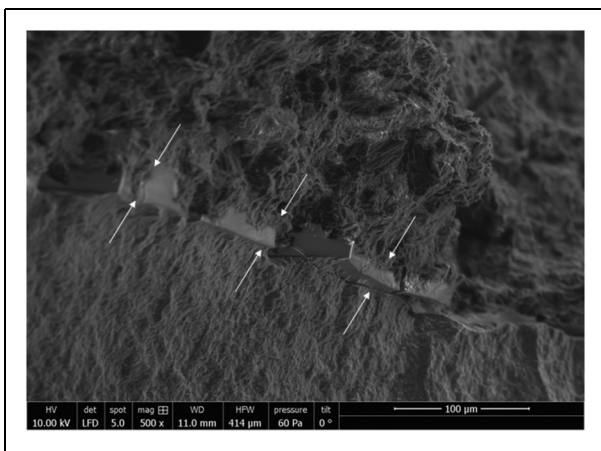
Further, there is a thin layer of material observed in between these two material compositions (Figure 19). Quantitatively, this layer is 10 μm thick.

Further, it is visible from Figure 20(a) that the top part representing the 300 μm later has a large carbon content as well. However, it is in concentrated patches. This corresponds to the darker patches evident from Figure 19 as

Figure 19. New seal fracture surface with thin layer separating lip coating from remaining seal material.

well. This indicates that this area is rich with graphite layers rather than carbon fillers and may contribute to the wear on the sleeve surface.

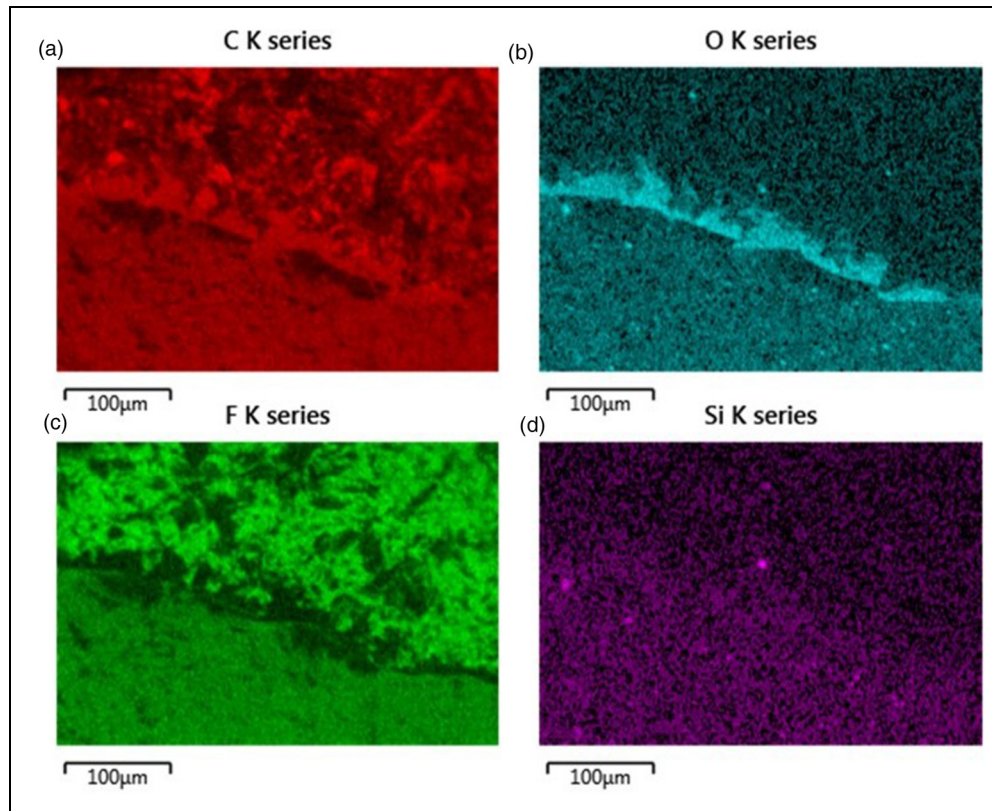
A dot map analysis presented in Figure 20 reveals that the elements identified are carbon (Figure 20(a)), oxygen (Figure 20(b)), fluorine (Figure 20(c)) and silica (Figure 20(d)).

Qualitatively, it is evident that the oxygen-rich region in Figure 20(b) corresponds to the fluorine poor region in Figure 20(c), indicating that this layer is not PTFE. This particular region does not correspond to any prominent silica-rich region, ruling out glass fibres too. This concludes that it is likely an adhesive layer applied to bind the 300 μm PTFE surface coating to the elastomer.

Figure 20. New seal fracture surface energy dispersive spectroscopy (EDS) dot map analysis: (a) carbon, (b) oxygen, (c) fluorine and (d) silica.

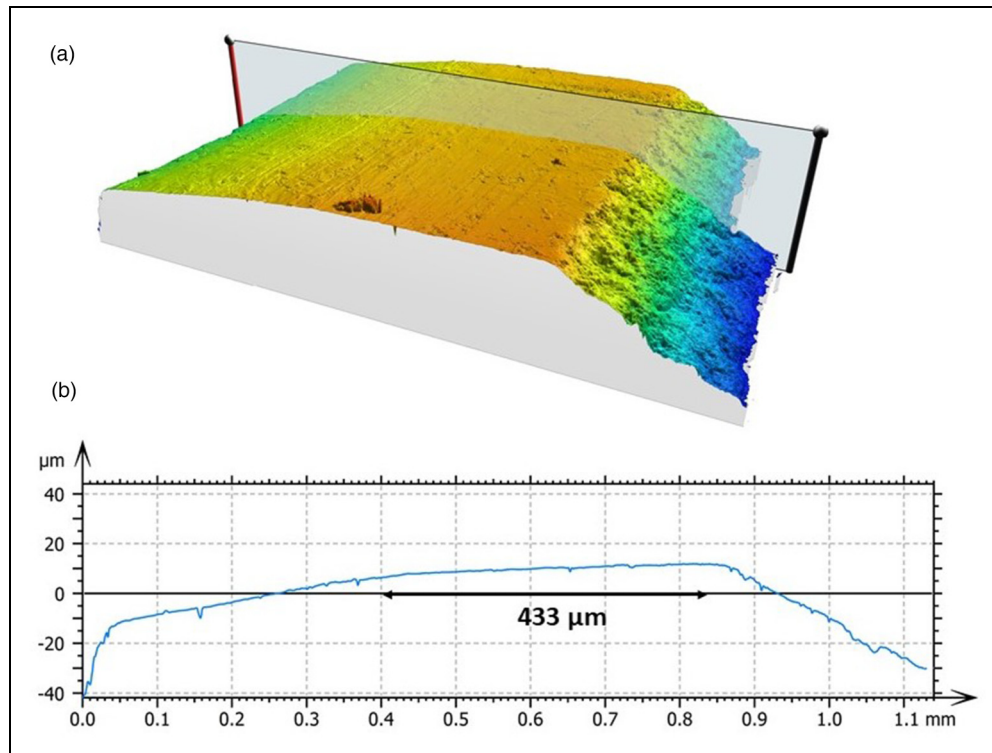
Surface topography of the seal lip. The lip region of the tested seal and a new seal is studied using the CSI. Figure 22 shows the surface topography of the used seal, measured by stitching multiple measurements across the lip area. Figure 22(a) displays a three-dimensional view of the seal lip, marked with a line to indicate the extraction of the surface profile shown in Figure 22(b). Qualitatively, Figure 22(b) reveals that the lip region has been flattened out after running on the sleeve from approximately $x = 0.4 \text{ mm}$ to $x = 0.85 \text{ mm}$.

For the peak lip region in the used seal (area marked in Figure 22(b)), an area of $433 \mu\text{m} \times 433 \mu\text{m}$ is extracted from the surface topography for measurements. For the new seal, an area of $120 \mu\text{m} \times 433 \mu\text{m}$ is extracted. As seen in Figure 21(c), the lip of a new seal is $123 \mu\text{m}$, explaining the reason for a reduced area taken for measurements compared to the used seal. An S-filter with a nesting index of $2.5 \mu\text{m}$ and an L-filter with a nesting index of $250 \mu\text{m}$ are applied.³⁴ Figure 23 displays a comparison of the new and used seal lip and Table 5 presents the calculated surface parameters.

Figure 22. Lip region: (a) a real view and (b) surface profile.

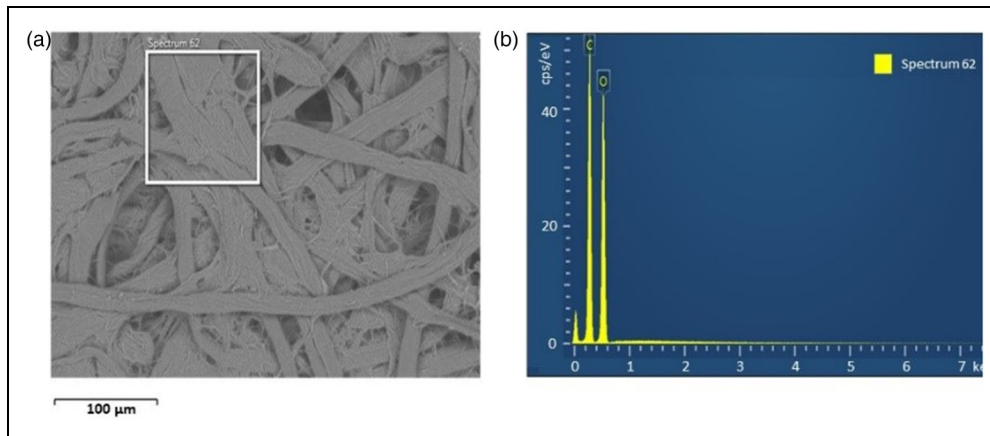
Figure 24. Filter paper analysis: (a) ESEM image and (b) EDS analysis showing elements carbon and oxygen present. ESEM: environmental scanning electron microscopy; EDS: energy dispersive spectroscopy.
