On understanding the microstructure of SiC/SiC Ceramic Matrix Composites (CMCs) after a material removal process

Abstract

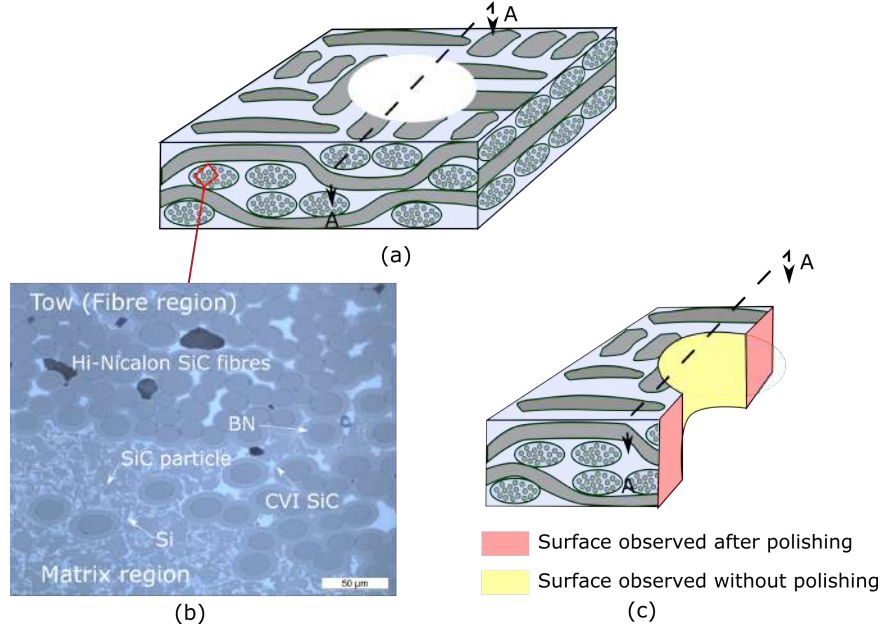
Figure 2: (a) Schematic of a CMC sample with a machined hole and showing (b) the microstructure of the “as-manufactured” CVI-MI SiC/SiC and (c) the “as-machined” surfaces to allow the evaluation of the damage induced by the machining, i.e. drilling process.

To allow for the observation of the machined surface, the drilled holes were sectioned along the height (section A-A in Fig.2a) by abrasive waterjet cutting at reduced feed rates to avoid any delamination. The sectioned “as-machined” samples were analysed in cross section after polishing (red surface in Fig.2c) and without polishing (yellow surface in Fig.2c). Furthermore, to gather the reference information from the “as-manufactured” state of the SiC-based CMC structure, several samples of the same material were polished (Fig.2b). All the samples were ultrasonic cleaned using methanol prior to the measurements.

magnitude is 1000 times greater (around $700\text{ }\mu\text{m}$) [19, 38]. The higher penetration depth presented by the SiC particles leads to a measurement where the subsurface is also analysed, adding non-affected SiC particles to the measurement and which is translated into greater standard deviations. In their work, Ghosh et al. [26] claimed to be able to calculate surface residual stresses induced by a scratch test on the SiC particles reinforcing a ZrB_2 matrix. Because of the lower concentration of SiC particles (5%), this measurement might have been more accurate, however, in the case of a SiC/SiC, the amount of SiC particles forming the MI-CMC matrix is considerably higher (as shown in Fig.2b) and the measurements can then be affected.

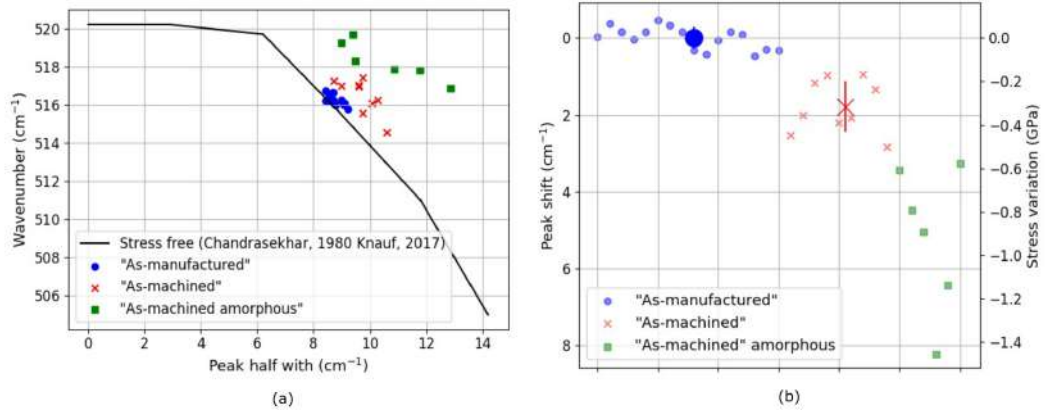
Figure 10: Raman spectroscopy results from the B-doped Si using (a) a stress free line in a wavenumber vs peak half width plot and (b) peak shift (left scale) and stress variation (right scale) using Eq.2 and normalising for the 'as-manufacturing' average.

Following the strategy defined by Knauf [20] to calculate the residual stresses in a B-doped Si with a non-constant concentration, a stress free line which considers the peak half width (as an indicator of the B concentration) and the wavenumber of the 520 cm^{-1} peak has been plotted with a black line in Fig.10a. It can be observed that initially (“as-manufactured”) the Si appears slightly under compression which shows a comparable tendency with the results from the literature [19]. However, back to back values should not be compared because in the current work a different laser wavelength is used (532 nm in the current work instead of 515 nm [31, 19]) and this can slightly influence the results. Nevertheless, as the main objective of this work is to enable deeper understanding of the effect of machining on CMC structures, the values of peak shift have been normalised by the “as-manufactured” average. It can be observed from Fig.10b that between the “as-manufactured” and the “as-machined” samples there is a variation in peak shift corresponding to $316 \pm 117\text{ MPa}$ of residual stresses in compression. However, in specific regions of the CMCs, the Raman peak shift seems to suffer a greater drop (green squares) which is directly related to a variation in the Raman spectrum.
