# Experimental and numerical investigations on the impact behaviour of pristine and patch-repaired composite laminates

The present paper investigates the impact behaviour of both pristine carbon-fibre reinforced-plastic (CFRP) composite laminates and repaired CFRP laminates. For the patch-repaired CFRP specimen, the pristine CFRP panel specimen has been damaged by cutting out a central disc of the CFRP material and then repaired using an adhesively-bonded patch of CFRP to cover the hole. Drop-weight, impact tests are performed on these two types of specimens and a numerical elastic-plastic (E-P), three-dimensional (3-D) damage model is developed and employed to simulate the impact behaviour of both types of specimen. This numerical model is meso-scale in nature and assumes that cracks initiate in the CFRP at a nano-scale, in the matrix around fibres, and trigger sub-micrometre intralaminar matrix cracks during the impact event. These localised regions of intralaminar cracking then lead to interlaminar, i.e. delamination, cracking between the neighbouring plies which possess different fibre orientations. These meso-scale, intralaminar and interlaminar, damage processes are modelled

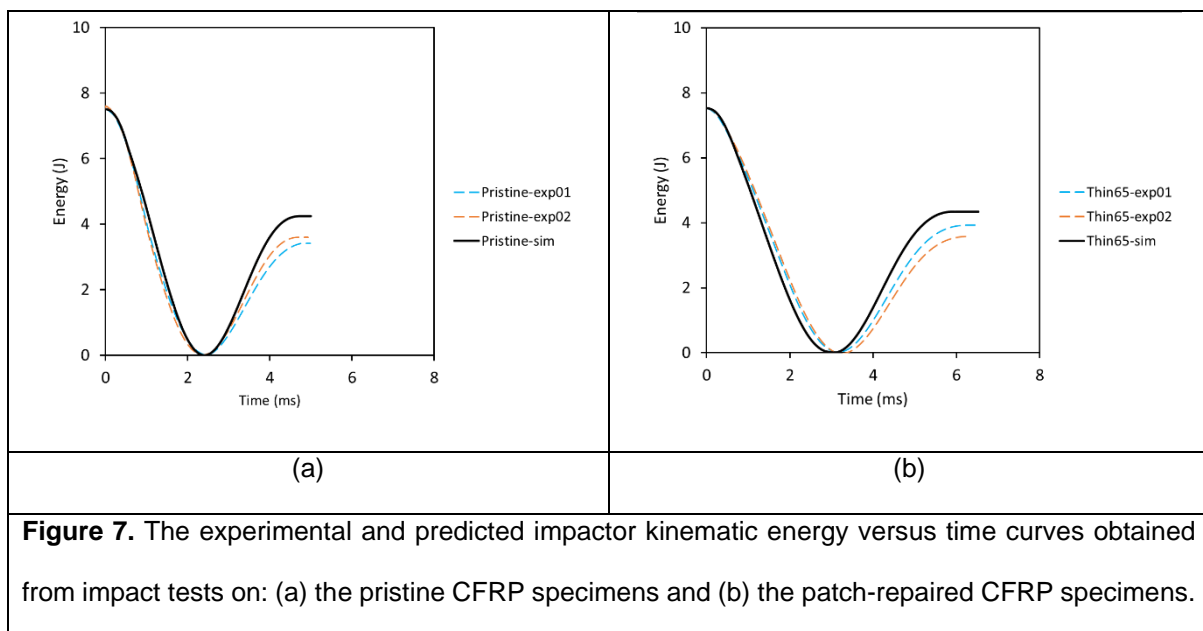
**Figure 7.** The experimental and predicted impactor kinematic energy versus time curves obtained from impact tests on: (a) the pristine CFRP specimens and (b) the patch-repaired CFRP specimens.

Figure 7 demonstrates that there is an appreciable energy loss of the impactor upon striking both the pristine and repaired specimens, which is of the order of 50%. This energy loss, which is also accurately modelled using the E-P, 3-D FEA simulations, is mainly associated with the initiation and propagation of damage processes in the pristine CFRP specimens and the CFRP patch of the repaired CFRP specimens, i.e. plastic deformation of the composite material and intralaminar and interlaminar cracking in the CFRP, as discussed below. The plastic deformation mainly occurs relatively locally around the impact site, where an indentation under the round-nosed impactor arises from the plastic deformation of the matrix. Further intralaminar damage, e.g. matrix cracking, also occurs under the impactor, which subsequently develops into the more significant damage process of interlaminar cracking.
