# HVOF and Laser-Cladded Fe–Cr–B Coating in Simulated Biomass Combustion: Microstructure and Fireside Corrosion

**Abstract** Biomass is often considered as a low carbon alternative to fossil fuels in the power industry. However, the heat exchangers in biomass plants can suffer from chloride-based aggressive fireside corrosion. A commercially available amorphous Fe–Cr–B alloy was deposited onto a stainless steel substrate by HVOF thermal spray and laser cladding. The controlled environment corrosion tests were conducted in a HCl-rich environment at 700 °C for 250 h with and without KCl deposits. The samples were examined with XRD, SEM and EDX mapping to understand the corrosion mechanisms. In the absence of any deposits, the amorphous HVOF coating performed very well with a thin oxide growth, whereas the crystalline laser cladding suffered from ~350 µm metal loss. The scales were composed of MnWO<sub>4</sub>, Fe<sub>2</sub>O<sub>3</sub>, Fe<sub>3</sub>O<sub>4</sub> and Cr<sub>2</sub>O<sub>3</sub>. When a KCl deposit was present, the HVOF-sprayed coating delaminated from the substrate and MnCl<sub>2</sub> was found in the scale.

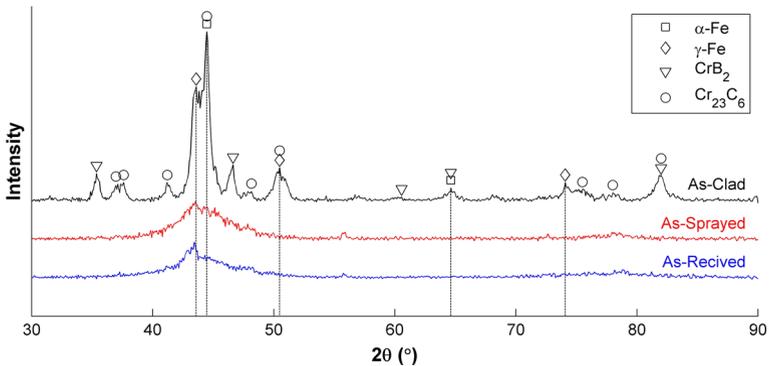
Figure 1 shows the phases that were present in the feedstock powder, the as-sprayed, and the as-clad material. The powder was predominantly amorphous with a broad hump, a typical feature of metallic glasses, seen centred around  $44^\circ$  [12].

**Fig. 1** XRD of Weartech® SHS™ 7574 powder as-received, after coating with HVOF onto a 304 stainless steel substrate and after laser cladding onto a 304 stainless steel substrate

Whilst there were no clearly defined peaks, the broad amorphous hump is centred on a  $\gamma$ -Fe reflection suggesting that some fraction of the powder had a crystalline structure.

The XRD of the HVOF-sprayed coating showed a slightly broader hump, with a less well-defined peak, corroborating the proposed beneficial effects of HVOF spray in retaining amorphous fraction in metallic glass feedstocks. The literature suggests that thermal spray can retain the amorphous fraction in the feedstock [7, 13–15]. It is suggested that this effect is due to the rapid cooling rates that occur when the molten particles from the spray process are incident on the substrate, on the order of  $10^6 \text{ k s}^{-1}$  [8]. Although after HVOF spray the coating became more amorphous, the characteristic peak of  $\alpha$ -Fe became visible. This appearance of ferrite is consistent with the process of melting and resolidification of the austenite phase observed in the as-received powder.

The laser-cladding process removed some of the amorphous fraction observed in the as-received powder. The two most prominent peaks in the XRD were still those of the  $\gamma$ -Fe and  $\alpha$ -Fe phases. There was also obvious formation of  $\text{CrB}_2$  and  $\text{Cr}_{23}\text{C}_6$ . Whilst the peaks were more defined, the patterns were much more diffuse than would be expected from a fully crystalline structure, suggesting some amorphous fraction had been retained.

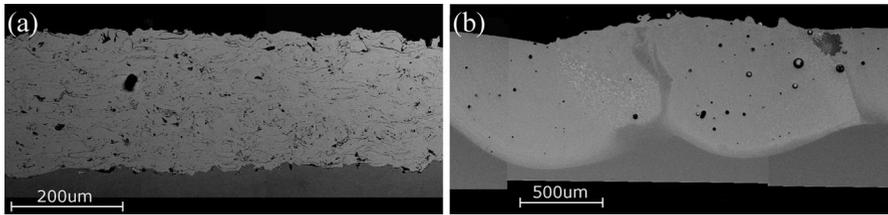
As-deposited coating cross sections can be seen in Fig. 2. The mean coating thickness before exposure was measured to be  $235 \pm 4 \mu\text{m}$  for the HVOF-sprayed coating and  $732 \pm 20 \mu\text{m}$  for the laser cladding. The HVOF coating was well bonded to the substrate, and there were no interfacial cracks present at the interface. Occasional porosities were noticed at the splat boundaries as well as within the splat. The laser cladding was metallurgically bonded to the substrate, and there were some gas pores present. Some mixing of the substrate is observed between tracks. Figure 3 shows the cross section of the coatings after exposure both without any

**Fig. 2** BSE images showing the cross-sectional microstructure of the **a** HVOF-sprayed coating and **b** laser cladding

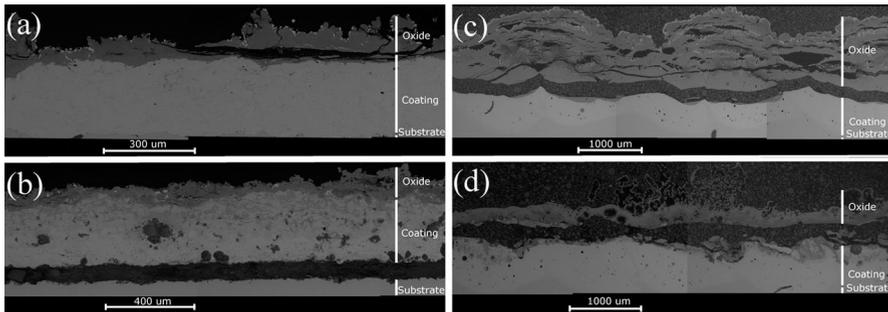
**Fig. 3** BSE images showing the cross-sectional microstructure of the **a** HVOF-sprayed coating with no deposit, **b** HVOF-sprayed coating with KCl deposit, **c** laser cladding with no deposit and **d** laser cladding with KCl deposit

deposit and with the KCl deposit at 700 °C for 250 h. The average thickness of the HVOF-sprayed coating without any deposit was  $274 \pm 3 \mu\text{m}$ , and with KCl deposit was  $276 \pm 7 \mu\text{m}$ . This minimal change in thickness has been observed in similar Fe–Cr–B coatings under similar conditions [16]. The laser cladding was strongly affected by the exposure, with an average coating thickness of  $381 \pm 24 \mu\text{m}$  for no deposit and  $557 \pm 33 \mu\text{m}$  for the KCl deposit. The HVOF-sprayed coating after exposure with KCl delaminated from the substrate.

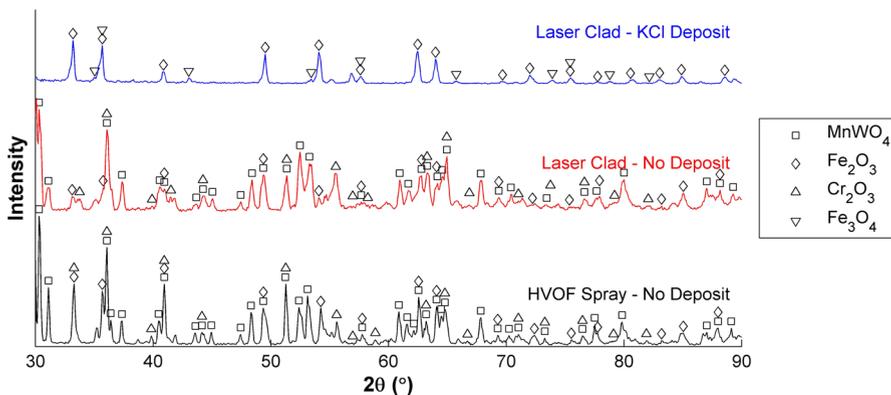
XRD analysis of the exposed coatings is shown in Fig. 4. The integrity of the HVOF-sprayed coating with KCl deposit was poor, and it was not possible to use XRD on that sample. Both the HVOF-sprayed and laser-clad samples showed strong reflections from  $\text{MnWO}_4$ , when no deposit was present. This oxide was not detected on the surface of the laser cladding with a KCl deposit.  $\text{MnWO}_4$  reacts with gaseous  $\text{Cl}_2$  to form  $\text{MnCl}_2$  and  $\text{WO}_2\text{Cl}_2$  [17]. No chlorides were detected on the surface of the samples without any deposit, suggesting that HCl from the gas did not react to form chlorides, and instead the KCl deposit was providing the gaseous  $\text{Cl}_2$  needed for the removal of  $\text{MnWO}_4$ .  $\text{Cr}_2\text{O}_3$  is another phase that was observed in both the HVOF-sprayed and laser-clad samples without any deposit, but not when KCl was present. The phase most dominant across all of the samples, however, was  $\text{Fe}_2\text{O}_3$ . On the laser-clad sample with the KCl deposit, the only other major phase identified other than  $\text{Fe}_2\text{O}_3$  was  $\text{Fe}_3\text{O}_4$ . It is well established that  $\text{Fe}_2\text{O}_3$  and  $\text{Fe}_3\text{O}_4$  are much less protective than  $\text{Cr}_2\text{O}_3$ . This suggests when KCl was involved the clad material, with 25 wt% Cr, failed to form a protective chromia layer.

**Fig. 4** XRD of HVOF and laser-clad samples after exposure

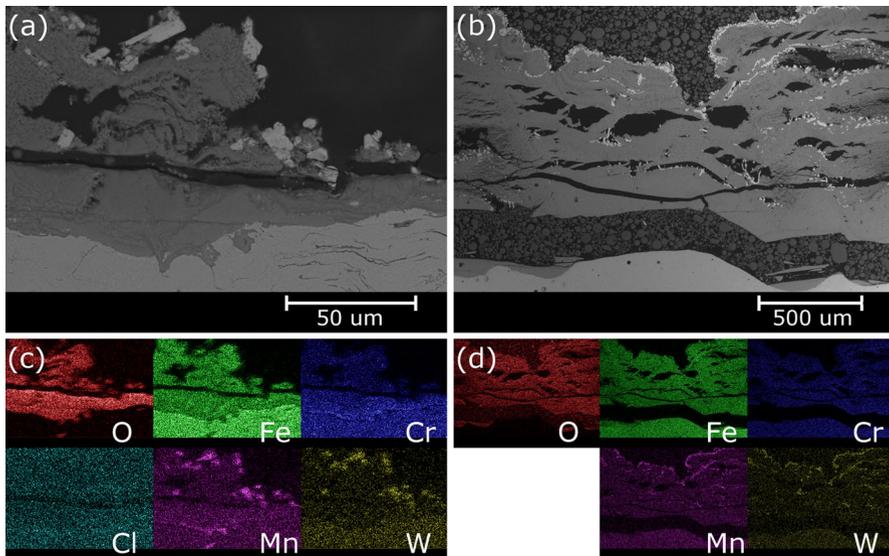
Figure 5 shows the cross-sectional images of both the samples without any deposit and corresponding EDX maps. Figure 5a shows a thick dark contrast oxide layer with a bright oxide phase on top. The external oxide layer was mainly composed of Fe and O with a small amount of Cr. This is likely to be a combination of  $\text{Fe}_2\text{O}_3$  and  $\text{Fe}_3\text{O}_4$  as determined by XRD. The  $\text{Cr}_2\text{O}_3$ , which was also detected in XRD, is underneath the Fe-rich oxide.  $\text{MnWO}_4$  was located on the top surface of the Fe-rich oxide. Cl was not detected in EDX maps in the cross section, suggesting that HCl did not react with the coating to form any chlorides.

The laser-clad sample is shown in Fig. 5b. The scale thickness was significantly more than that of the HVOF-sprayed sample. It showed many of the same phases as those found in the HVOF-sprayed sample. The oxide layer was mainly composed of Fe, Cr and O, with the Cr present in higher quantities towards the scale-coating

**Fig. 5** Cross-sectional BSE images of the HVOF-sprayed (a) and laser-clad (b) samples after 250 h at 700 °C with no deposit. The corresponding EDX maps are shown in c for HVOF coating and d for laser cladding

interface. EDX analysis of these regions showed the oxides were likely of the same composition as those found in the HVOF-sprayed sample.  $\text{MnWO}_4$  was also present in the scale of the laser-clad sample, as was confirmed with EDX mapping and XRD.

Unlike the samples with no deposits seen in Fig. 5, these KCl-covered samples did not show the  $\text{MnWO}_4$  phase. A Cr-rich oxide formed underneath the  $\text{MnCl}_2$ . This Cr-rich layer did not contain any Fe, although no  $\text{Cr}_2\text{O}_3$  was detected in the XRD due to the thickness of the mixed corrosion products. The laser-clad sample after 250-h exposure is shown in Fig. 6b where the mixed corrosion product layer was observed to be over 300  $\mu\text{m}$  thick. The outer oxide was a Fe-rich oxide which was porous at the top. The Cr was only detected below the Fe oxide, an area which

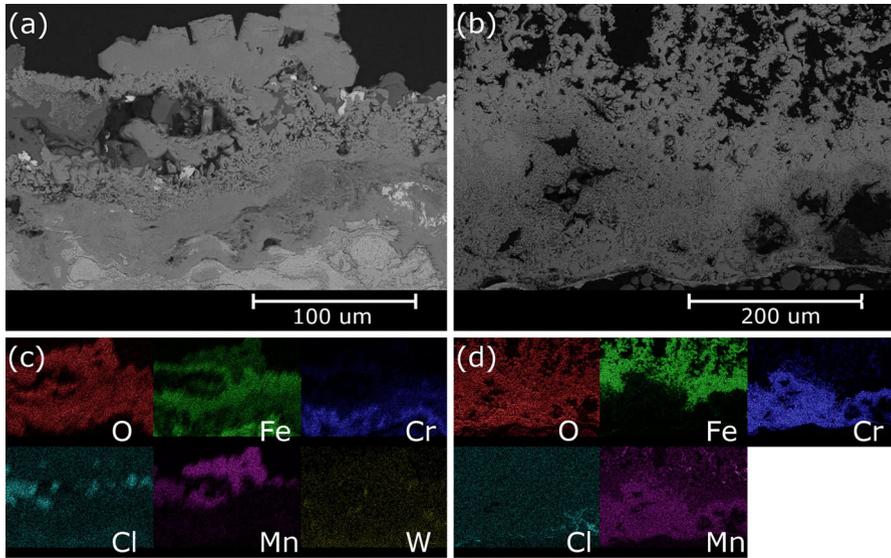
The cross-sectional images of the samples with deposits are shown in Fig. 6. When comparing these cross sections to those with the KCl deposit, the most noticeable difference was the presence of Cl in the scales. Mn and O were detected on the outside of the scale with a Fe-rich oxide formed underneath. EDX maps showed another Mn-rich layer contained Cl embedded within this Fe-rich oxide. EDX spot analysis suggested its composition is close to  $\text{MnCl}_2$ . One mechanism for the formation of  $\text{MnCl}_2$  is through  $\text{MnO}_2$  interacting with HCl via Eq. (1) [18]. This formation process is corroborated by the presence of Mn and O which is seen in Fig. 6a as the cubic, fan-like structure at the surface of the sample.

**Fig. 6** Cross-sectional BSE images of the HVOF-sprayed (a) and laser-clad (b) samples after 250 h at 700 °C with KCl deposit. The corresponding EDX maps are shown in c for HVOF coating and d for laser cladding

also contains Mn. This was a mixture of Cr and Mn oxides although there was no Cr or Mn phase detected in the XRD due to the small penetration depth. Cl was detected underneath the oxide scales, suggesting that the scales were not protective in nature. Cl ions can migrate through the non-protective oxide readily.

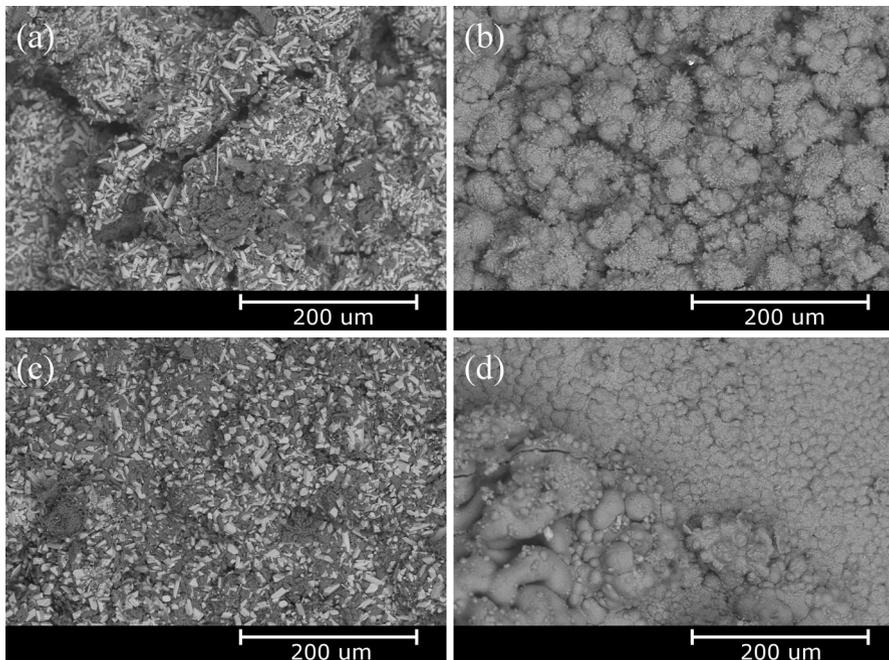
Figure 7a, c showed the morphology of the oxide scales grown on the HVOF-sprayed coating and laser cladding without any deposit. In both cases, the bright phase in the BSE image was detected to be  $\text{MnWO}_4$ . The oxides were rod shaped and grew up to 20  $\mu\text{m}$  in length on the HVOF-sprayed coating.

The top surface of the HVOF-sprayed coating with KCl deposit, Fig. 7b, showed two morphologically different phases. There was an iron oxide phase making up the bulk of the surface similar to all of the other samples; however, this sample was unique in that it had a second, diamond-shaped, iron oxide.

Similarly, there were two distinct textures that could be seen on the surface of the laser-clad sample with a KCl deposit, Fig. 7d. Small globular-shaped oxides formed the majority of the sample surface, which comprised of Fe and O. EDX and XRD analysis showed it to be  $\text{Fe}_2\text{O}_3$ . EDX analysis did not detect any Cr, suggesting this was a very thick region of  $\text{Fe}_2\text{O}_3$ . The other region seen on the bottom of Fig. 7d showed this is a mix of  $\text{Fe}_2\text{O}_3$  and  $\text{Cr}_2\text{O}_3$ .

**Fig. 7** Top surface after 250 h in 500 ppm HCl, 5% O<sub>2</sub>, N<sub>2</sub> Bal. at 700 °C **a** HVOF spray with no deposit, **b** HVOF spray with KCl deposit, **c** laser cladding with no deposit, **d** laser cladding with HCl deposit
