# Application of small punch creep testing to a thermally sprayed CoNiCrAlY bond coat

High velocity oxy-fuel thermal spraying was used to prepare free-standing CoNiCrAlY (Co-31.7%Ni-20.8%Cr-8.1%Al-0.5%Y (wt%)) bond coat alloy samples approximately 0.5 mm thick. Creep tests were conducted at 750 °C on these samples using a small punch (SP) creep test method. The samples were characterised before and after creep testing using scanning electron microscopy with electron backscatter diffraction (EBSD). EBSD revealed a two phase fcc  $\gamma$ -Ni and bcc B2  $\beta$ -NiAl microstructure with grain sizes ~  $1-2 \mu m$  for both phases, which did not change significantly following testing. The constant temperature SP test data were characterised by a minimum creep strain rate,  $\dot{\varepsilon}_{min}$ , and a total time to failure, t<sub>f</sub>, at different applied stresses. The data are fitted to conventional power law equations with a stress exponent for creep close to 8 in the Norton power law and between 7 and 10 in the Monkman-Grant creep rupture law. Creep rupture was predominantly due to creep cavitation voids nucleating at both the  $\gamma - \beta$  interphase boundaries and

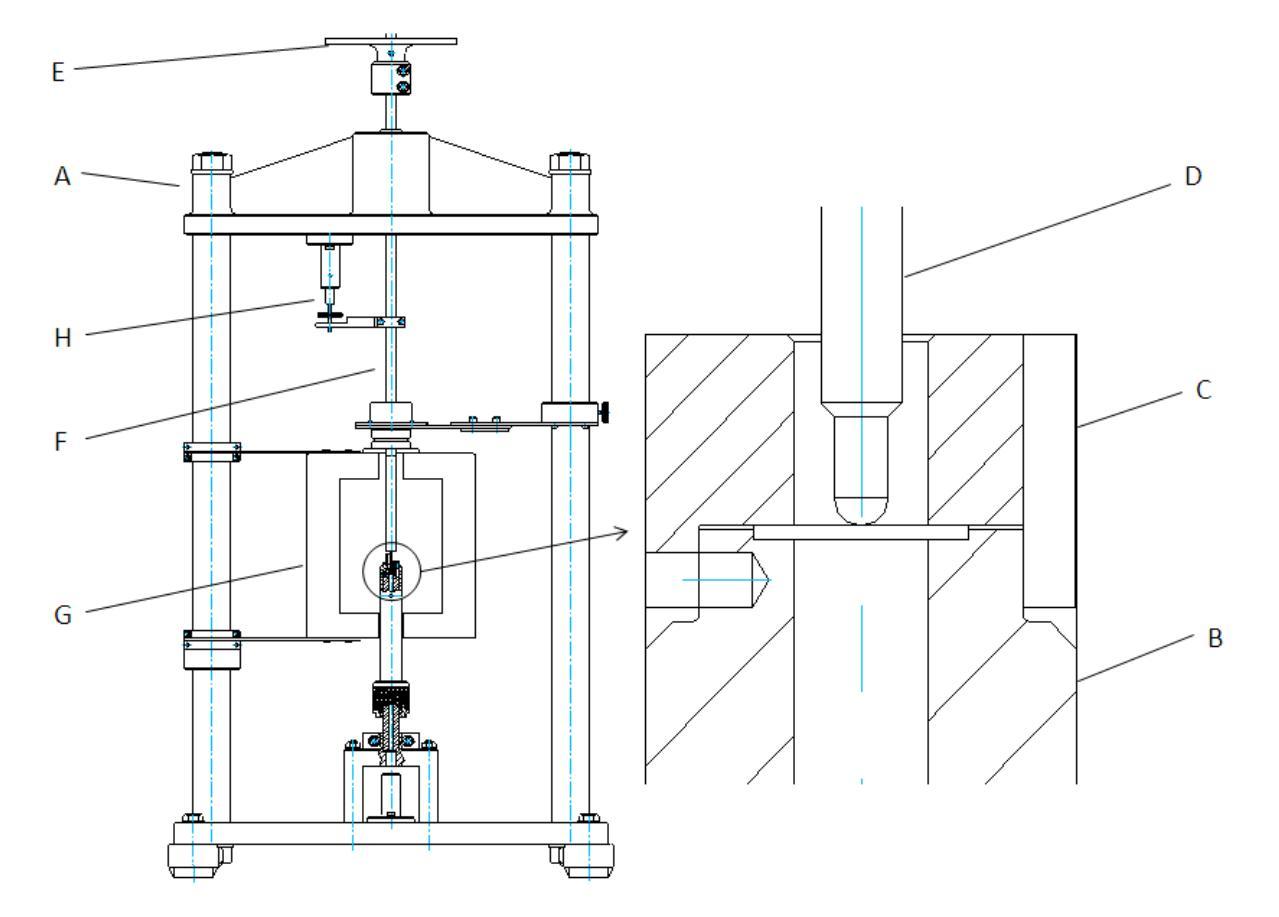
# Figure 1.

A schematic diagram of the small punch test rig showing an overall view and an enlarged view of the sample holder, B.

The small punch tests were carried out in line with the guidance provided in the CEN Workshop Agreement, CWA 15627:2006 E [25], using the equipment shown schematically in Fig. 1. It comprises a steel frame, A, a sample holder, B, which supports the sample and a clamping head, C. A hemispherical, high temperature steel, punch, D, is positioned co-axially with respect to the axis of the sample. The load is placed on the pan, E, and is transmitted to the sample via the vertical rod, F. The sample is maintained at a constant temperature by the furnace, G, and displacements are measured through the punch movements and recorded by a LVDT transducer, H, to an accuracy of  $\pm 1 \ \mu m$ .

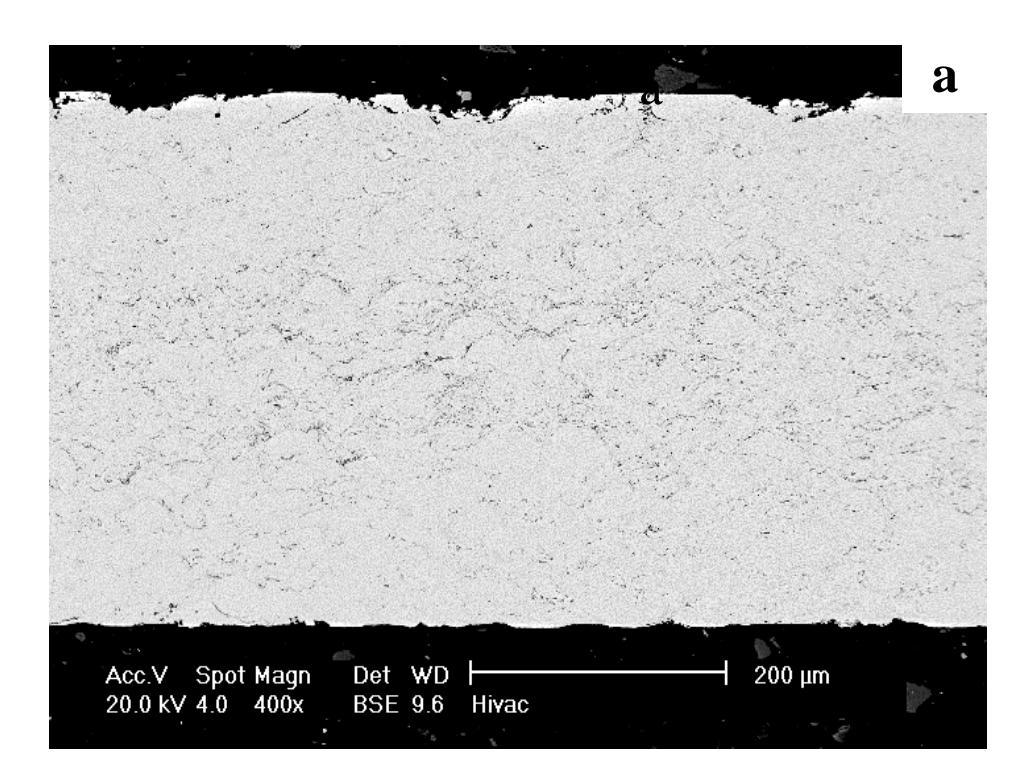
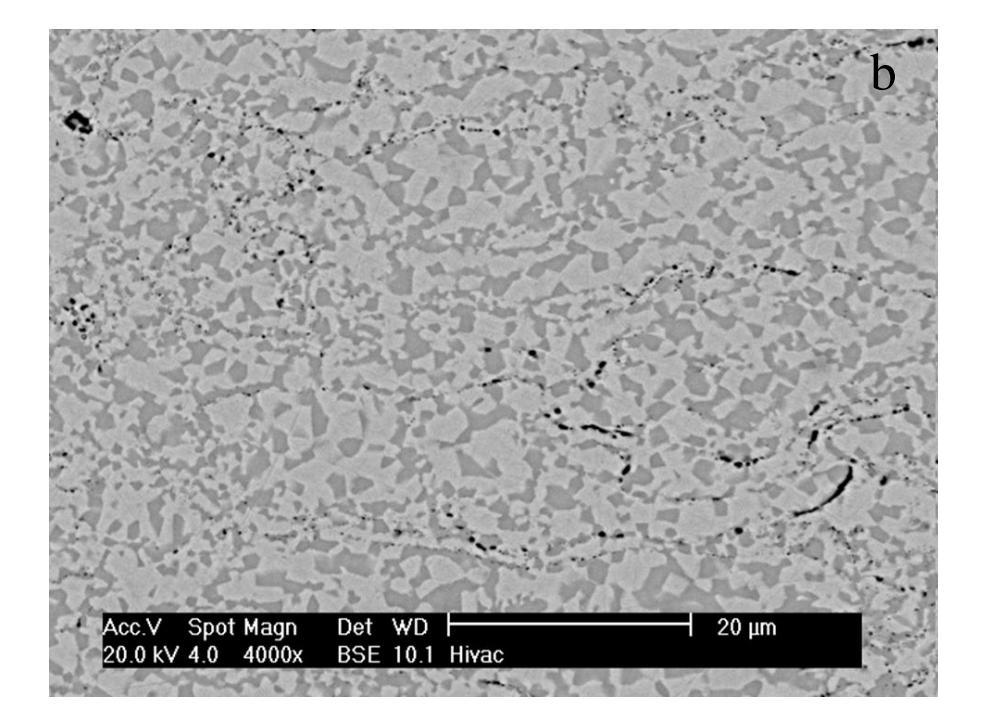
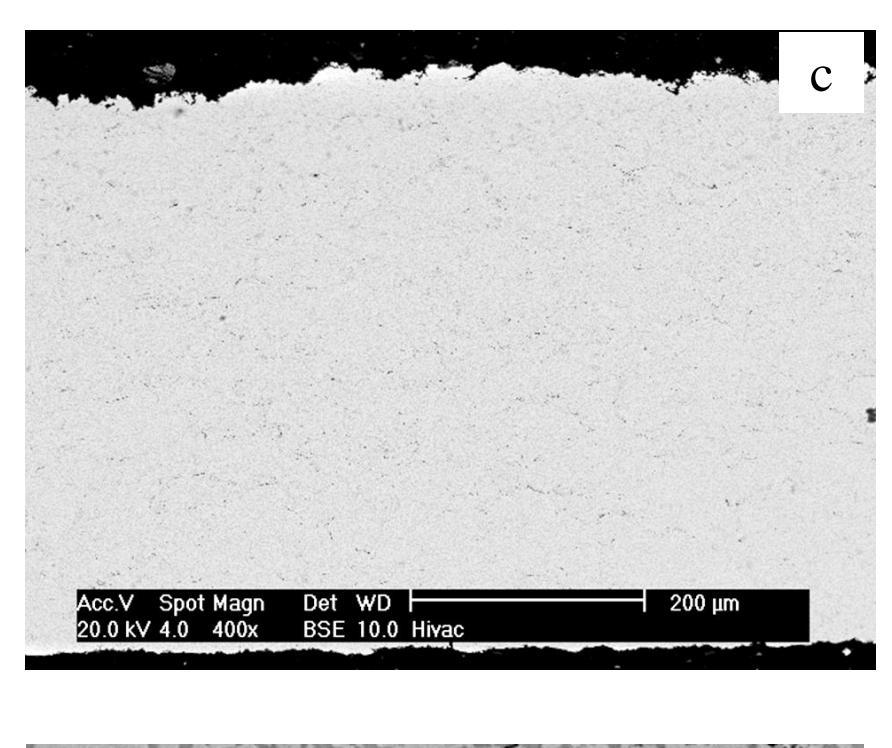
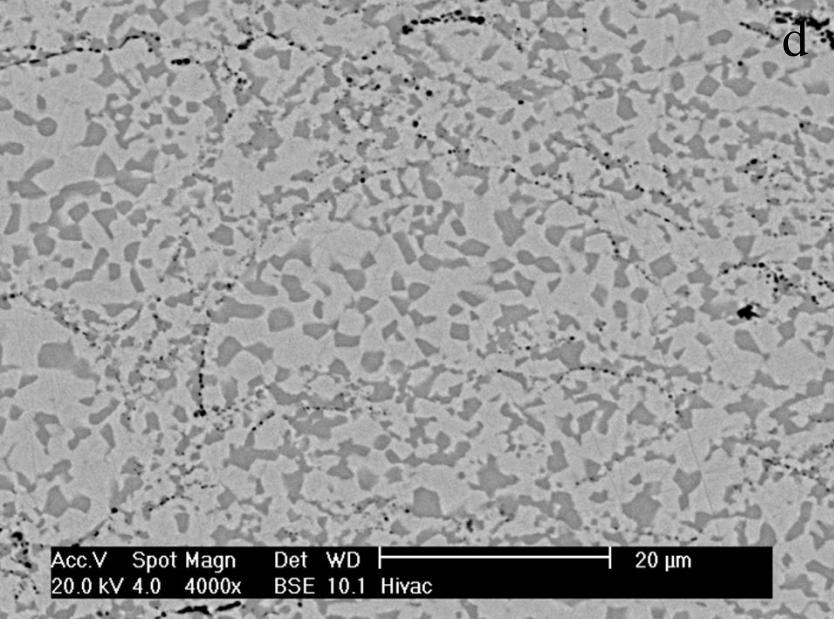
### Figure 2

Back scattered electron micrographs showing the microstructures of the vacuum heat treated samples prior to testing. (a) low magnification and (b) high magnification of sample C1; (c) low magnification and (d) high magnification of sample C2.

The microstructures of the vacuum heat treated coatings C1 and C2 prior to testing are shown in Fig. 2. It is evident from Figs. 2(a) and (c) that there is very little porosity apparent in both of the samples. As previously reported [24], this CoNiCrAIY coating has a two phase microstructure, consisting of the dark contrast bcc- $\beta$  (Co,Ni)Al phase and the light contrast fcc- $\gamma$  Ni-rich matrix phase. The volume fraction of the uniformly distributed  $\beta$  phase was found by image analysis to be around 33% in both C1 and C2, with an average  $\beta$ -phase size of 1- 2 µm.

Micron sized, dark contrast particles are also visible in Figs. 2(b) and (d). These tend to occur around powder particle boundaries as either discrete particles or thin stringers. Indeed they delineate particle boundaries and reveal the deformed and partially flattened nature of the sprayed powder particles which were originally spherical. EDX analysis showed them to be rich in oxygen and aluminium and they are presumably aluminium oxide which has formed by oxidation of powders in-flight during the HVOF spraying process. From the figures it is clear that their volume fraction is less than 1% in both C1 and C2. However, in C1 there is a more concentrated band of these features visible in the lower half of the coating as seen in Fig 2 (a). Samples of the debonded coatings were chemically analysed to determine their oxygen contents which were found to be 0.40 and 0.36 wt% O for C1 and C2 respectively and this difference is consistent with the microstructural observations.

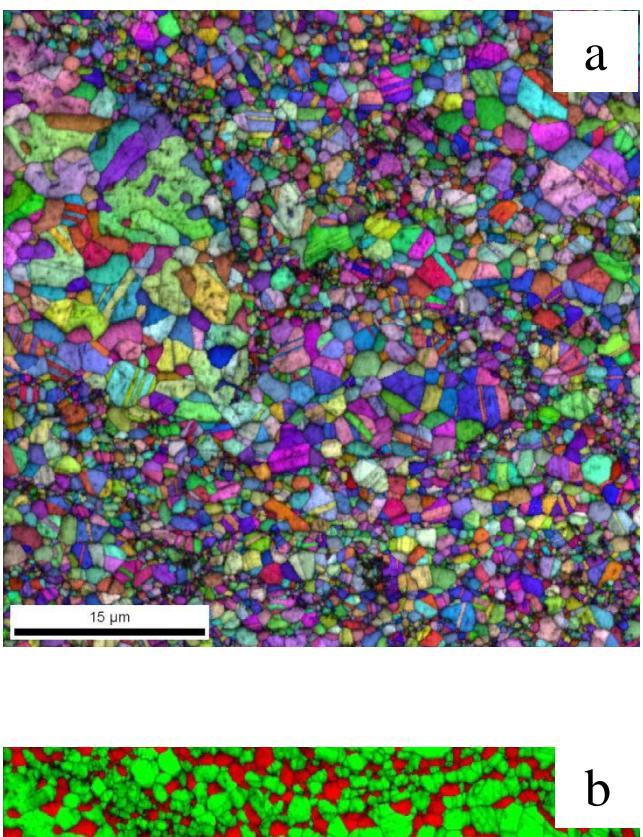
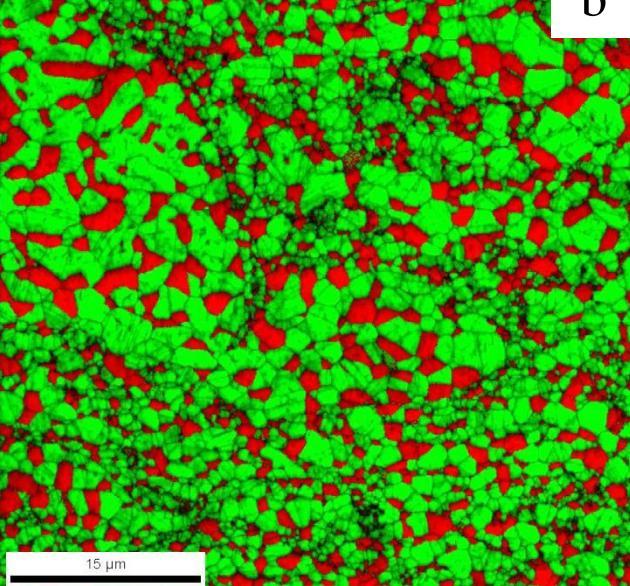
# Figure 3.

(a) Inverse pole figure map and (b) phase distribution map derived from ESBD data of heat treated coating C1 prior to creep testing. The  $\beta$ -phase is coloured red and the  $\gamma$ -phase green in (b).

Figure 3 shows EBSD - derived inverse pole figure and phase distribution maps for vacuum heat treated coating C1 prior to testing. These figures reveal that the  $\beta$ -phase dimensions are typically 0.8-2 µm as noted previously and that  $\beta$ - regions appear to be monocrystalline, The  $\gamma$ -phase is clearly polycrystalline with equiaxed grains that display a wide range of grain diameters typically from 2 µm 500 nm or less. Many of the  $\gamma$  grains are also twinned. There is no evidence for preferred orientation in either the  $\beta$  or  $\gamma$  phases.

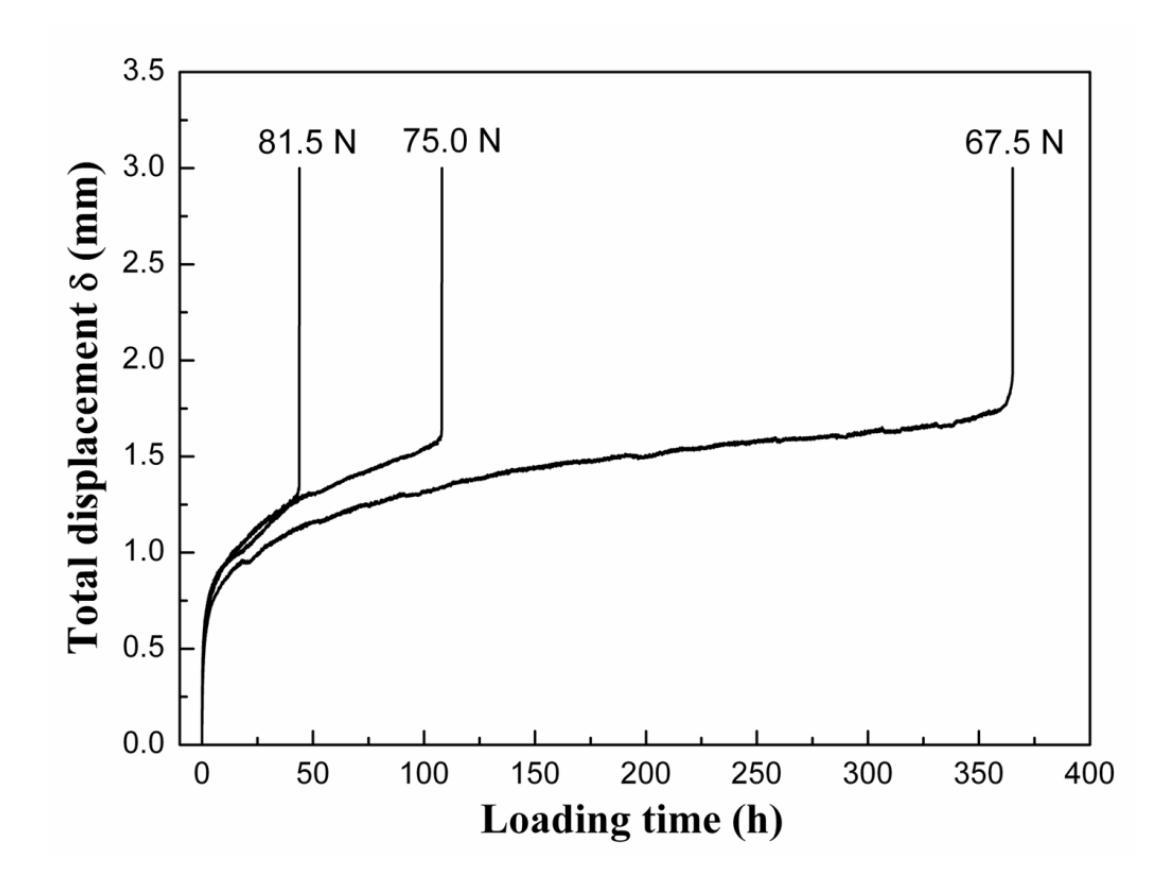
**Figure 4.** Typical small punch test displacement curve at 750 °C of coating C1 for three different loads

Typical small punch test creep curves from tests of C1, showing the increase in displacement with time, are seen in Fig. 4. It can be observed that there is a large initial and primary component of deformation, an approximately linear, secondary, region with a gradient,  $\delta_{min}$ , which is the minimum displacement rate. Finally, an accelerating tertiary region leads to fracture. These curves show a similarity to typical uniaxial creep curves which normally exhibit primary, secondary and tertiary creep regions. The constant temperature SP test data can also be characterised by a minimum creep strain rate,  $\dot{\varepsilon}_{min}$ , and the total time to failure,  $t_f$ , at different applied stresses. These values are usually represented graphically on plots of  $\log(\dot{\varepsilon}_{min})$  versus  $\log(\sigma)$  and  $\log(\sigma)$  versus  $\log(t_f)$ , as depicted in Figs. 5(a) and 5(b), respectively; the  $\sigma$  and  $\dot{\varepsilon}_{min}$  values are obtained using equations (2) – (4). Linear relationships have often been obtained in these types of plots for various steels and other alloys using the Norton power law at constant temperature (Eq. (5)),

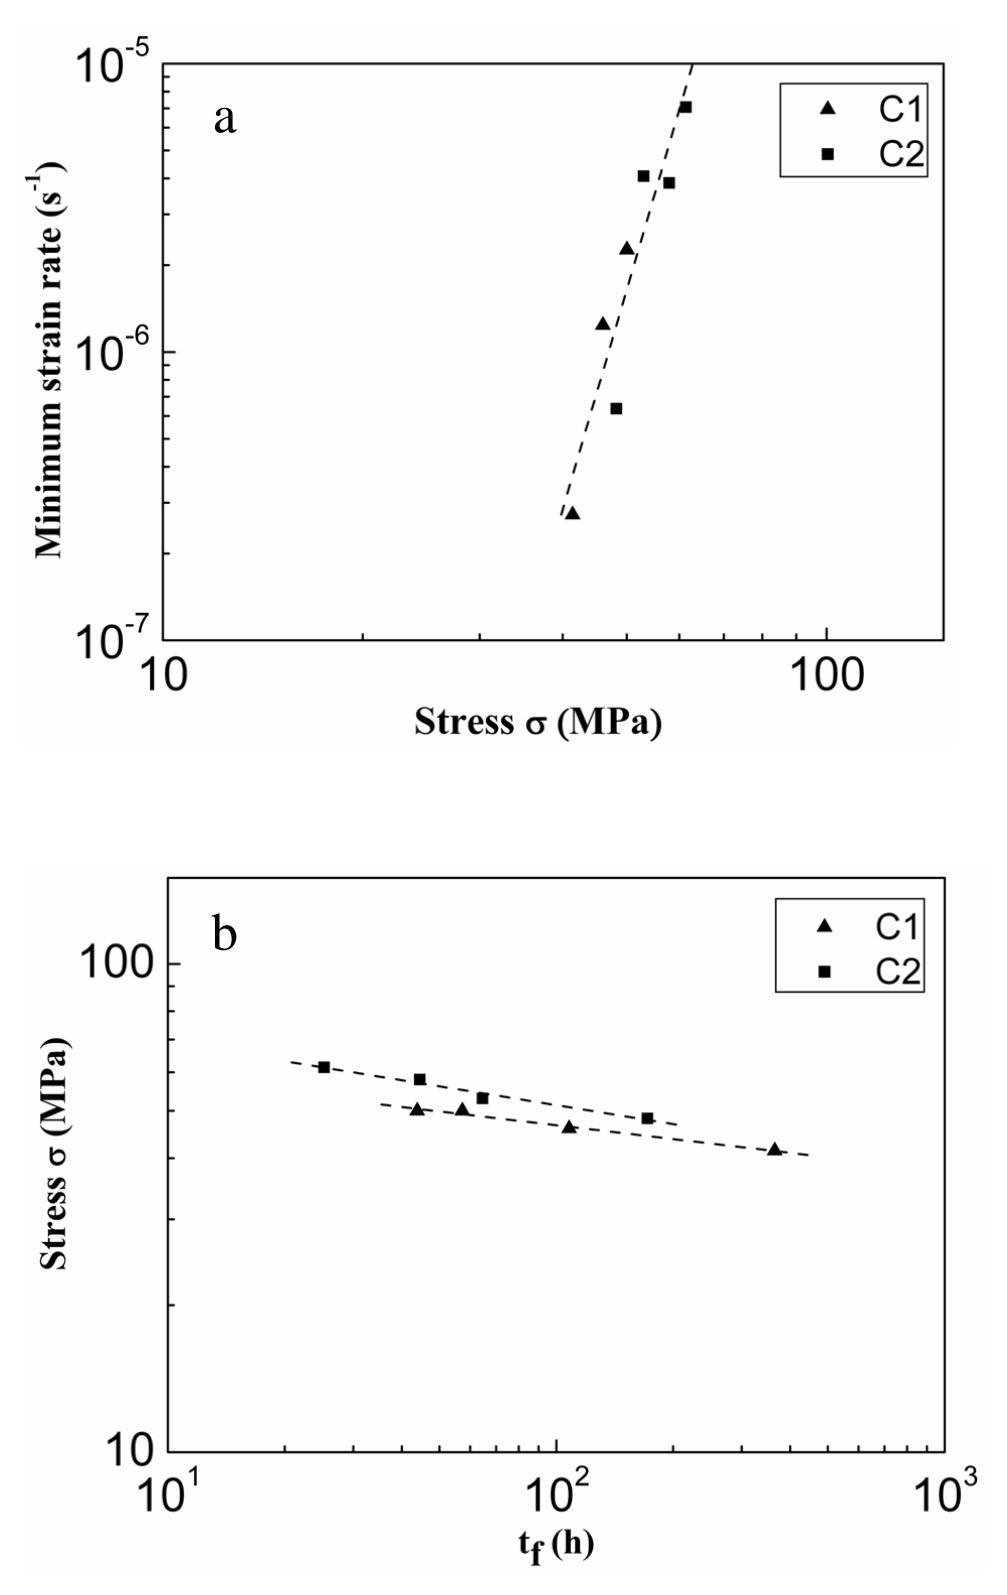
**Figure 5.** Log-log plots of (a) minimum strain rate versus stress and (b) stress versus time to failure for C1 and C2 in the small punch creep test. Experimental data are represented by symbols and best fitting lines obtained using equations (5) and (6)

In the present case, data for C1 and C2 (Fig. 5(a)) are found to lie on a common Norton power law best fit line and the parameters B and n are given in Table 1. In the case of the rupture power law, there is evidently a displacement of the data sets for C1 and C2 (Fig. 5(b)) and each coating has been separately fitted to the rupture power law (equation 6) with the parameters, M and  $\chi$  given in Tables 2; for an equivalent stress level, coating C1 fails at a shorter time.

hitherto and that SP creep test data can be usefully used to estimate material creep constants from the well known creep laws (equations (5) and (6)). The log-log plots in Fig. 5 show that the results obtained from SP testing of these HVOF CoNiCrAlY coatings also fall on straight lines, indicating that their constant temperature creep behaviour at 750 °C can be described by the Norton and Monkman-Grant laws. Hence, even if there are limitations in relating SP data to uniaxial creep test data the SP method is a valuable tool for assessing and, quantitatively comparing, creep behaviour of thin, thermally sprayed bond coat alloys.

The log-log plot of minimum strain rate versus stress (Fig. 5(a)) shows that results from both coatings fall on the same straight line, indicating very similar material behaviour during creep deformation. This is not, in itself, surprising given the essentially identical microstructures of the two coatings. However, some difference in behaviour of the two coatings is seen in the plot of stress versus time to failure (Fig. 5(b)) where coating C1 fails at shorter times for a given stress. Coating C1 was found to have a marginally higher overall oxygen content by chemical analysis, 0.40 compared with 0.36 wt% O and, as can be seen from Fig. 2(a), there is a visible band of material in the middle of C1 which was particularly rich in oxide stringers which would account for the higher oxygen level in chemical analysis. The formation of such a band is possibly due to a temporary perturbation in the HVOF process. It seems possible therefore that this microstructural difference between the two coatings is somehow responsible for the earlier creep failure of C1 as discussed below.

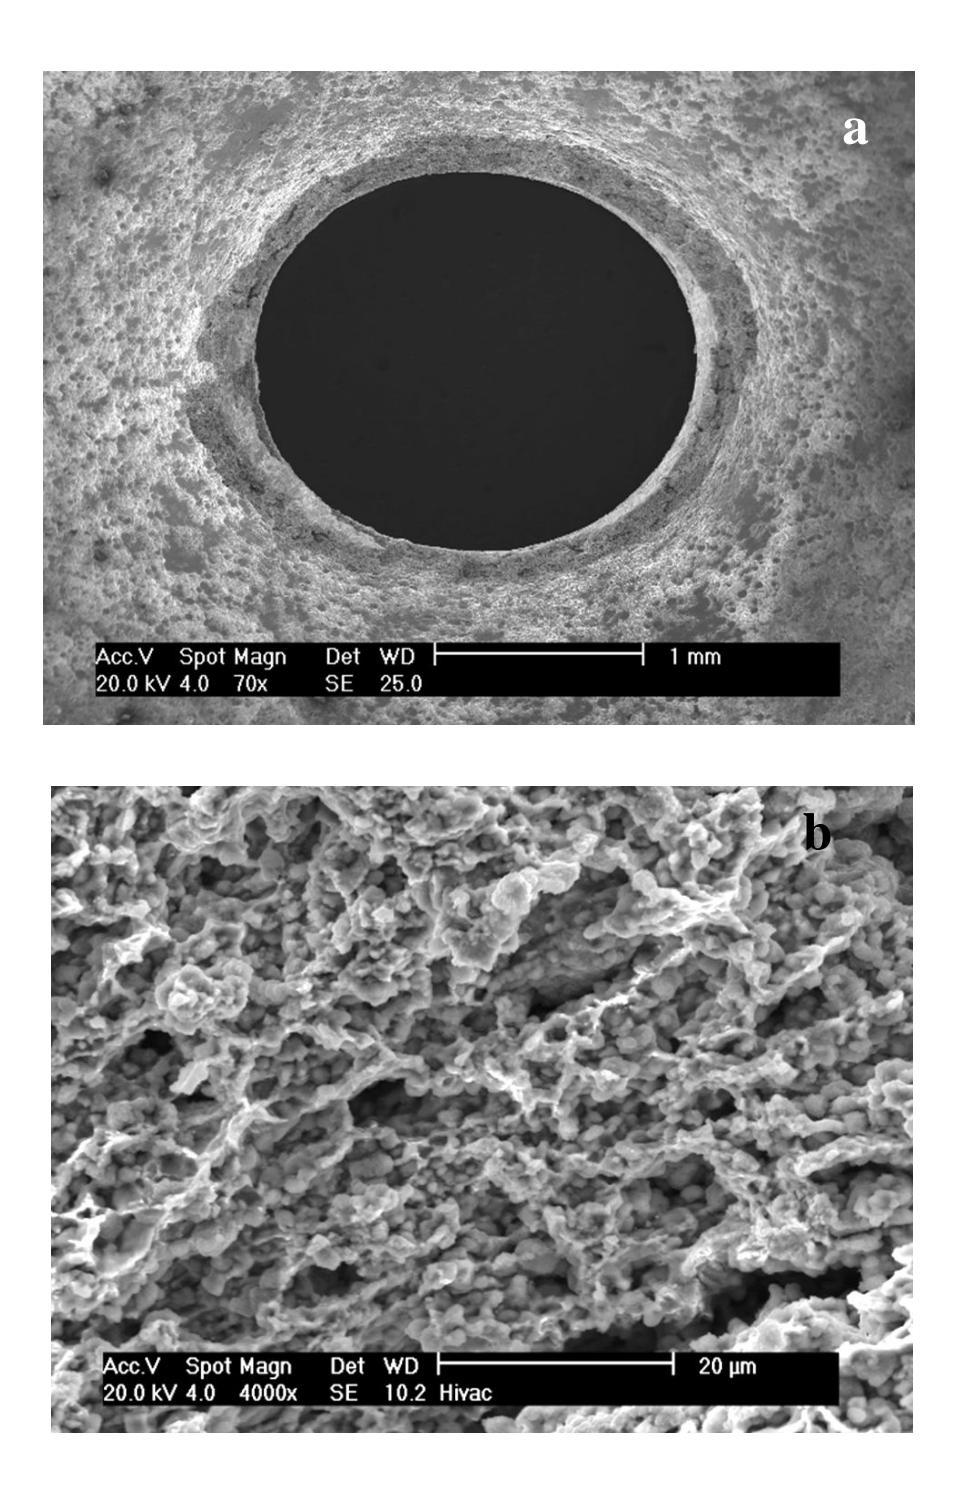
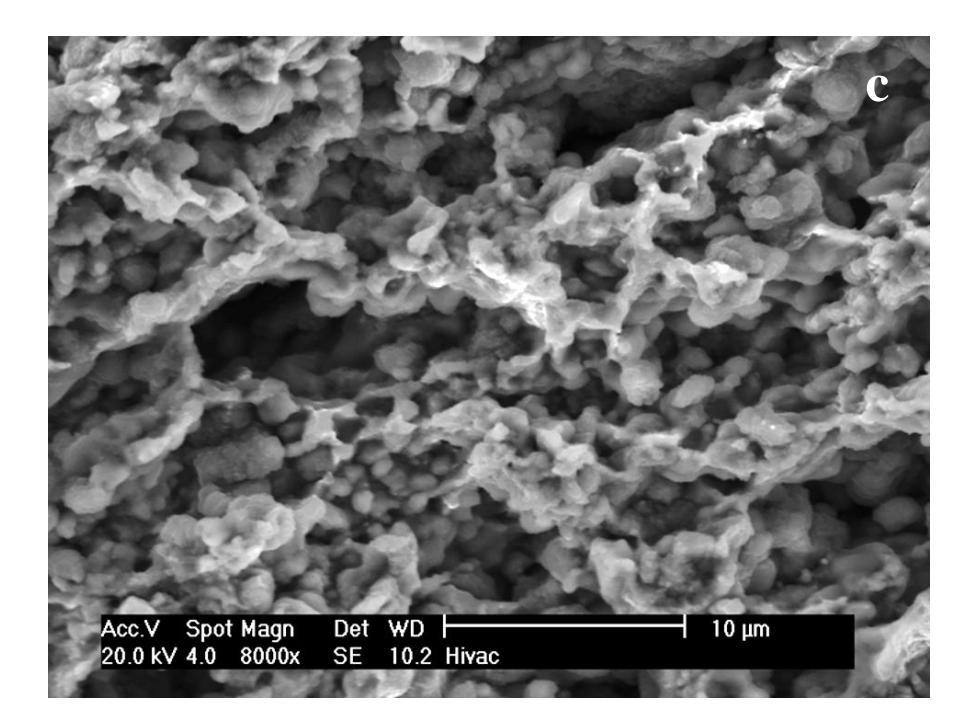
**Figure 6** Fracture surface of C1 at a stress of 50 MPa and 750 °C: (a) overall view of sample fracture. (b) and (c) fracture surface and higher magnification showing evidence of cavitation, ductile tearing and variety of rounded and angular particles

**Figure 6** Fracture surface of C1 at a stress of 50 MPa and 750 °C: (a) overall view of sample fracture. (b) and (c) fracture surface and higher magnification showing evidence of cavitation, ductile tearing and variety of rounded and angular particles.

Fig. 6 shows typical secondary electron images of the fracture surface of coating C1 tested at 50 MPa. The dome-shaped nature of the failed disc is evident in Fig. 6(a). There is no evidence for any brittle cracking and extensive deformation is evident which is consistent with the punch displacement of ~ 1.5 mm at this stress. At higher magnification, Figs. 6(b) and (c), there is evidence of cavitation, ductile tearing of the  $\gamma$ -matrix and a variety of rounded and angular particles are evident on the fracture surface; the latter are presumably the  $\beta$  phase. To investigate creep failure further a limited number of samples were loaded in the rig but then removed prior to final failure. Fig. 7(a) shows a low magnification cross-section of a typical specimen which underwent creep deformation at a stress of 40 MPa but was not tested to final failure; in this case the test duration was 1000 h. Material thinning and the formation of macroscopic cavities are observed in area B. This is the region in which fracture was observed in samples which were allowed to fail. Creep rupture was thus observed to

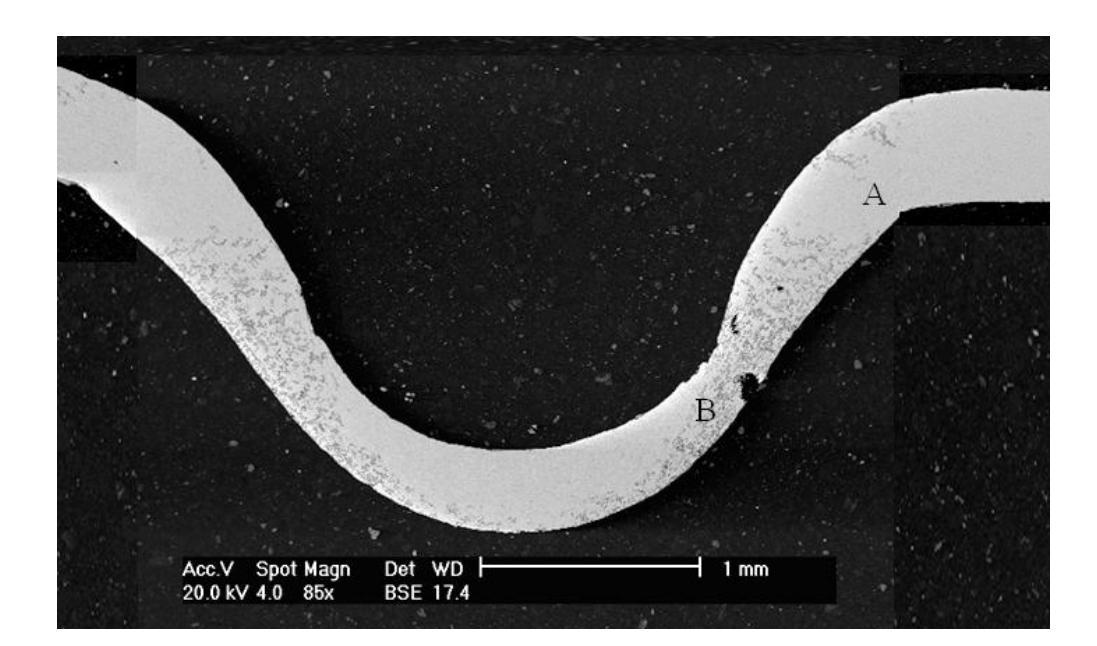
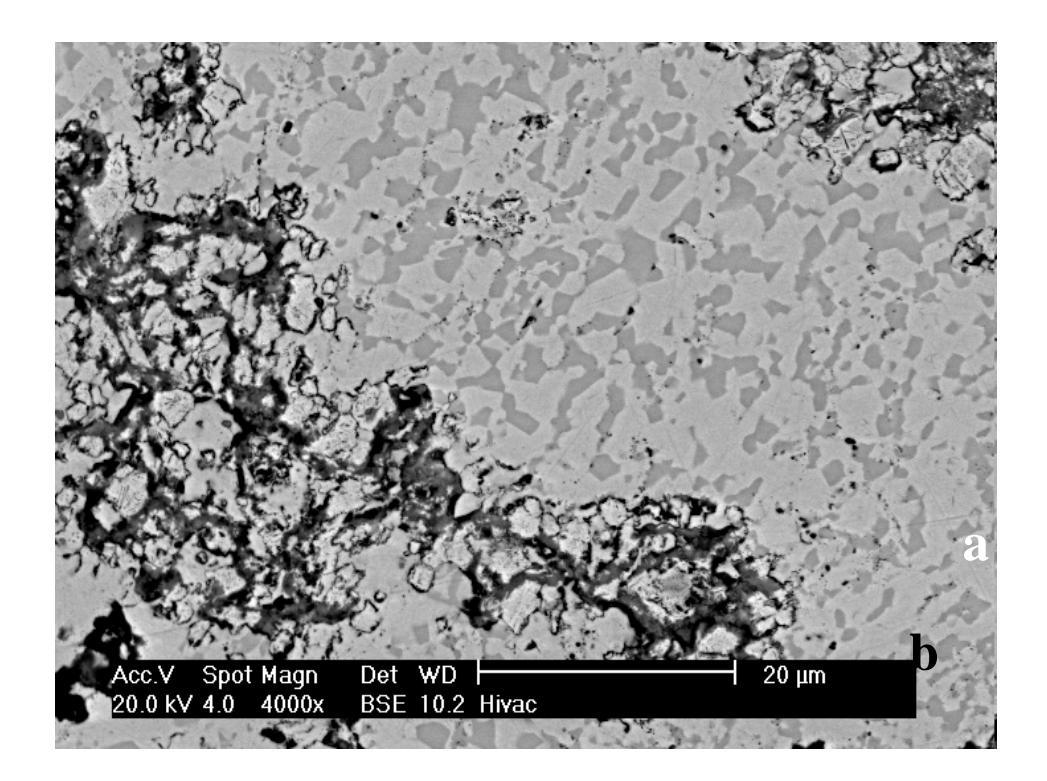
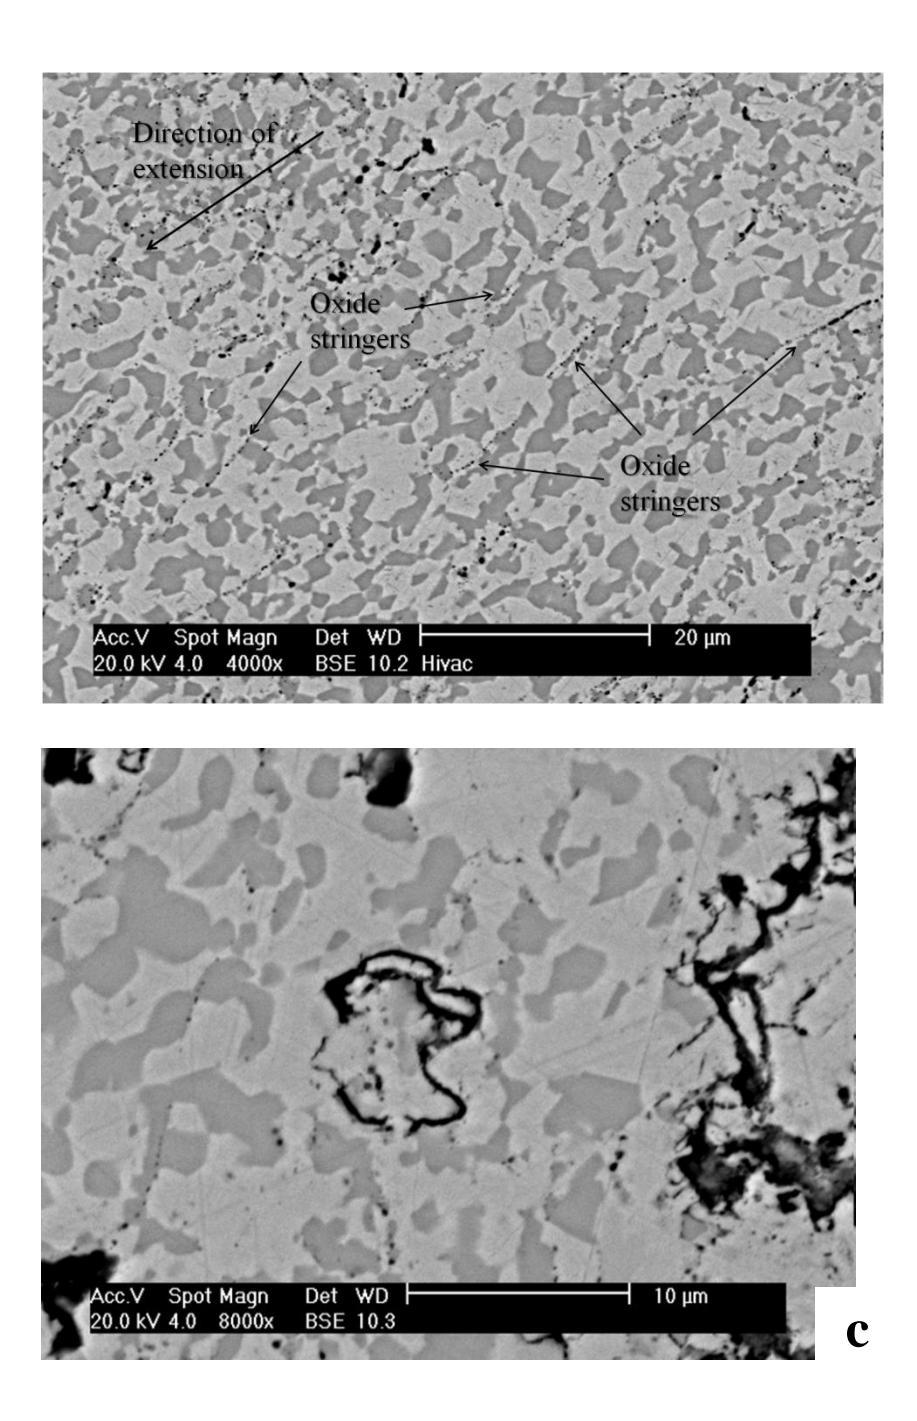
**Figure 7.** (a) Low magnification BSE image of a cross section through a sample removed from the test rig prior to final failure ( 40 MPa for 1000 h) showing cavity formation between A and B and final fracture beginning close to B. (b) Higher magnification image of region near B showing grey contrast features are oxide-filled creep rupture cavities. (c) and (d) are BSE images of cross sections taken from areas close to region A and B respectively. The arrows on (c) show some alignment of the micron- sized oxides whilst in (d) small voids are visible (early stage creep rupture).

In the clamped region, i.e. to the right of region A, the microstructure was found to be essentially unchanged in terms of the  $\beta$ -phase size and morphology and the  $\gamma$ : $\beta$ phase proportions. This indicates that exposure to 750 °C for the duration of the test did not, in itself, induce significant microstructural changes. The grey contrast features in between regions A and B were found to be cavities with extensive internal oxide brought about by oxidation during testing which was undertaken in air, Fig. 7(b).

Higher magnification micrographs of the region A and B are shown in Figs. 7(c) and (d) respectively. There is some evidence that the fine oxides formed during thermal spraying align as a result of the creep deformation as shown by the arrows. In Fig. 7(d) it is evident that local voids are initiated in region B and appear to have linked together to form rather larger cavities seen in Fig. 7(b). 8

material, but is also affected by the large strain, changing cone angle and changing contact conditions which occur in the secondary region of the SP test curve as discussed in detail in reference [19]. As can be seen in Fig. 7, the most extensively deformed regions are approximately half way down the wall of the deforming disc. This is consistent with the deformation shapes and equivalent creep strain distributions produced by Ma et al.'s finite element modelling of the SP test [27]. In spite of these limitations, it is generally agreed that uniaxial creep results correlate well with SP results for the wide range of high temperature alloy steels studied

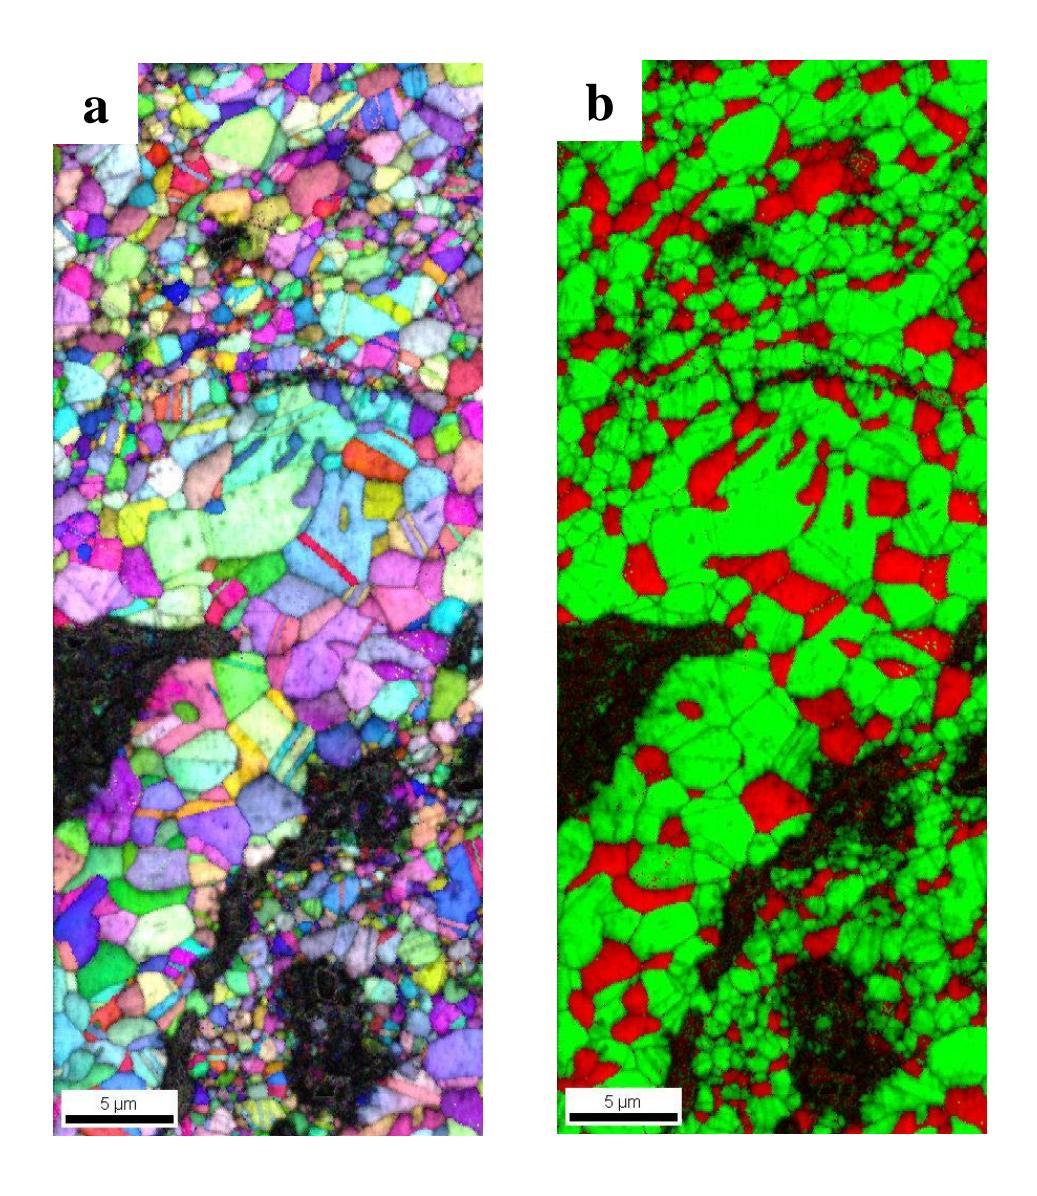
**Figure 8.** (a) Inverse pole figure map and (b) phase distribution map derived from ESBD data of a section taken from a creep tested sample corresponding to region B in Fig. 7. The  $\beta$ -phase is coloured red in (b) and there is no evidence of preferred orientation in (a).

Figure 8 shows both an EBSD – derived inverse pole figure and a phase map of a section taken from region B shown in Fig. 7. It is clear that  $\beta$ -phase regions have not coarsened significantly during the test and that  $\beta$  has remained monocrystalline with no preferred orientation. Similarly the  $\gamma$ -phase grains show little change in that they have remained equiaxed, of similar diameter range and have not developed a preferred orientation. Creep failure seems to be occurring predominantly along both  $\gamma$ - $\gamma$  grain boundaries and  $\gamma$ - $\beta$  interphase boundaries. There is no evidence for preferential cracking of the  $\beta$  phase, intragranular failure of the  $\gamma$ -phase or plastic elongation of either phase in the direction of deformation.
