Title: High temperature strain heterogeneities tracking within hole-specimens of FV566 turbine steel via digital image correlation

Keywords: High temperatures; Digital image correlation; Strain heterogeneities; FV566 steel; Finite element analysis

Corresponding Author: Mr. Jianguang Bao,

Corresponding Author's Institution: University of Nottingham

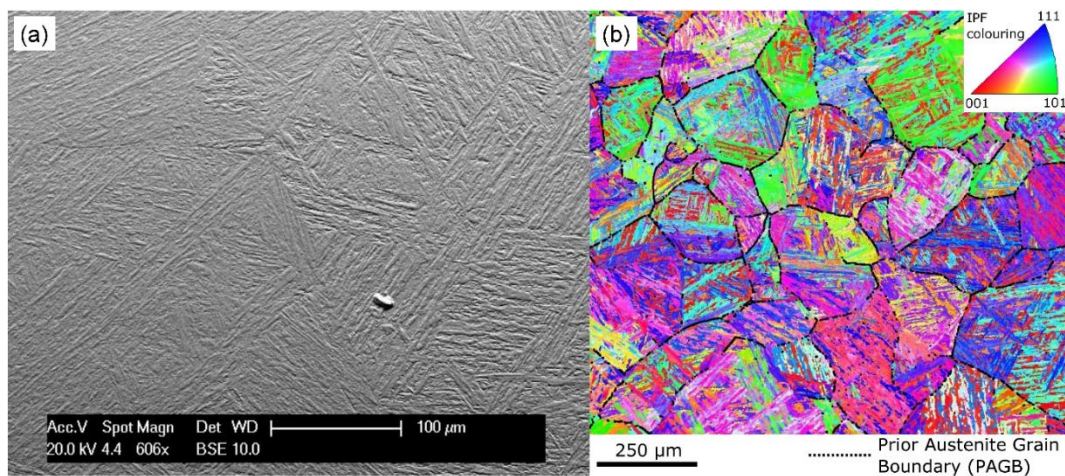
Fig. 1. (a) Backscattered electron image and (b) an EBSD orientation map of the as received FV566 material.

Fig.1a presents the microstructure of the FV566 steel after heat treatment with the average grain size of 30 μm . After tempering, a typical tempered martensitic microstructure in the as-received material can be seen in Fig.1b [33]. Prior austenite grains (PAGs), packets, blocks, sub-blocks and laths, were involved, as has been noticed in [34]. Also, according to the Kurdjumov-Sachs orientation relationship with the parental austenitic phases [35], the PAGs in the as-received material are less than 300 μm in size with the misorientation in a range of 23° - 41°. Sub-blocks and laths have the average misorientation angles of 1.8° and 8.3°, respectfully.

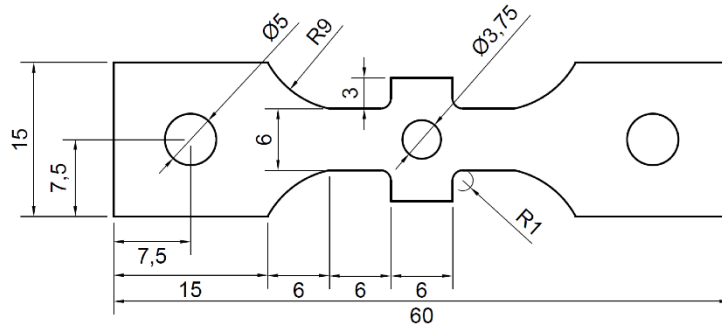
Fig. 2. Specimen configuration (All dimensions are in mm, the thickness is set at 2 mm).

Many structural components possess geometrical features such as holes, corners or gaps that are necessitated by design to accommodate fasteners, joints, or for weight reduction. Under the influence of combined thermal and mechanical loads, such stress concentration sites may become initiation sites of void nucleation and fracture [30]. The local strain fields can be highly inhomogeneous in such biaxial, or in general triaxial, stress states [36]. Hence, specimens with a hole of $\varnothing 3.75$ mm at the central part and symmetrical protrusions of 3 mm on both extremities were designed and tested under high temperature tensile loading. The holes of $\varnothing 5$ mm on both sides were machined to satisfy the loading pins' requirement. Dimensions of the specimen are shown in Fig. 2.

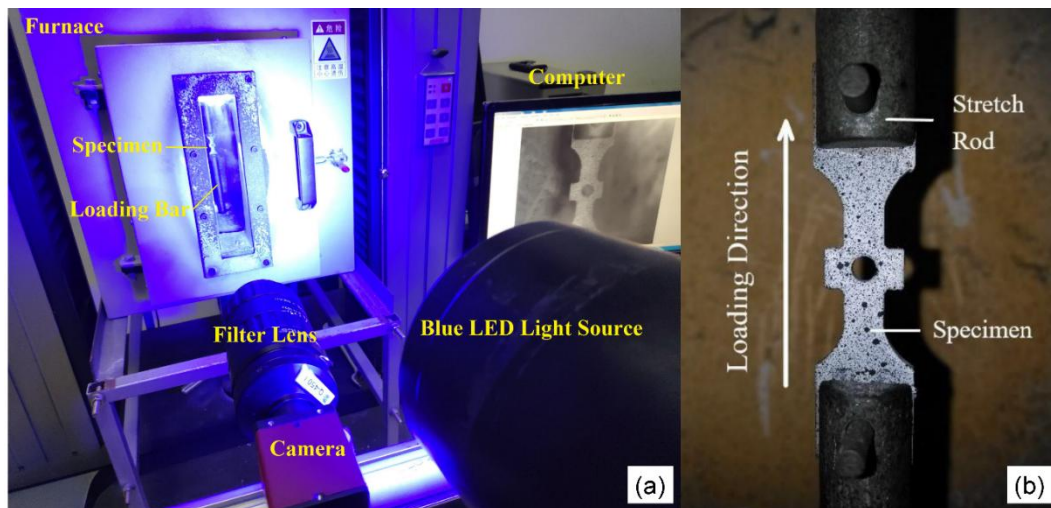
Fig. 3. (a) The experimental setup showing the digital camera used for the DIC measurements, a high temperature furnace, a narrow band pass filter lens of $441 \text{ nm} \pm 10 \text{ nm}$ bandwidth and a monochromatic light source with the wavelength of $440 \text{ nm} \pm 20 \text{ nm}$. (b) The test specimen sprayed with a black/white speckle.

equipped with a glass window, a charged-coupled-device (CCD) camera (AVT Stingray F-504B), a band-pass filter ($441 \text{ nm} \pm 10 \text{ nm}$), a blue LED light source and a stretching machine. The furnace was employed to monitor the test temperature up to $600 \text{ }^{\circ}\text{C}$. The detector of the camera was operated with a 2452 by 2056 pixels window size and $19 \text{ }\mu\text{m}$ pixel size. The camera was positioned on a tripod approximately 1 m from the specimen surface. It was fixed and kept perpendicular to the gauge part during the loading in order to collect reliable visible images. The camera frame rate was set at 4 frames per second to obtain enough sampled data while the integration time was set at 50 ms . The blue LED light source with a wavelength of $440 \text{ nm} \pm 20 \text{ nm}$ was used to provide quasi-monochromatic illuminations.

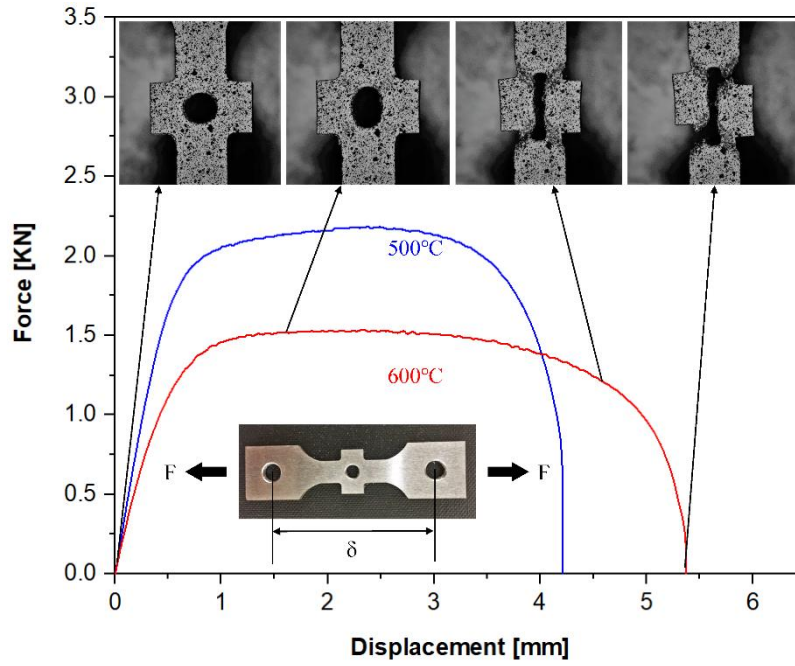
Fig. 4. The F (force) vs. δ (displacement) curve of the test specimens under both 500 °C and 600 °C temperatures, along with four images captured by the digital camera at different stages of the test.

The tensile responses (force vs displacement) of the investigated specimens for both 500 °C and 600 °C test temperatures are given in [Fig. 4](#). The results show a maximum reachable load increases for low temperatures (the ultimate force decreases by about 30% when going from 500 °C to 600 °C). Also, the tensile strength at 500 °C was higher than that at 600 °C, showing a noticeable temperature dependence effect. A macroscopic structural softening, highlighted by a displacement of necking lips, is also observed followed by a broad plateau. This ductile behavior is more pronounced for the high test temperature conditions, exhibiting the fracture displacements of ~ 4.2 mm and ~ 5.4 mm for 500 °C and 600 °C, respectively.

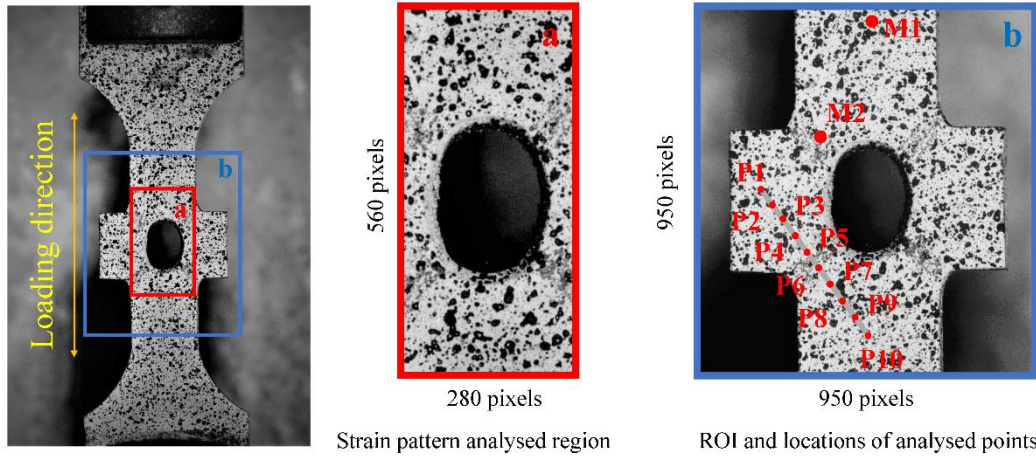
Fig. 5. Subfigures highlighting the region of interest, region for strain pattern analysis and locations of points of interest for the local kinematic analysis.

The kinematic assessments were analyzed in terms of the mean logarithmic strain components. The objective was to track the possible development of strain localization zones throughout the tensile test. The local mechanical response of the test specimens at the region of interest (ROI) was thus evaluated (see Fig.5). Dantec Dynamics software was used to post-process the visible images and assess the strain maps. Note that a preload of 100 N was performed prior to the tensile test in order to eliminate the superfluous load and strain resulted from the vacuum and thermal expansion. A subset of 41×41 pixels and a grid step of 17 pixels were used to evaluate the strain tensor at each point of interest. Cubic B-spline interpolations with normalized squared differences criterion were chosen. An area corresponding to a hole of $\varnothing 3.75$ mm at the ROI and symmetrical protrusions of 3mm on both extremities, with a size of 300000 pixels (Approximately 820 subsets per specimen), was chosen as the ROI (see Fig. 5).

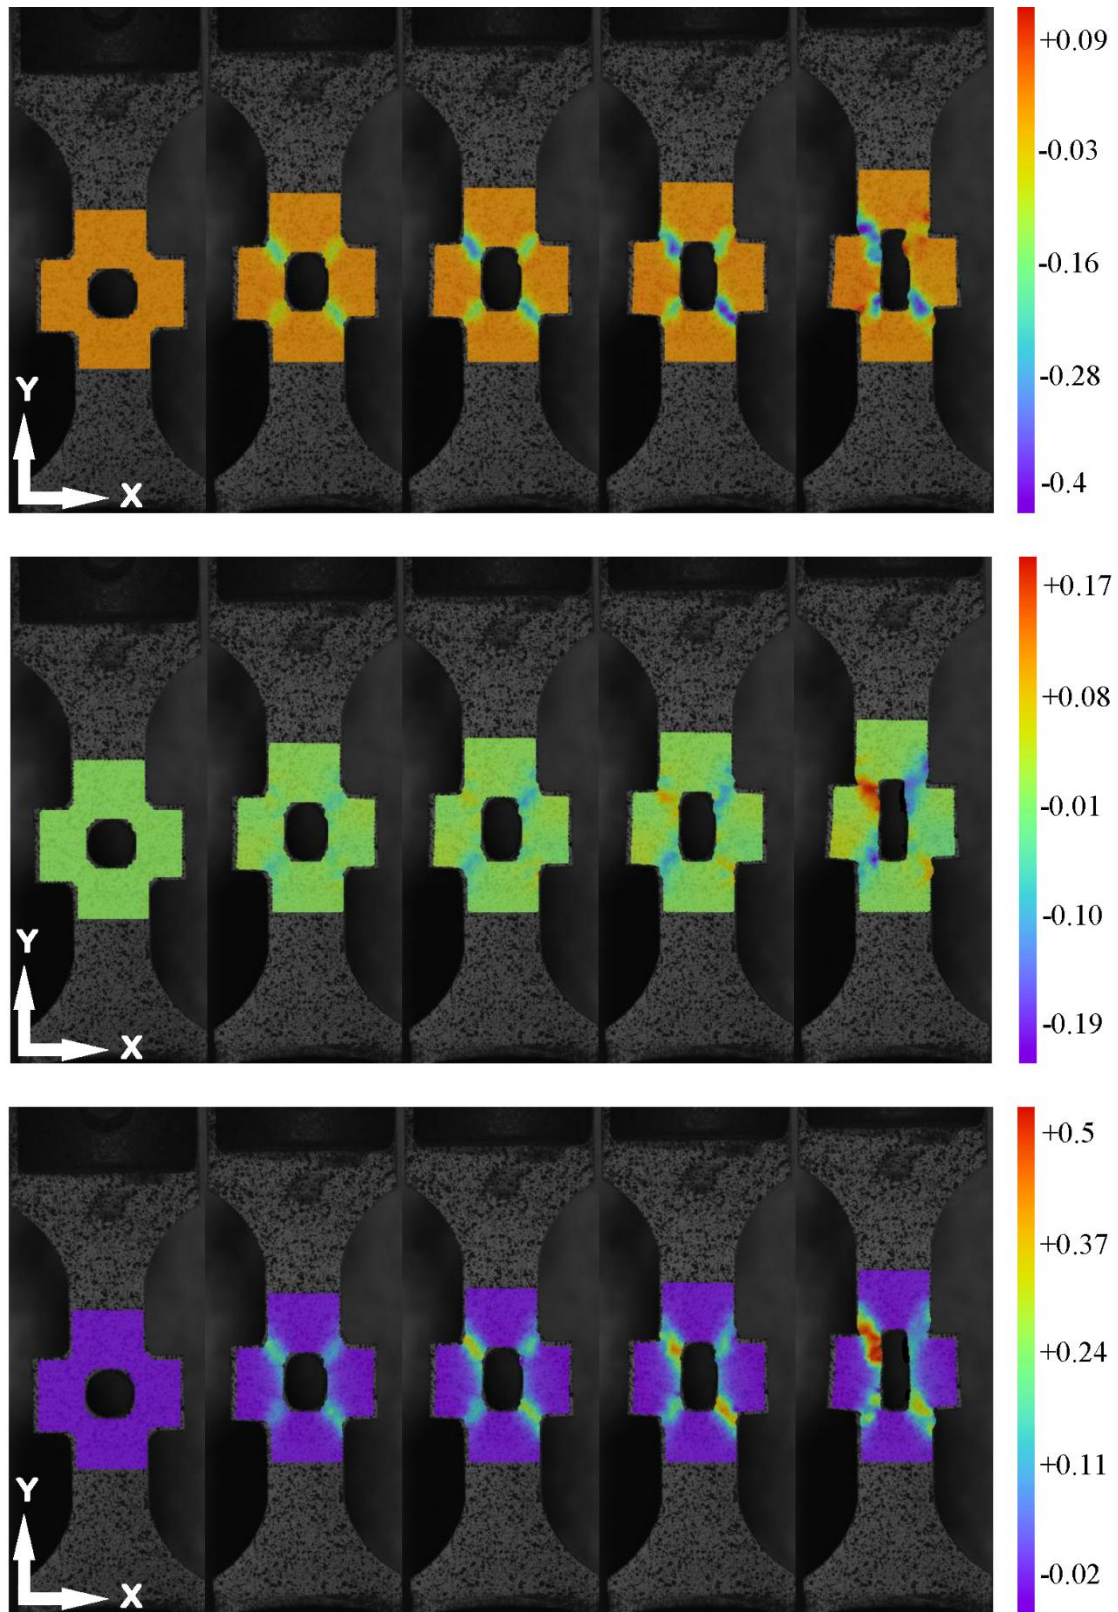
Fig. 6. 2D maps of the transverse strain, ϵ_{xx} (top), shear strain, ϵ_{xy} (middle), and longitudinal strain, ϵ_{yy} (bottom) at: the very beginning of the test ($\tau_1=0s$), intermediate times ($\tau_2=810s$, $\tau_3=1060s$ and $\tau_4=1310s$) and the last stage before the macroscopic fracture ($\tau_5=1877s$). These results were extracted from measurements performed under the 500 °C test temperature.

Fig. 6 and Fig. 7 show the full-field strain maps for the investigated FV566 tensile specimens at both 500 °C and 600 °C test temperatures, selected at different specimen life stages ($\tau_1, \tau_2, \tau_3, \tau_4, \tau_5$). The spatial resolution was set at 20 μm per pixel. The results show a precocious and gradual development of strain localization zones. These zones were clearly visible for all the strain components (longitudinal, ϵ_{yy} , transverse, ϵ_{xx} , and shear, ϵ_{xy} , components). For 500 °C condition, at the very beginning of the loading, the spatial heterogeneities were less visible as indicated at τ_1 . These heterogeneities started to intensify at the following life stages till the macroscopic failure (see Fig. 6). It is worth noting that the painting near the strain concentration zones (where the hole is located) eroded due to the high temperature and large displacement exhibited by the test specimens. This results in inaccurate strain estimate at the last stages before the macroscopic fracture. Note that most of the observed hotspots were located around the specimen hole at the ROI due to the geometry singularity. Nevertheless, the strain field contours show that the strain concentrations were not perfectly symmetric. For the transverse strain, the top-left and the bottom-right sides of the hole were slightly intensive than these on the top-right and the bottom-left sides. However, at the instant τ_5 , some of strain localization zones were significantly less intensive than others. This is probably caused by inhomogeneous features of the investigated specimen and/or the inaccuracy of the measurements. The spatial distributions of the longitudinal strain component on the top-left side of the hole were more intensive than these on the bottom-right side. From a statistical point of view, the absolute values of both the minimum and maximum longitudinal strain were almost the same at the

very beginning of the loading, highlighting the homogeneous character of the investigated gauge part. However, with the increase of the load, the absolute value of the minimum longitudinal strain was about thousand-fold lower than the maximum longitudinal strain. For the shear component, the spatial strain concentrations were mostly located on the top-left and top-right sides of the hole. As expected, the localization patterns seemed to progress preferably according to 45° angle (with a shape of “X” letter). At 600 °C (see [Fig. 7](#)), the strain localizations for the transverse and longitudinal components showed similar patterns as those obtained for the 500 °C condition while the higher values of the shear strain were appeared at top-right and bottom-left side with a shape of “/” from where sample fractured finally.

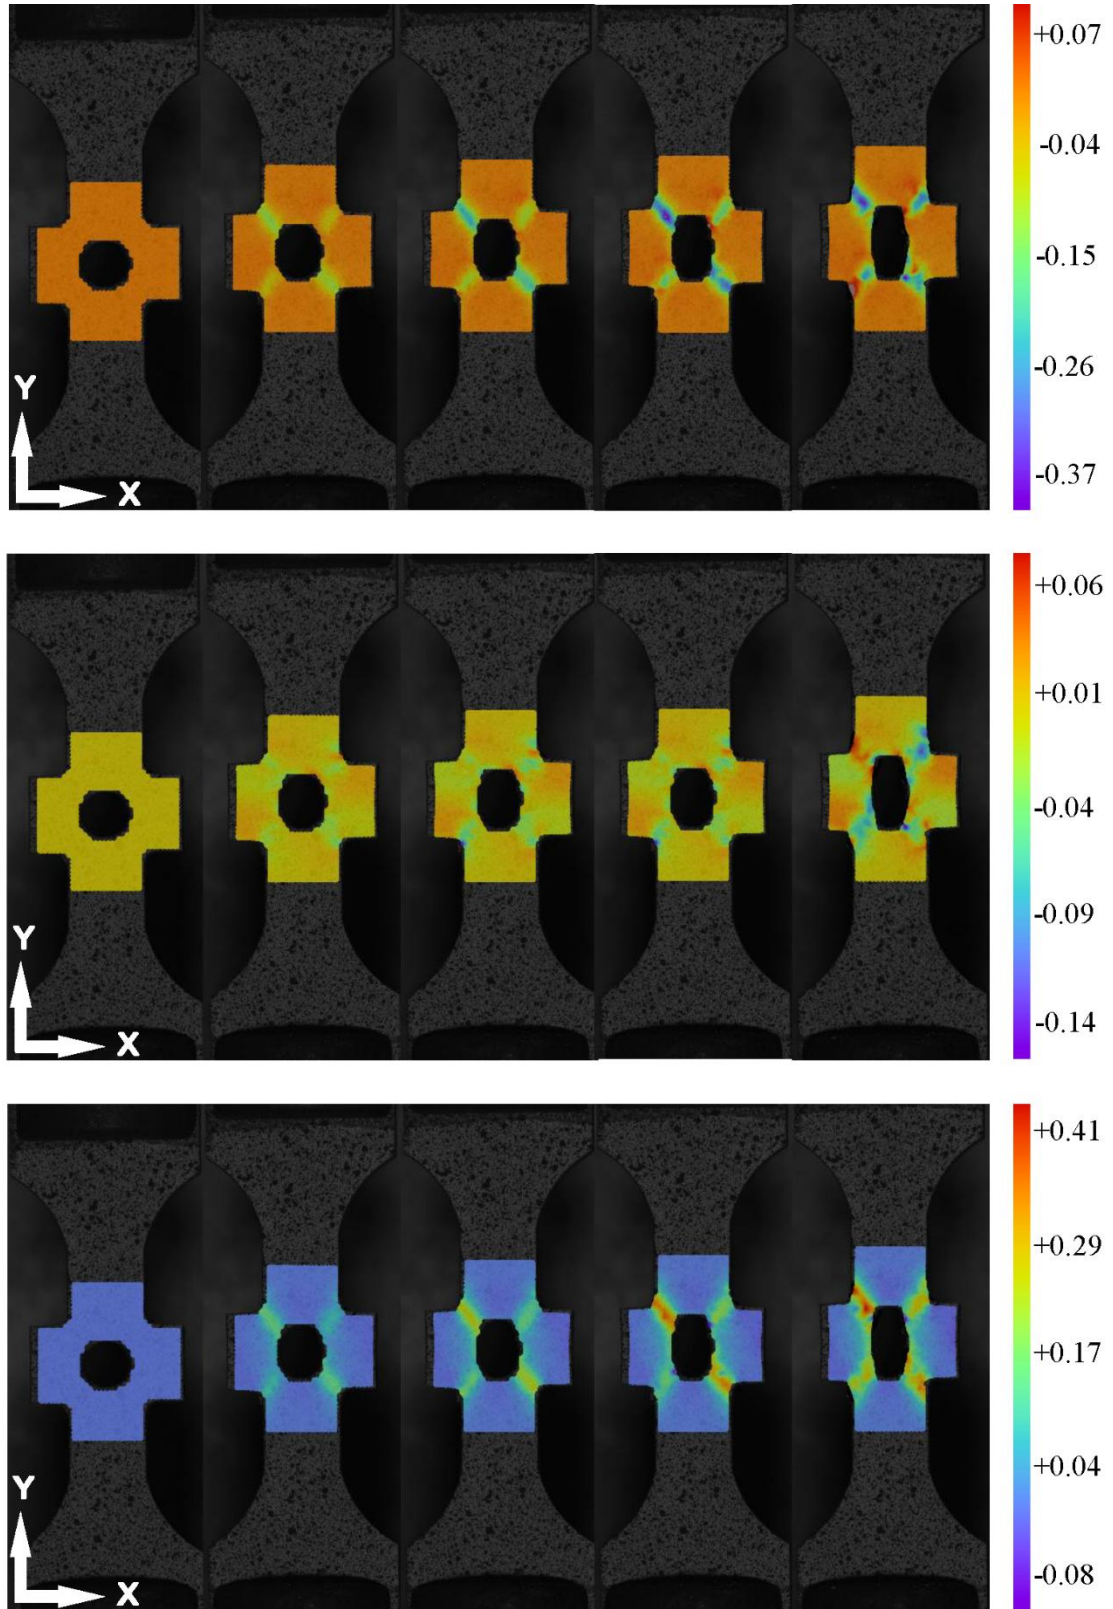
Fig. 7. 2D maps of the transverse strain, ϵ_{xx} (top), shear strain, ϵ_{xy} (middle), and longitudinal strain, ϵ_{yy} (bottom) at: the very beginning of the test ($\tau_1=0s$), intermediate times ($\tau_2=810s$, $\tau_3=1060s$ and $\tau_4=1310s$) and the last stage before the macroscopic fracture ($\tau_5=1709s$). These results were extracted from measurements performed under the 600 °C test temperature.

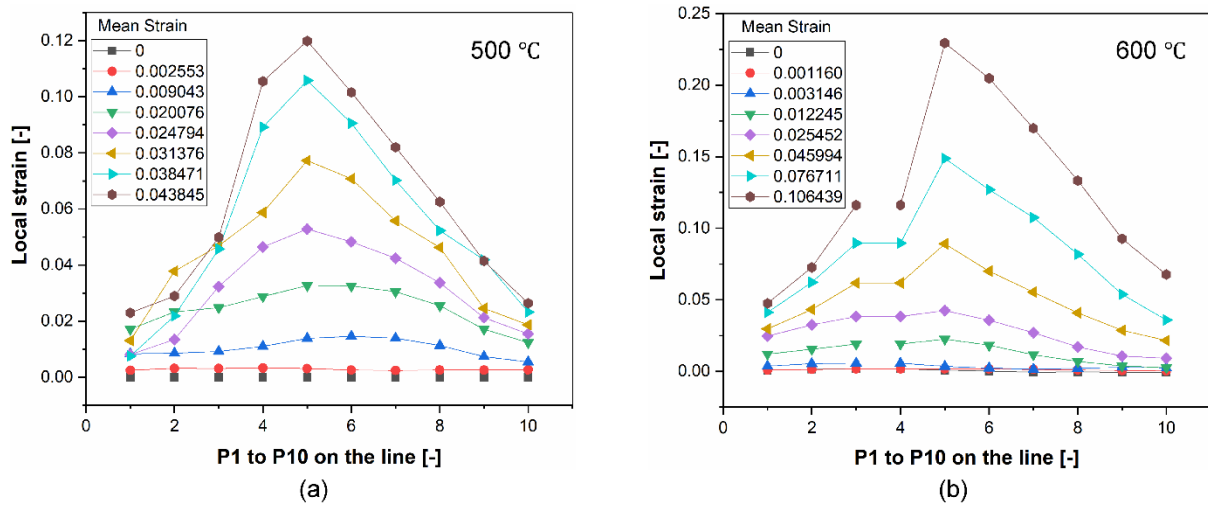
Fig. 8. Spatial-temporal distributions of the longitudinal strain component extracted at the selected points $\{P_i\}_{i=1,\dots,10}$.

Fig. 8 depicts the local spatial profiles of the longitudinal strain component, selected at different life stages (corresponding to different average strain values on the total line) and different location points $\{P_i\}_{i=1,\dots,10}$ (see Fig. 5b), from which a strain concentration zone is activated. At the very beginning of the loading, the strain distribution on the selected points was uniform. Then, strain concentrations started to appear for both temperatures when the local maximum strain magnitude reached 0.01. As expected, the local strain magnitude for both P5 and P6 was higher compared to that of the other location points. This is due to the fact that these points (where the peak of strain is occurred) are located close to the regions where the strain heterogeneities are more pronounced. The necking is especially driven by these high strain concentrations as it is highlighted in Fig. 4.

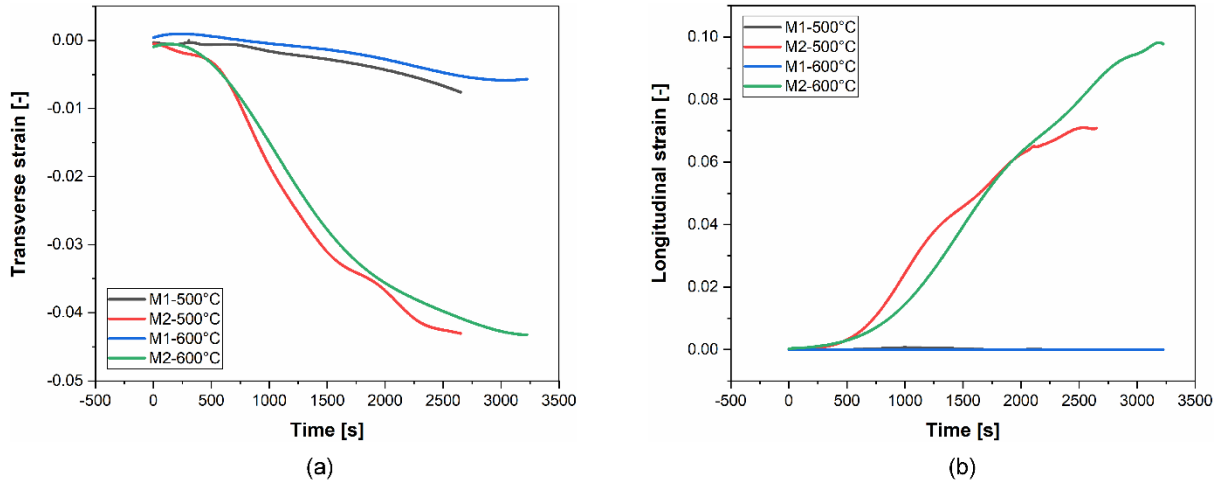
Fig. 9. (a) True transverse strain curves, and (b) true longitudinal strain curves with respect to the test time at M_1 and M_2 .

compared to those of M_2 , which were almost identical to the true principle strains under both test temperatures. This allows to suggest that the longitudinal strain component significantly contributed to the ductile failure of the specimen. The maximum longitudinal strain value at 600 °C was around 0.1, while this value reached 0.07 at 500 °C, highlighting the effect of temperature on the ductile damage evolution of the FV566 steel under investigation.

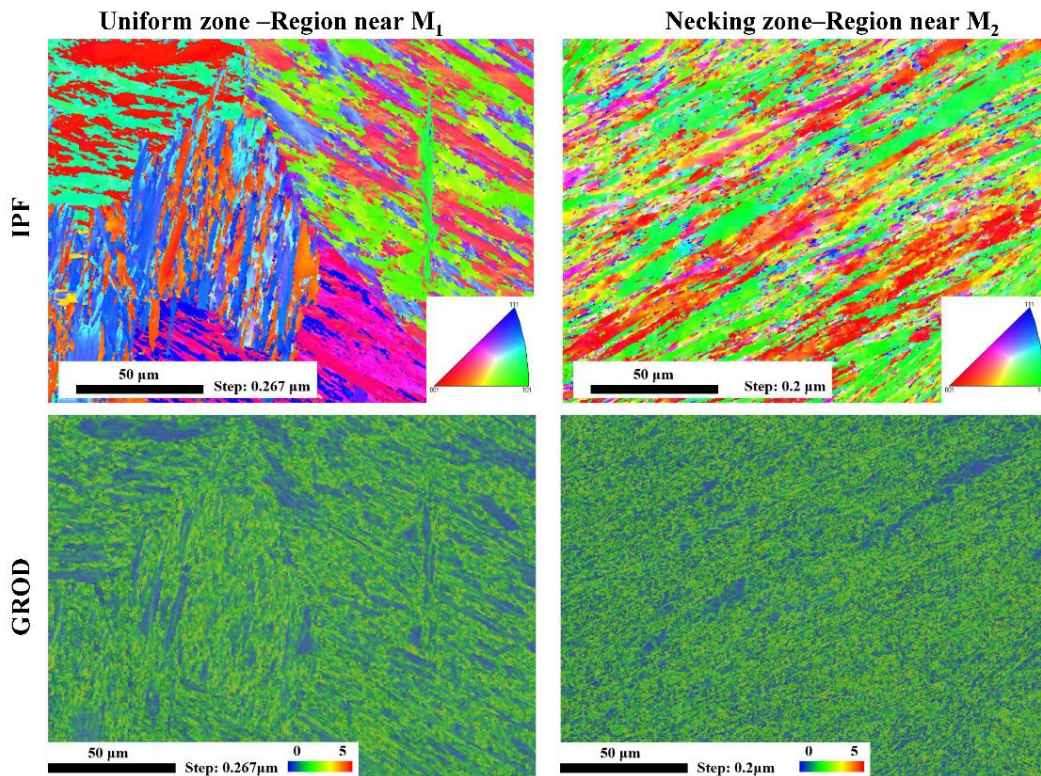
Fig. 10. EBSD results of the uniform M_1 (left) and necked M_2 (right) zones extracted from 600 °C test fractured sample.

Two areas from the ruptured surface, close to the DIC time dependent analysis regions (i.e. M_1 and M_2) were further investigated to highlight the microstructure evolution. Extensive EBSD examination has been conducted and the results are presented in Fig. 10. The inverse pole figure (IPF) images show that the pre-existing martensitic microstructure was significantly distorted along the principal loading direction, accompanied with the formation of a finer martensitic substructure. In addition, the presence of sub-block boundaries at 5 to 6 degrees in the as-received material as well as the variation of sub-block boundaries and the frequency of the low angles boundaries are highlighted in Fig. 11. The findings suggest that the dislocation slip could be the dominant deformation mechanism for the material, since dislocation slip activated by the high temperature and tensile loading may generate a large number of dislocation accumulations, which can contribute to the formation of the low angles boundaries [40]. As is well known, dislocation movement in the

Additionally, the grain reference orientation deviation (GROD) parameter was introduced to compare the local crystal deformation in two separate zones of the fractured specimens. It is proven to be linearly related to the nominal plastic strain under both tension and creep condition [41]. The higher value of GROD extracted from the necked zone implies that the plastic deformation in the necked area is larger than that in the uniform zone away from the fracture area, which is consistent with the aforementioned DIC measurement results. As is observed in Fig. 6 and Fig. 7, significant strain concentration was observed around the necked area due to the geometry singularity of the tested specimens. The strain concentrations in the necked area result in the deformation heterogeneity and microstructural rearrangements of the FV566 specimen at high temperature tensile conditions.

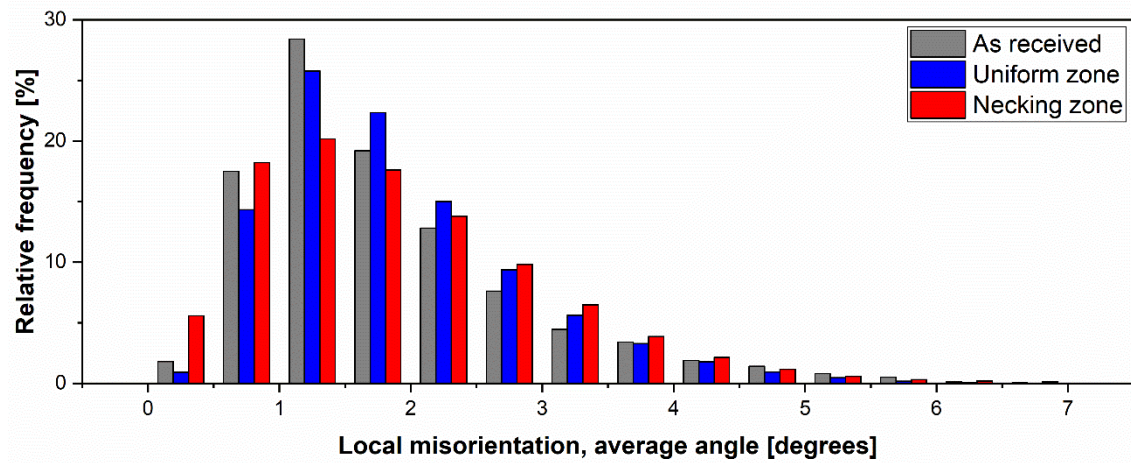
Fig. 11. The distributions of the misorientation angles across the lath and sub-block boundaries for the as-received material and uniform/necked zones of fractured sample.

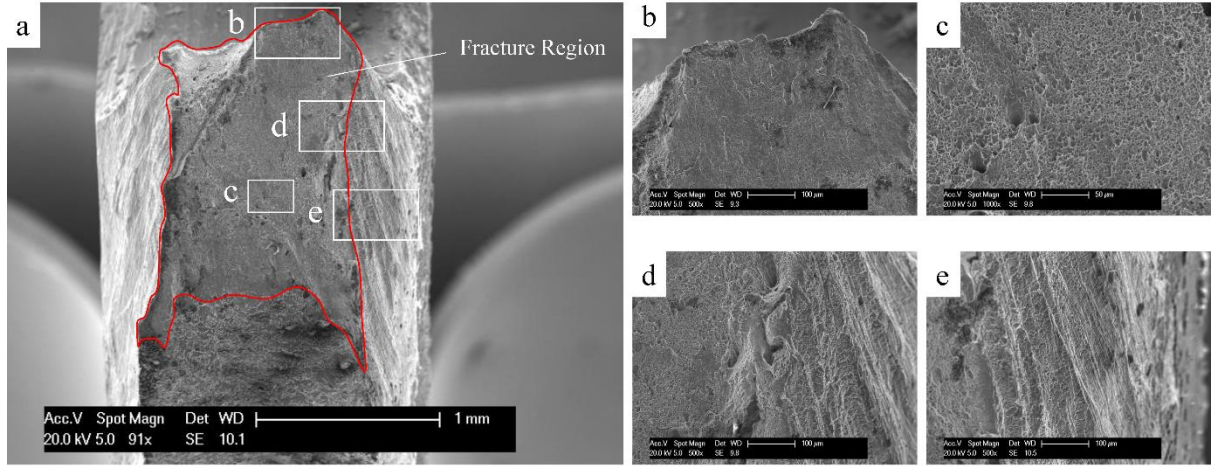
Fig. 12. Scanning electron micrographs of fractured specimens tested at 500 °C showing (a) the overall fracture morphology and (b-e) zoomed details of the local fracture features.

In Fig. 12a and Fig. 13a, a visible necked area as well as a rough surface can be observed on SEM fractography images of both fractured samples subjected to 500°C and 600°C test temperatures, highlighting a large amount of plastic deformation. Zoomed details of other subset areas (namely b, c, d and e in Fig. 12a and Fig.13a) are exhibited in order to deeply investigate the fracture characteristics. A typical dimpled zone and some equiaxed shear dimples surrounded by a shear lip show the typical ductile fracture behavior of the fractured samples at high temperature conditions. The rough surface caused by the large amount of plastic slip during tensile deformation is observable on the plastic deformation path and the micrographs near the shear lip of the sample are also illustrated. Different from the fracture surface of the sample tested at 500 °C, 600 °C tested sample involves a more distinct necking lip on the fracture surface as shown in Fig .13a. Highly correlated to the displacement of ~ 4.2 mm and ~ 5.4 mm for both 500 °C and 600 °C, respectively, see Fig. 4, this fractography observation proves, from micro scale aspect, that the ductile behavior is more pronounced for the specimen tested at higher temperature.

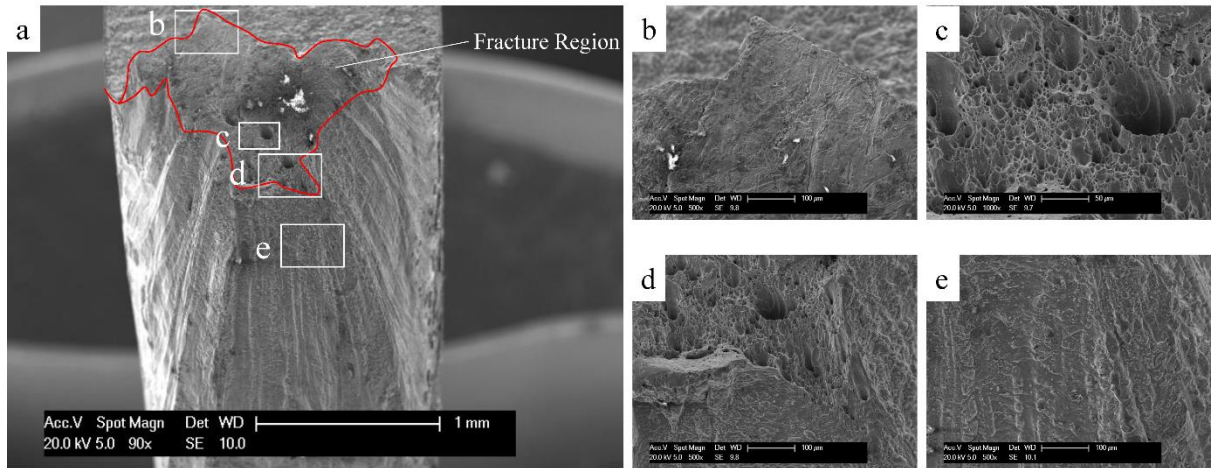
Fig. 13. Scanning electron micrographs of fractured specimens tested at 600 °C showing (a) the overall fracture morphology and (b-e) zoomed details of the local fracture features.

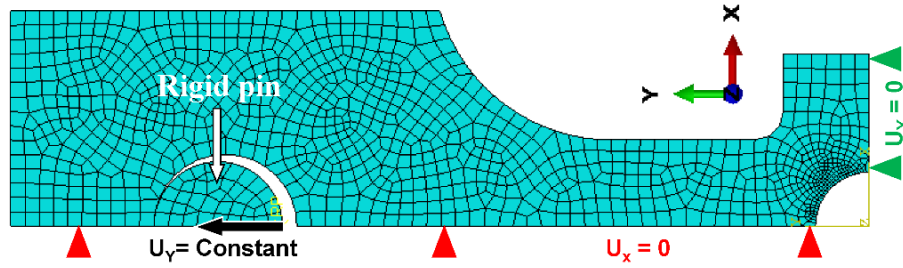
Fig. 14. FE model showing the mesh properties and boundary conditions ($U_y = 1.8\text{mm}$ for the 500°C test and $U_y = 2\text{mm}$ for the 600°C test) used for comparison with the experimental DIC results. Two symmetry conditions were considered with a sample quarter body modelled.

A quarter of the specimen was considered for the FE analyses as indicated in Fig. 14. The loading pins were modelled by a rigid body while a friction free contact was considered between the pins and the specimen holes. The contact between the pin and the specimen was assumed as standard surface to surface interaction where the outer surface of pin was the master surface and the inner surface of the specimen hole was the slave one. A constant displacement loading was applied in the Y-direction at the pin reference point in order to simulate a similar experimental protocol, for which the magnitude was set at 1.8 mm and 2 mm for both the 500 °C and 600 °C test temperatures, respectively. The 3D FE model mesh consisted of 4979 C3D8R elements with 8-noded linear brick, reduced integration, and hourglass controlled.

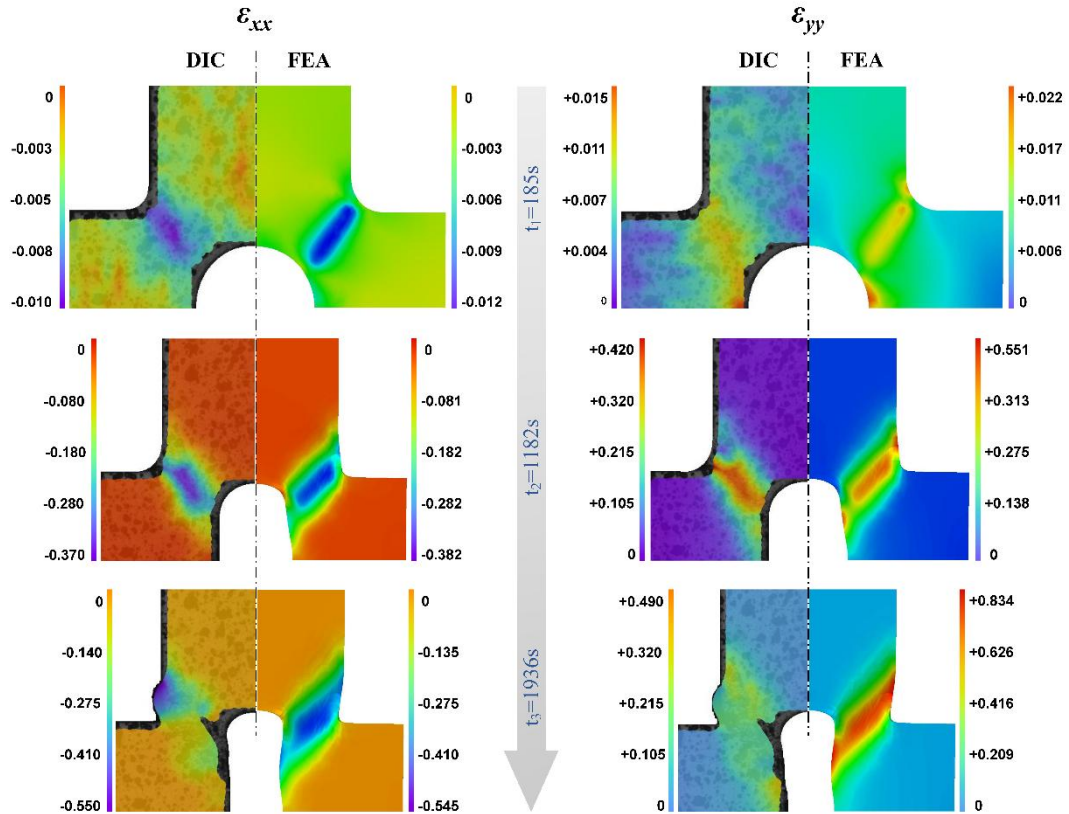
Fig. 15. Comparison of the DIC (left) and numerical (right) strain contours at 500°C test temperature.

Transverse and longitudinal strain patterns of the ROI obtained by DIC measurement and FE analysis are presented and compared in [Fig. 15](#) and [Fig. 16](#). For both 500°C and 600°C investigated temperatures, the spatial-temporal strain distributions and magnitudes were found to be in good agreement, revealing that DIC data trends were consistent with the FE simulation results. The strain localization zones for both experimental and FE data were almost identical even on an atypical strain concentrations area. However, an important difference in the strain magnitude was reported for the longitudinal strain component at the last stages of the loading. This difference may be attributed to the error accumulation of the loading rig, inaccuracy of the DIC measurements, inhomogeneous character of the investigated specimens and/or limitations of current FE model. [Fig. 17](#) shows a comparison of the longitudinal strain plots for both DIC and FE analysis on positions extracted from the same line as introduced in [Fig. 5b](#). The FE simulation results show strain magnitudes that were mostly higher than those of the DIC measurements especially for the high strain locations. Although the magnitude differences are not ignorable, it can be inferred that this methodology provides a good quantitative validation of the DIC measurements at high temperature conditions.

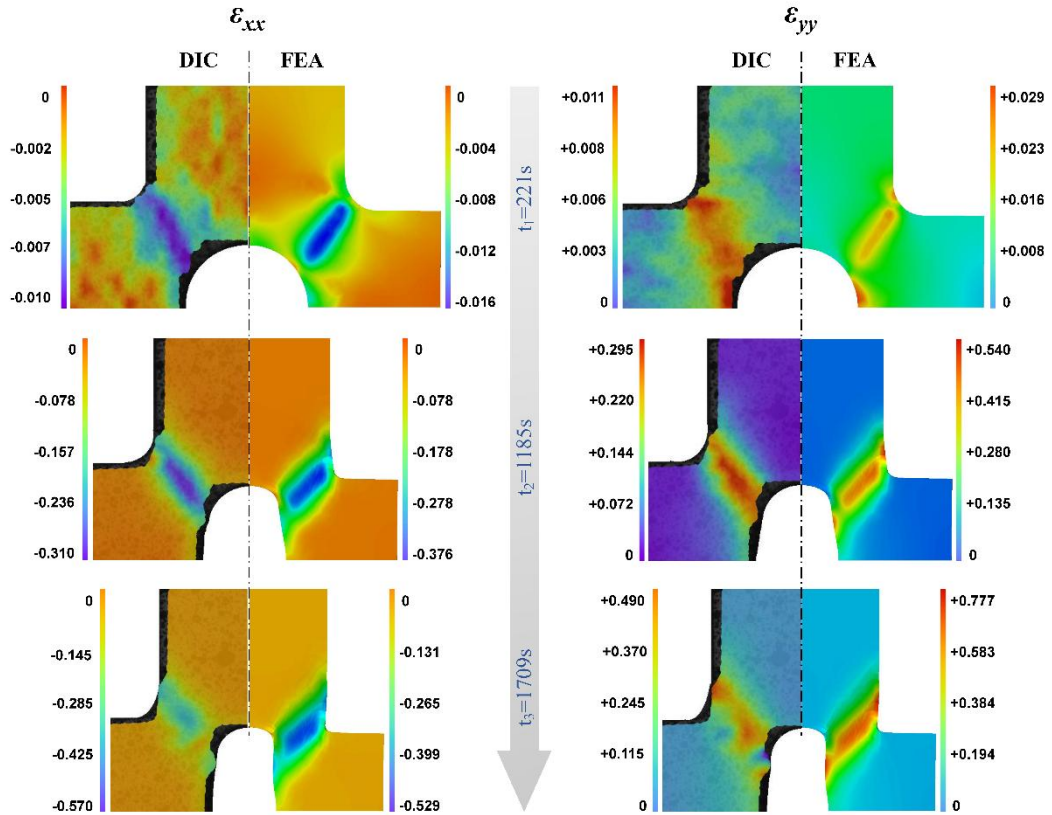
Fig. 16. Comparison of the DIC (left) and numerical (right) strain contours at 600°C test temperature.

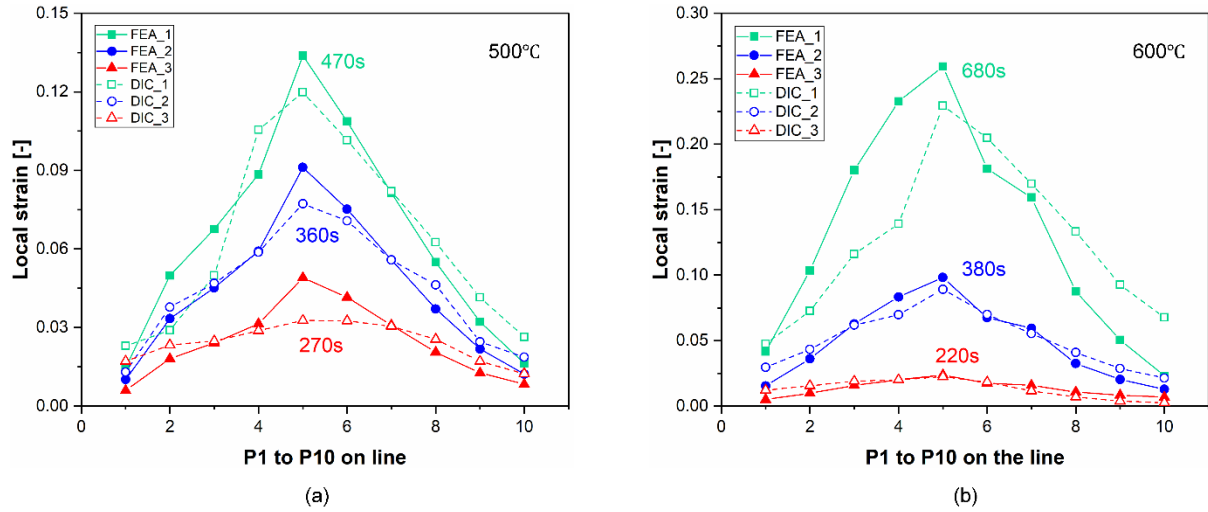
Fig. 17. DIC and FEA longitudinal strain profiles on positions extracted from the same line P1 to P10 (see Fig. 5b).

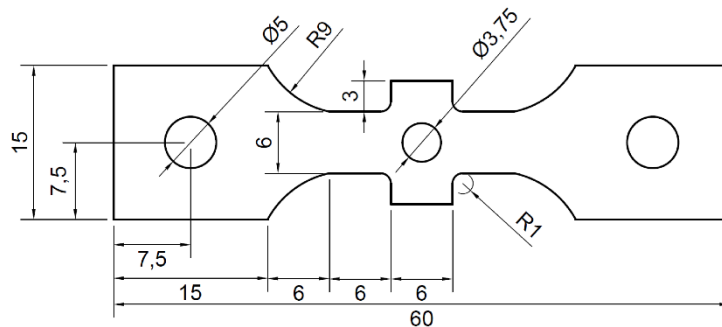
Fig. 2. Specimen configuration (All dimensions are in mm, the thickness is set at 2 mm).

Many structural components possess geometrical features such as holes, corners or gaps that are necessitated by design to accommodate fasteners, joints, or for weight reduction. Under the influence of combined thermal and mechanical loads, such stress concentration sites may become initiation sites of void nucleation and fracture [30]. The local strain fields can be highly inhomogeneous in such biaxial, or in general triaxial, stress states [36]. Hence, specimens with a hole of $\varnothing 3.75$ mm at the central part and symmetrical protrusions of 3 mm on both extremities were designed and tested under high temperature tensile loading. The holes of $\varnothing 5$ mm on both sides were machined to satisfy the loading pins' requirement. Dimensions of the specimen are shown in Fig. 2.

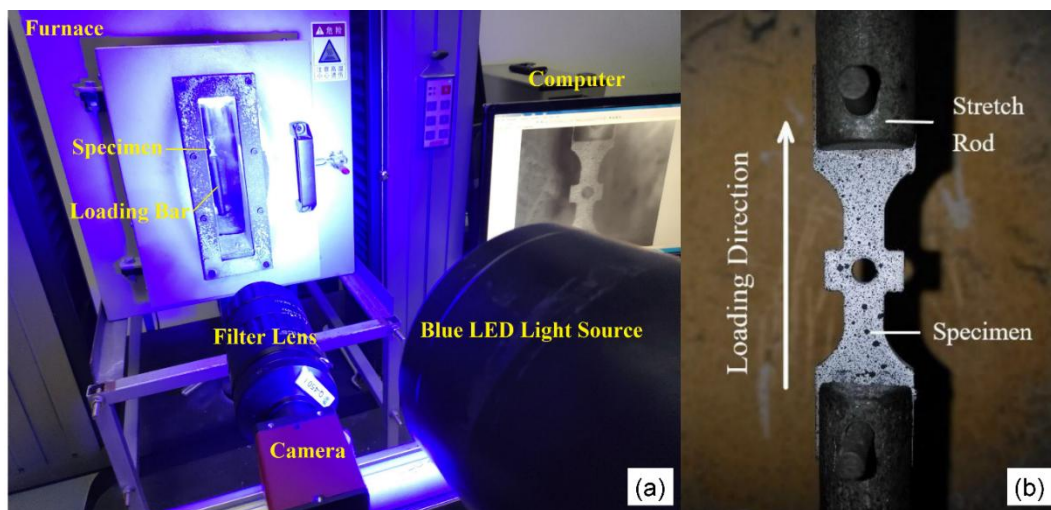
Fig. 3. (a) The experimental setup showing the digital camera used for the DIC measurements, a high temperature furnace, a narrow band pass filter lens of $441 \text{ nm} \pm 10 \text{ nm}$ bandwidth and a monochromatic light source with the wavelength of $440 \text{ nm} \pm 20 \text{ nm}$. (b) The test specimen sprayed with a black/white speckle.

Different techniques are available in the literature to generate the high temperature resistance speckle for DIC [38]. In order to increase the contrast between the speckle pattern and the background, the specimens were first covered with white inks and then, after a drying process, the black ink speckle pattern was sprayed. The pretreatment was necessary for a better adhesion of spray painting for high temperature environments. The gauge part was first ground with coarse grind paper to increase its surface roughness. After cleaned the grease on the surface and rinsed with water, the specimens with white painting were placed in a furnace for 2 hours at 200°C in order to make the white paint solidified completely. The same procedure was repeated for the black one. Furthermore, the white uniform ink layer serves to avoid "shiny" surface, sensitive to the light reflection [39]. The example of obtained speckle pattern for the test specimens is presented in Fig. 3b.

The experimental setup is shown in Fig. 3. It consists of a high temperature furnace

equipped with a glass window, a charged-coupled-device (CCD) camera (AVT Stingray F-504B), a band-pass filter ($441 \text{ nm} \pm 10 \text{ nm}$), a blue LED light source and a stretching machine. The furnace was employed to monitor the test temperature up to $600 \text{ }^{\circ}\text{C}$. The detector of the camera was operated with a 2452 by 2056 pixels window size and $19 \text{ }\mu\text{m}$ pixel size. The camera was positioned on a tripod approximately 1 m from the specimen surface. It was fixed and kept perpendicular to the gauge part during the loading in order to collect reliable visible images. The camera frame rate was set at 4 frames per second to obtain enough sampled data while the integration time was set at 50 ms . The blue LED light source with a wavelength of $440 \text{ nm} \pm 20 \text{ nm}$ was used to provide quasi-monochromatic illuminations.

The test specimens were fastened to a cylindrical and slender high temperature stretch rod which passes through upper and lower walls of high temperature furnace by high temperature metal pins, as shown in Fig. 3b. The specimen was heated from ambient temperature to the investigated temperatures ($500 \text{ }^{\circ}\text{C}$ and $600 \text{ }^{\circ}\text{C}$) with a rate of $25 \text{ }^{\circ}\text{C}/\text{minute}$, and then exposed to the test temperature for a half hour prior to the mechanical loading. In order to remove the gap between the test sample and the stretching rod, a preloading was applied to capture the reference image for DIC computations. Then monotonic tensile test under constant strain rate of $0.1\% \text{ s}^{-1}$ were conducted until the macroscopic fracture.

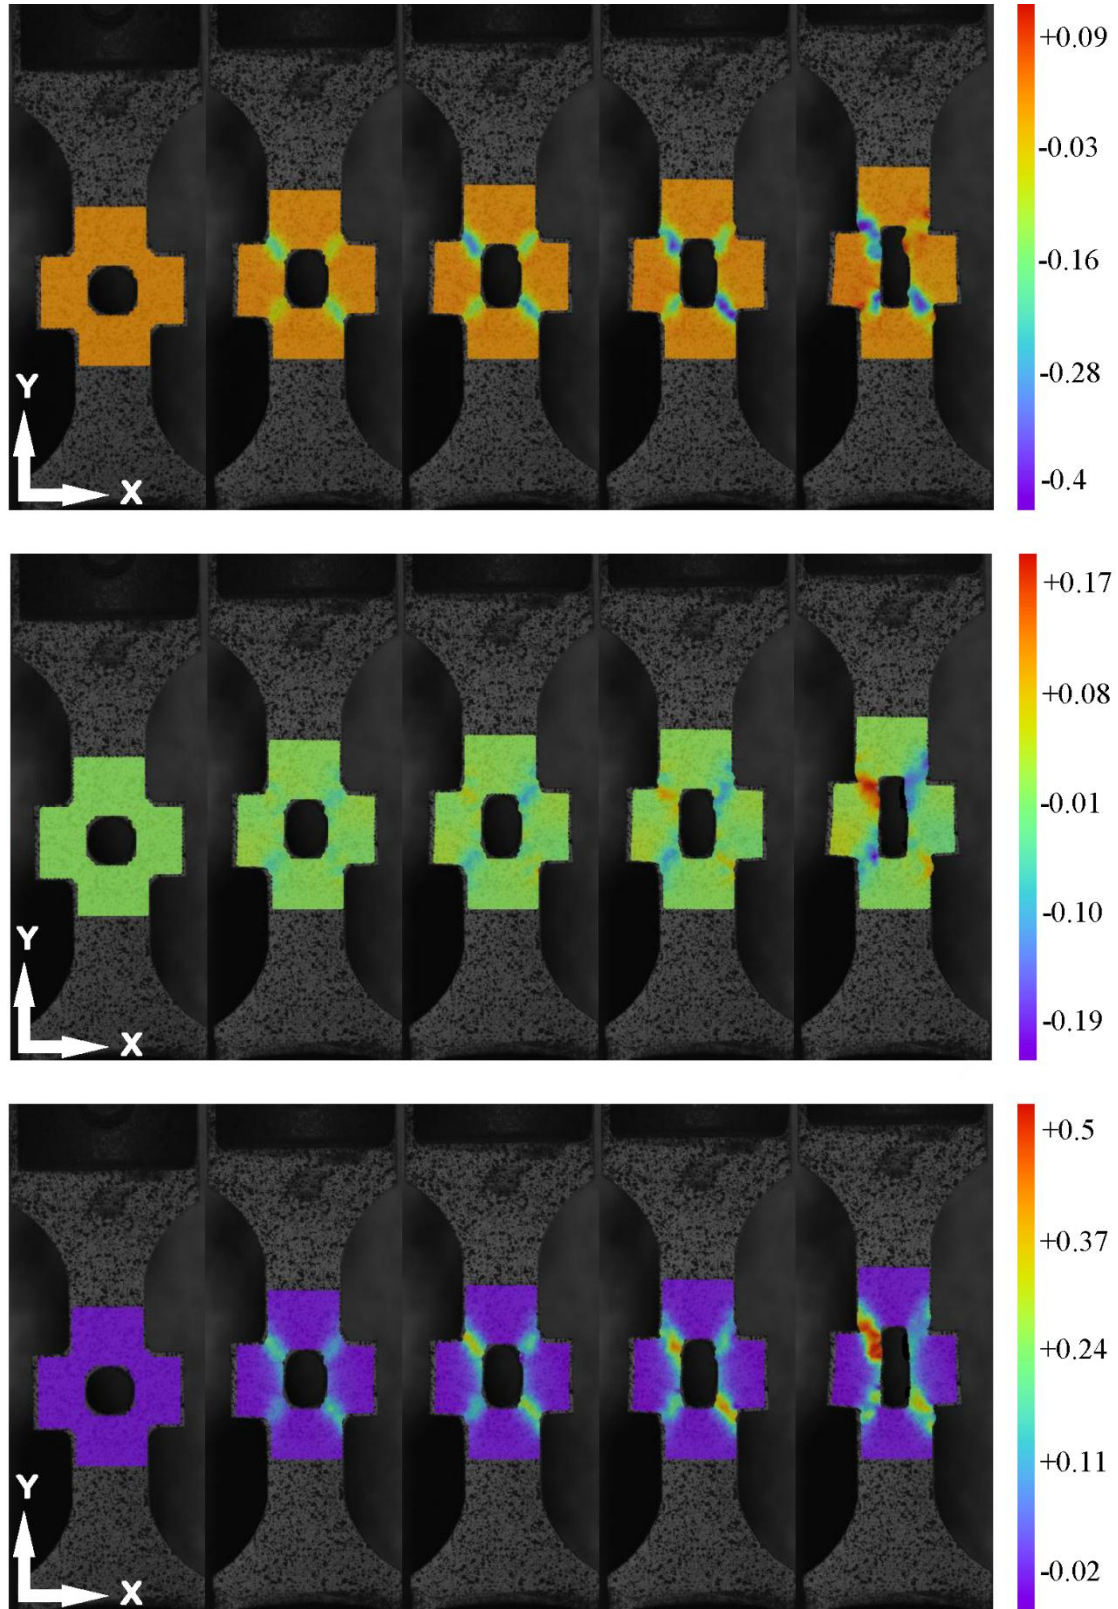
Fig. 6. 2D maps of the transverse strain, ϵ_{xx} (top), shear strain, ϵ_{xy} (middle), and longitudinal strain, ϵ_{yy} (bottom) at: the very beginning of the test ($\tau_1=0s$), intermediate times ($\tau_2=810s$, $\tau_3=1060s$ and $\tau_4=1310s$) and the last stage before the macroscopic fracture ($\tau_5=1877s$). These results were extracted from measurements performed under the 500 °C test temperature.

Fig. 6 and Fig. 7 show the full-field strain maps for the investigated FV566 tensile specimens at both 500 °C and 600 °C test temperatures, selected at different specimen life stages ($\tau_1, \tau_2, \tau_3, \tau_4, \tau_5$). The spatial resolution was set at 20 μm per pixel. The results show a precocious and gradual development of strain localization zones. These zones were clearly visible for all the strain components (longitudinal, ϵ_{yy} , transverse, ϵ_{xx} , and shear, ϵ_{xy} , components). For 500 °C condition, at the very beginning of the loading, the spatial heterogeneities were less visible as indicated at τ_1 . These heterogeneities started to intensify at the following life stages till the macroscopic failure (see Fig. 6). It is worth noting that the painting near the strain concentration zones (where the hole is located) eroded due to the high temperature and large displacement exhibited by the test specimens. This results in inaccurate strain estimate at the last stages before the macroscopic fracture. Note that most of the observed hotspots were located around the specimen hole at the ROI due to the geometry singularity. Nevertheless, the strain field contours show that the strain concentrations were not perfectly symmetric. For the transverse strain, the top-left and the bottom-right sides of the hole were slightly intensive than these on the top-right and the bottom-left sides. However, at the instant τ_5 , some of strain localization zones were significantly less intensive than others. This is probably caused by inhomogeneous features of the investigated specimen and/or the inaccuracy of the measurements. The spatial distributions of the longitudinal strain component on the top-left side of the hole were more intensive than these on the bottom-right side. From a statistical point of view, the absolute values of both the minimum and maximum longitudinal strain were almost the same at the

very beginning of the loading, highlighting the homogeneous character of the investigated gauge part. However, with the increase of the load, the absolute value of the minimum longitudinal strain was about thousand-fold lower than the maximum longitudinal strain. For the shear component, the spatial strain concentrations were mostly located on the top-left and top-right sides of the hole. As expected, the localization patterns seemed to progress preferably according to 45° angle (with a shape of “X” letter). At 600 °C (see Fig. 7), the strain localizations for the transverse and longitudinal components showed similar patterns as those obtained for the 500 °C condition while the higher values of the shear strain were appeared at top-right and bottom-left side with a shape of “/” from where sample fractured finally.
