Title: High temperature strain heterogeneities tracking within hole-specimens of FV566 turbine steel via digital image correlation

Keywords: High temperatures; Digital image correlation; Strain heterogeneities; FV566 steel; Finite element analysis

Corresponding Author: Mr. Jianguang Bao,

Corresponding Author's Institution: University of Nottingham

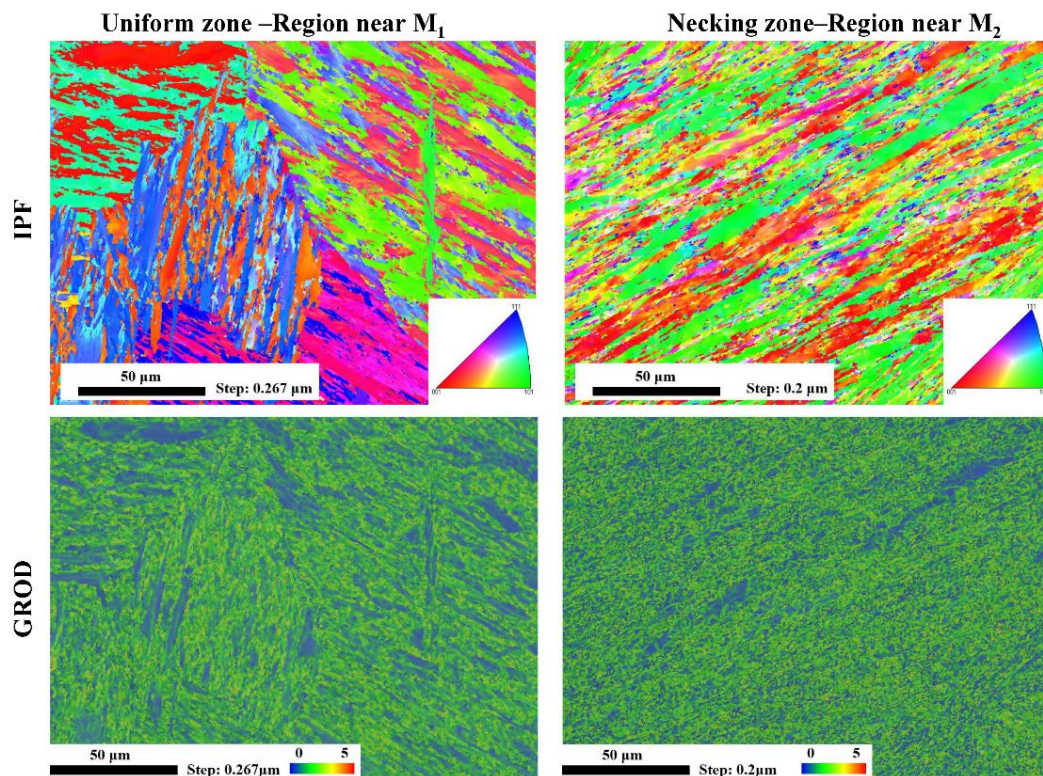
Fig. 10. EBSD results of the uniform M_1 (left) and necked M_2 (right) zones extracted from 600 °C test fractured sample.

Two areas from the ruptured surface, close to the DIC time dependent analysis regions (i.e. M_1 and M_2) were further investigated to highlight the microstructure evolution. Extensive EBSD examination has been conducted and the results are presented in Fig. 10. The inverse pole figure (IPF) images show that the pre-existing martensitic microstructure was significantly distorted along the principal loading direction, accompanied with the formation of a finer martensitic substructure. In addition, the presence of sub-block boundaries at 5 to 6 degrees in the as-received material as well as the variation of sub-block boundaries and the frequency of the low angles boundaries are highlighted in Fig. 11. The findings suggest that the dislocation slip could be the dominant deformation mechanism for the material, since dislocation slip activated by the high temperature and tensile loading may generate a large number of dislocation accumulations, which can contribute to the formation of the low angles boundaries [40]. As is well known, dislocation movement in the

Additionally, **the grain reference orientation deviation (GROD)** parameter was introduced to compare the local crystal deformation in two separate zones of the fractured specimens. **It is proven to be linearly related to the nominal plastic strain under both tension and creep condition [41].** The higher value of GROD extracted from the necked zone implies that the plastic deformation in the necked area is larger than that in the uniform zone away from the fracture area, which is consistent with the aforementioned DIC measurement results. As is observed in Fig. 6 and Fig. 7, significant strain concentration was observed around the necked area due to the geometry singularity of the tested specimens. The strain concentrations in the necked area result in the deformation heterogeneity and microstructural rearrangements of the FV566 specimen at high temperature tensile conditions.

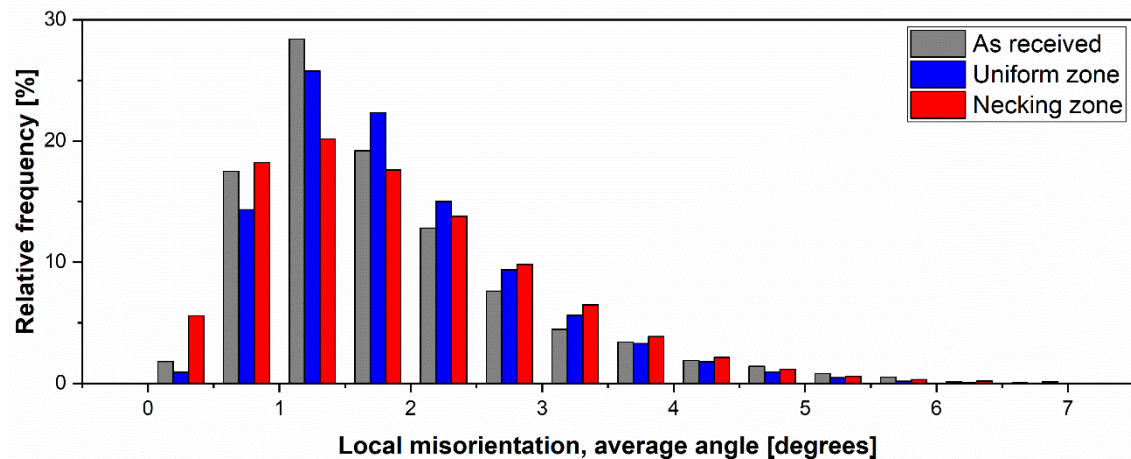
Fig. 11. The distributions of the misorientation angles across the lath and sub-block boundaries for the as-received material and uniform/necked zones of fractured sample.

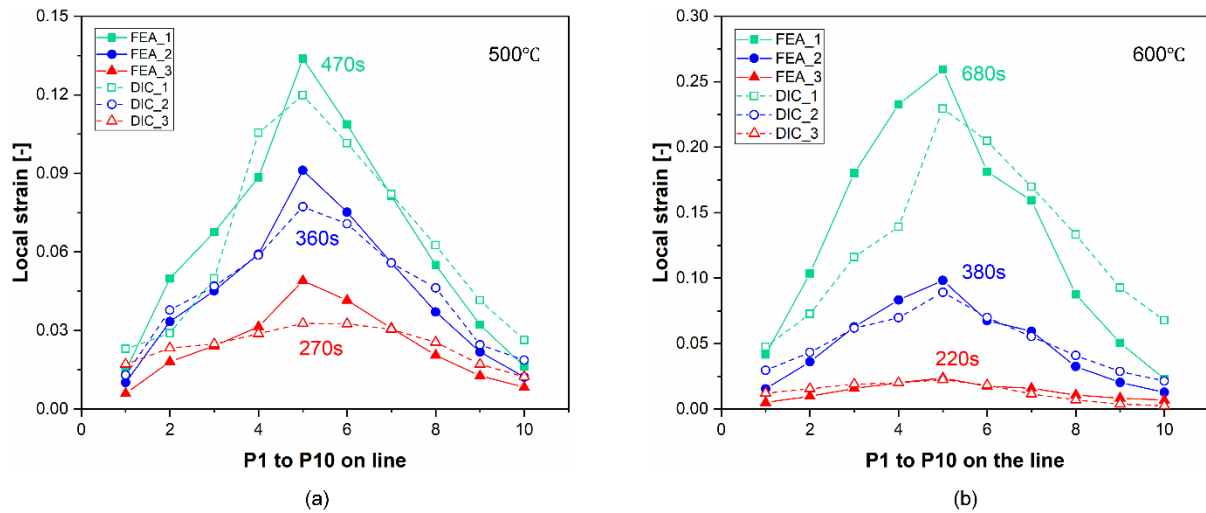
Fig. 17. DIC and FEA longitudinal strain profiles on positions extracted from the same line P1 to P10 (see Fig. 5b).

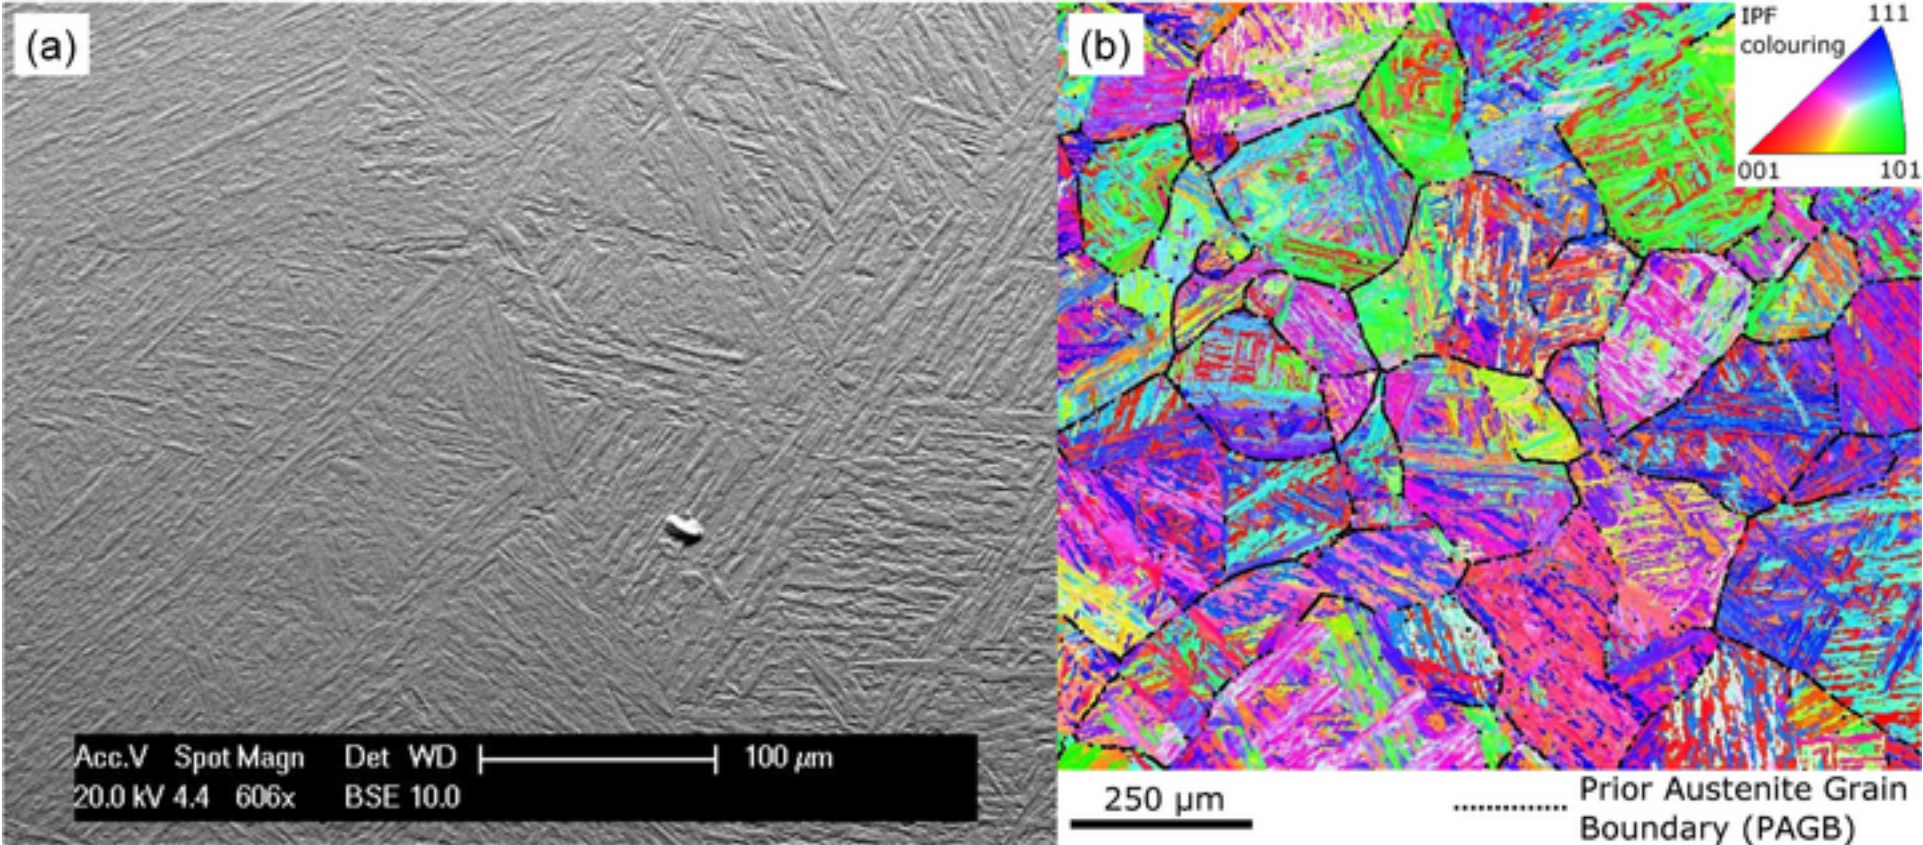
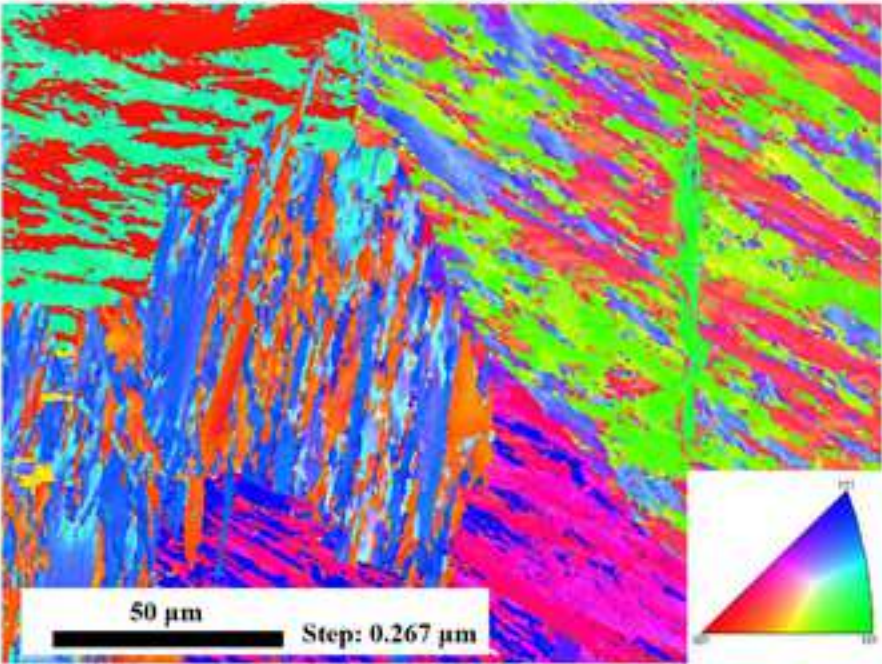
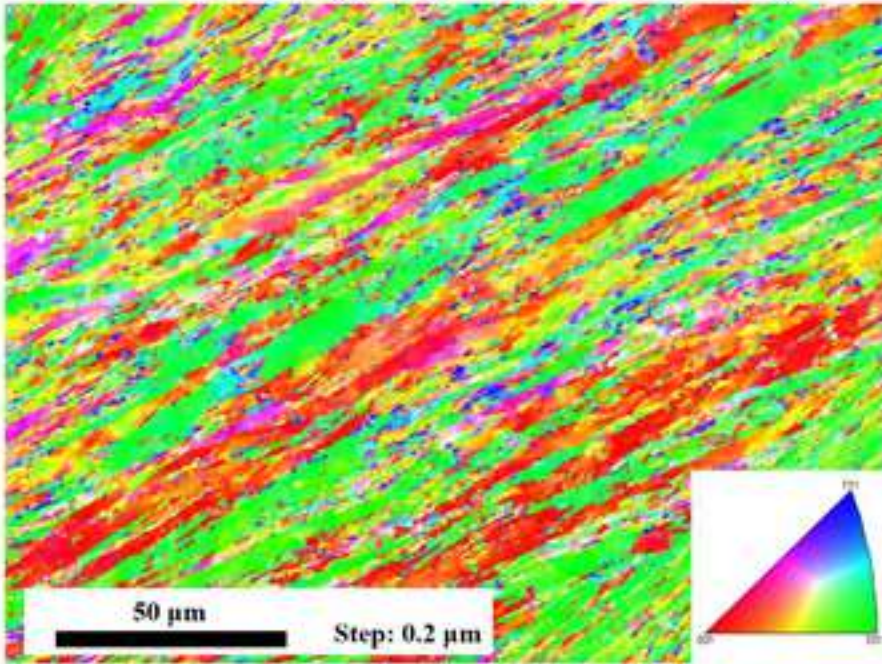
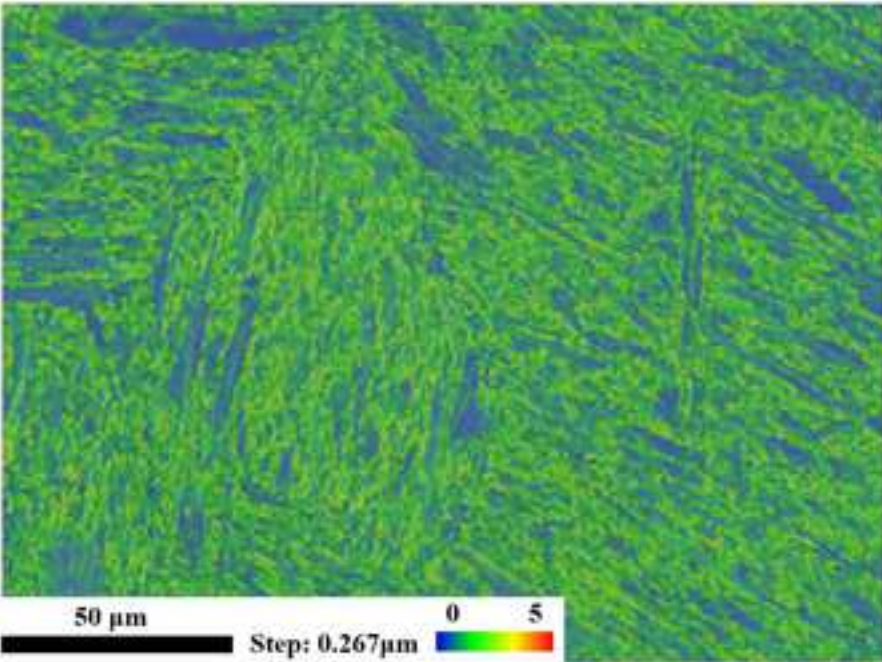
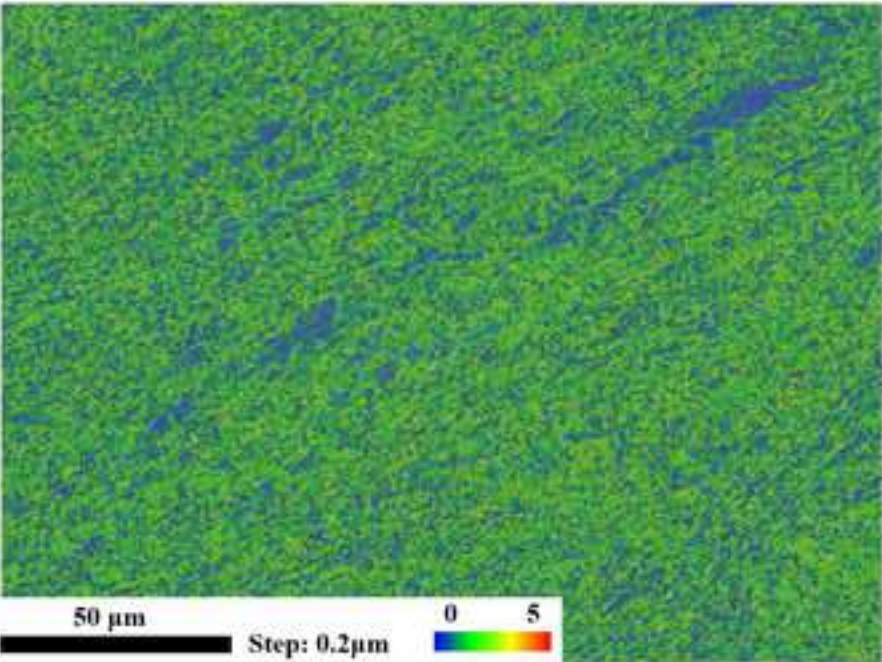
IPF

Uniform zone –Region near M_1

Necking zone–Region near M_2

GROD
