Advanced documentation technologies for people-centred preparedness and *re-construction* in Bela, India

Disaster
Prevention and
Management: An
International
Journal

Keywords Community engagement, Bela, Earthquake risk management, Re-construction, Digital documentation, Built heritage

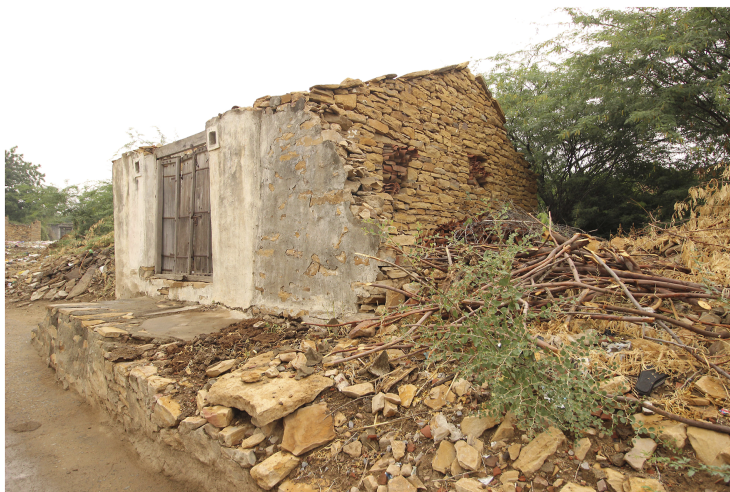
Plate 1.
A dwelling damaged
by the 2001 Bhuj
earthquake in Bela,
India. November 2021

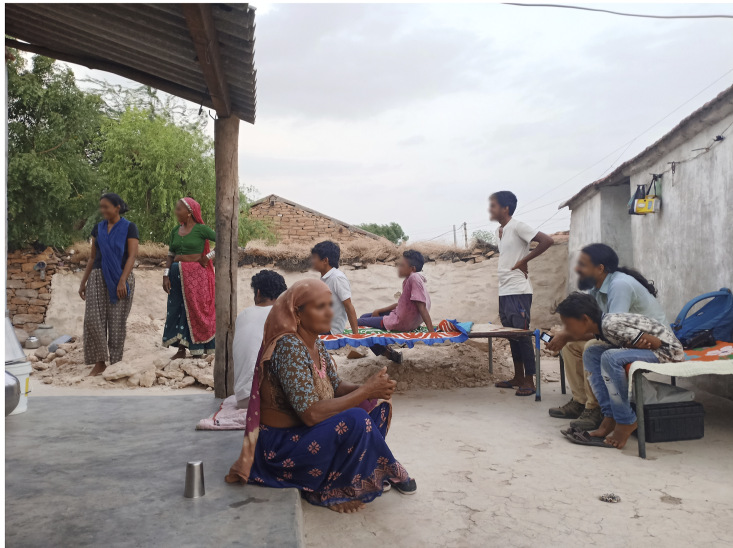
Plate 2.
Team members explain the research's purpose to the residents of Bela and the 3D laser scanner capturing data on-site. July 2021

The methodology was informed by previous research, adapted locally, and implemented through an institutional collaboration between the universities involved and the Hunnarshala Foundation. This regional non-profit organisation works closely with communities to improve construction practices (see acknowledgements). CEPT University collected data, while this

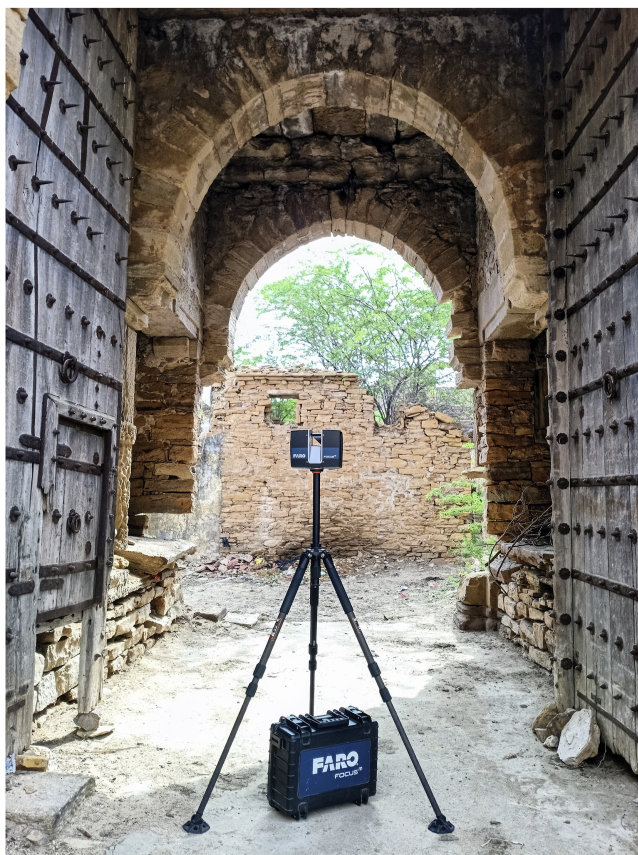
Plate 3.
3D laser scanner
capturing data on-site.
July 2021

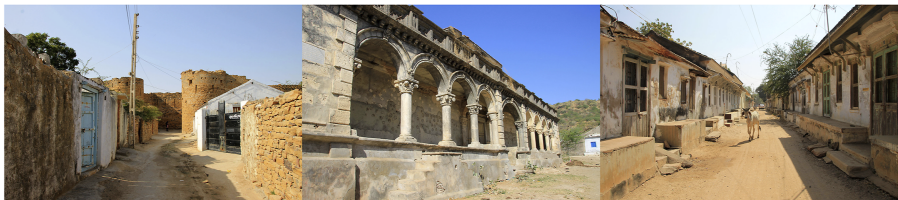
Plate 4.
Glimpses of the construction typologies in three of the 11 potential villages identified during the reconnaissance field trip. From left to right: Bela, Roha and Moti Khakhar.
February 2021

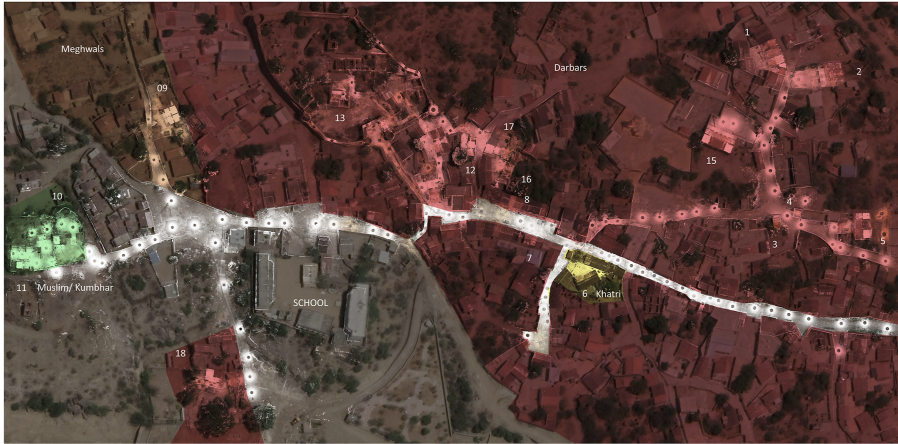
Plate 8.
Plan of Bela, mixing the aerial photograph with the 3D laser-scanned area (in white), indicating the casts present in the central area of the village and the buildings documented. 2021

As mentioned earlier, the first approach to community engagement was made during the reconnaissance trip to inquire regarding the residents' interest. The second approach consisted of semi-structured interviews conducted in preparatory stages and during the 3D data capture. The interviews were mainly associated with the 18 buildings interiorly documented in 3D (Table 1). The interviewees represented five traditional neighbourhoods in the village, each corresponding to one specific community, most located in the historical area (Plate 8).

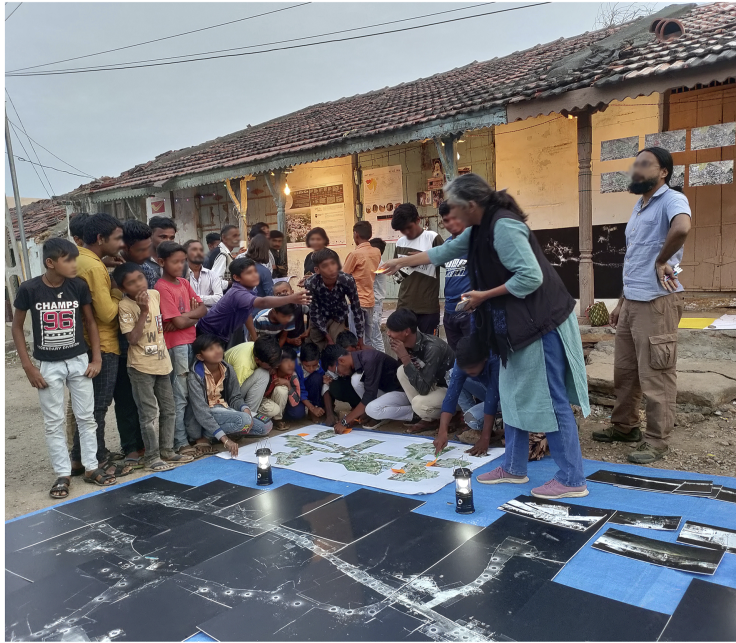
Plate 12.
Residents identifying known buildings on the aerial map of Bela at the Market Square exhibition. November 2021

their homes within their broader village context. Then, they related the map to the laser scan data images, orienting their understanding through their homes and other prominent village landmarks identified using the aerial map (Plate 12). This is relevant as a starting point when working with historical areas; a greater understanding of the representations can be achieved if starting with what is known and familiar.

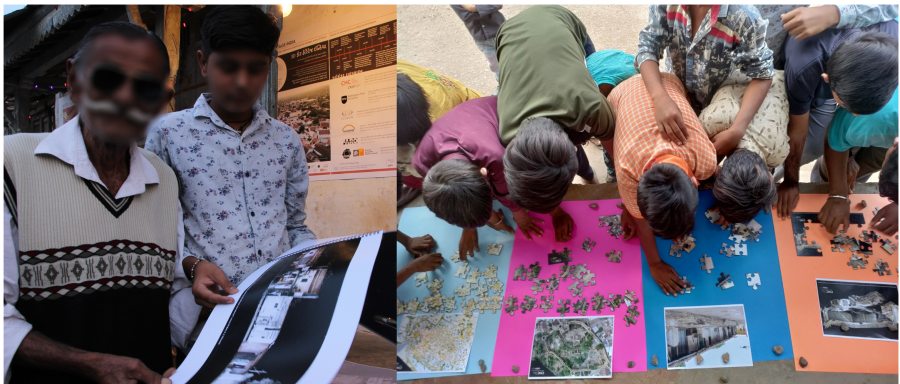
Plate 13.
Discussing the 3D laser scanning output with the local communities through booklets compiling the records of each house (left) and children engaging with jigsaw puzzles (right) in the exhibition at Bela. November 2021

For each of the 18 buildings interiorly surveyed, a series of architectural projections from the data were created: 3D views, plans, elevations, sections, and aerial views, compiled in a booklet that was given to each owner or carer of those buildings and used to have conversations with them about the record, the possibilities for understanding the spaces and the potential risks associated in some of them (Plate 13). When not present in the activities, the team delivered the booklet to as many surveyed houses as possible in the local community for them to see the records of the village and their own homes, discuss them and keep a physical copy for future reference, understanding that digital versions are inaccessible to most people in Bela. In this way, it was intended to address an imbalance observed in the first engagement through interviews, where men came forward as family leaders and representatives, and the Darbar caste was over-represented in comparison with other groups.

Visual representation is key for a more direct apprehension and interpretation of the record, which, combined with playful methods, can further stimulate engagement. In this case, jigsaw puzzles worked as a tool to capture the children's curiosity (Plate 13). They were a challenge to the children, as who could solve them in the least amount of time. They started seeing a photograph, a map, or 3D point cloud data and relating that information spatially to the rest of the village map exhibited and the other pin-up sections to identify the data they wanted to understand. In some critical cases, such as buildings with severe damage yet still inhabited, the representations were used to have additional conversations with the occupants in further visits to the village to suggest safer internal arrangements and possible evacuation routes in the event of an earthquake. For example, in the case of a Darbar temple with a damaged wall posing risk (Plate 14), temporary alternative sleeping arrangements suggested
