Procedia Engineering 155 (2016) 8 - 17

International Symposium on "Novel structural skins - Improving sustainability and efficiency through new structural textile materials and designs"

# MULTITEXCO - High performance smart multifunctional technical textiles for tensile structures

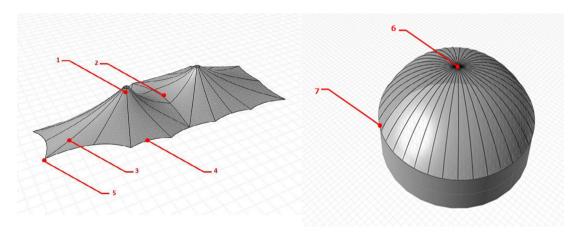
Fig. 1: Proposed positioning of the various sensors for tensile structures, see table 1 for respective sensing parameters left: double curved structure, right biogas dome

Sensing parameter	Technology	Applicability	Status	Positioning *
Crack propagation	Conductive tread	In seams	Need for large scale testing facility	3
Fabric strain	String sensor	Near connection point	Proof of concept	5
Pressure	Piezoresistive	Localized on areas susceptible for ponding/snow load	Lab demonstration	2
Vibration	Piezoelectric	In keders, edges	Testing on demonstrator structure	4
Misuse	Thermochromic	On seams, inside	Lab scale coating, localized coating on seams is preferred	1
	Thermoelectric	Distributed point sensing	Lab demonstration	1
	Biogas sensing	Patch inside structure	Lab scale demonstration	
	Ammonia			6
	$H_2S$			7

From the various sensors mentioned above, it is clear that correct positioning is crucial for reliable monitoring. Fig. 1 illustrates the most effective position of the various sensors in structural health monitoring of tensile structures.

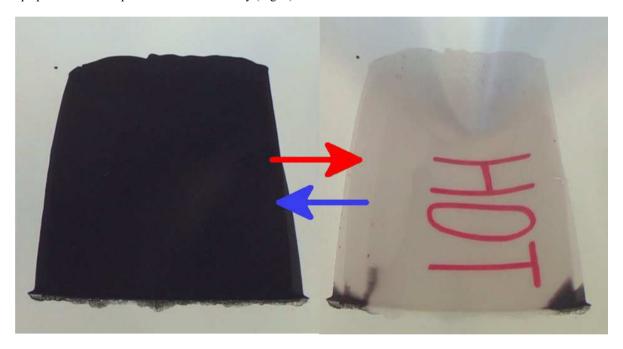
Fig. 2: Textile coating with thermochromic pigments. The coating becomes transparent when submerged in hot water (70°C) (red arrow) and returns black when cooling down (blue arrow).

Thermo responsive coatings allow for a rapid visual inspection of the structure and are recommended in projects where the structure can be easily inspected from underneath. The thermo responsive coating is an acrylate binder with a water soluble reversible thermo chromic pigment with desired threshold temperature in order to be personalized for each specific application and maximum temperature. For the tests carried out for MULTITEXCO, the sensor is designed for a maximum temperature of 65°C, once reached that value the pigment will change from its opaque color to transparent in a reversible way (Fig. 2).

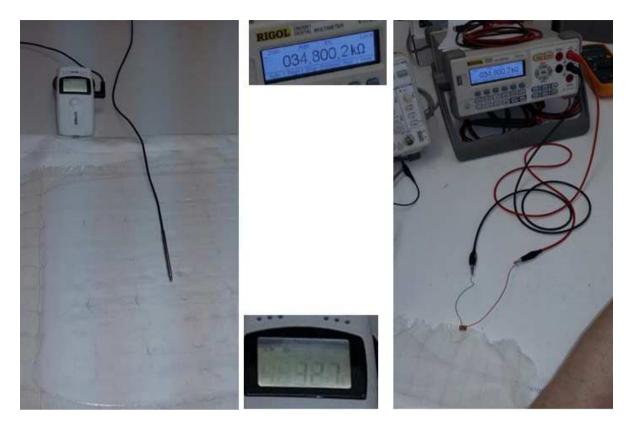
Fig. 3: Electronic sensor integrated in PVC coated polyester fabric for the monitoring of the operating temperature.

In contrast to the temperature changing color above, the integrated thermo-electric sensor can be used as an independent alarm unit. The miniature thermo resistive sensor is integrated in the fabric and connected with copper leads that run in the fabric towards the rim. These copper leads have been integrated in the fabric during weaving. The sensor should be placed in a well-considered area during confectioning and the leads should be marked at the fabric rim to ease later installation of the readout. The leads are connected to a standard temperature monitor with PT100 functionality. Due to the very thin and long leads, there may be a temperature bias recorded. It is therefore advised to select a readout unit with bias compensation capabilities (Fig. 3).

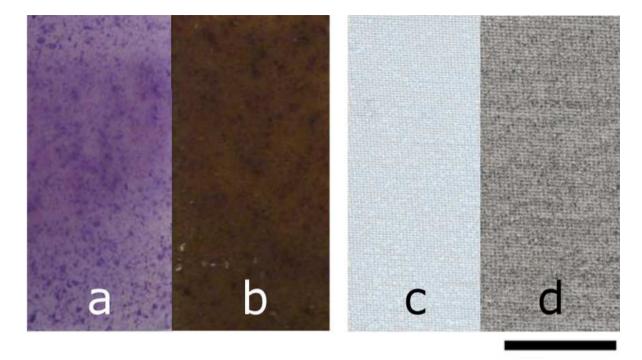
Fig. 4: Chemical responsive coatings with irreversible colour change: left ammonia, right hydrogen sulphide, a and c are before exposure, b and d after exposure. Scale bar is 1 cm.

The use of chemical sensors in tensile structures may seem farfetched at first glance. However, fabrics for tensile structures are sometimes used in situation they are not really designed for. One may think about for example biogas domes. [8] In such fermenters, high levels of hydrogen sulfide and ammonia may accumulate and attack the fabrics [9]. If the fabrics used in such construction are not designed for these harsh conditions, the corrosive gases will deteriorate the materials leading to hazardous situations. [10] Is such event, the fabric manufacturer may find himself in aggravating warranty dispute. The use of irreversible chemical sensors may therefore be very useful in identifying exposure events to reactive biogases. If the sensor signals gas exposure on fabrics not developed for such applications, warranty can be waived more easily. Two sensors have been developed within the MULTITEXCO project: one for the detection of ammonia, and one for the detection of hydrogen sulphide. Both show an irreversible colour change upon exposure (Fig. 4).

Although the sensors are stable, it has proven difficult to set a precise detection limit. The accuracy of the chemical sensors is reported to be around 0.1-4% for H<sub>2</sub>S and 0.5-30% for ammonia [11]. As a result, we do not suggest using both sensors for analytical purposes and only the presence of potentially dangerous levels of toxic gases can be detected. However, the current sensitivity is high enough to signal misuse of fabrics not suited for biogas fermenters.

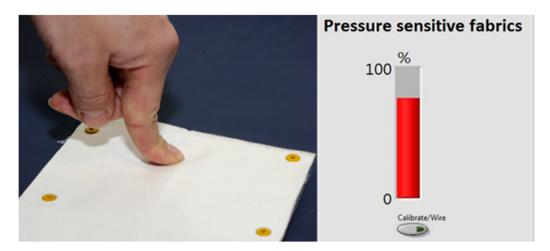
Fig. 5: Pressure responsive sensor integrated in PVC coated polyester fabric (left), response on acquisition software (right)

The flexibility and elasticity of textiles permit designers to create very attractive forms and organic shapes for tensile structures. [5] These unique properties of textiles as a building material are also responsible for a very complicated and iterative modeling process. Because both form and shape of the structure change when forces are applied, modeling tools based on rigid structures are no longer valid. Every change in applied force on the structure therefore requires a new loop of form finding and a new loop of calculations in order to obtain strain and tension distributions. [12] Especially for smaller structures with a limited modeling budget, it can be troublesome to avoid snow pile-up or water ponding. The pressure sensors integrated in the fabric developed within the MULTITEXCO project allows monitoring of critical areas of the structures susceptible of overloading (snow, water ponding, etc). The sensors are integrated in the fabric and can be used for triggering an alarm in case of an emergency, or help to improve structure design in the development phase. The sensor is a piezo resistive film with control leads are soldered to thin copper wires. Similar to the electronic temperature sensor mentioned above, the copper wires were previously integrated in a polyester fabric during weaving to fit the pin-out configuration of the pressure sensor. The fabric with pressure sensor is subsequently laminated on the fabric used for tensile structures and embedded in a PVC layer. In this way the sensor is well protected from the surroundings and the connector leads reach the fabric rim making both the sensor and the leads almost invisible (Fig. 5).

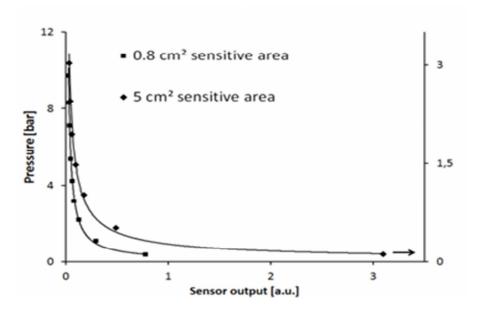
Fig. 6: Calibration curves of small and large area sensors.

The calibration of the sensors allows for calculating the load exerted on the fabric by measuring the sensors resistivity. For architectural applications the sensor can measure applied loads form 0 to 500mbar for low pressure sensors. However, the sensors are very sensitive in the lower third of the detection window, which makes them useful for snow load ( $\pm$  1800 Pa) and water ponding ( $\pm$  3000 Pa) (Fig. 6).

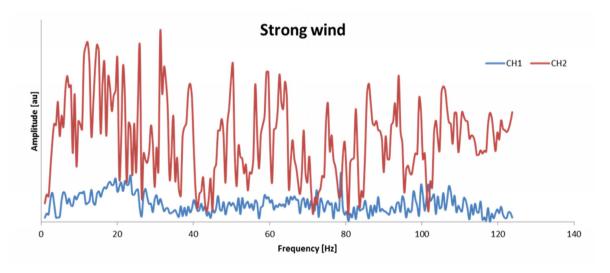
Fig. 7: FFT output of piezosensors on a tensile structure during strong wind load. Ch1: sensor positioned on a plain area, Ch2: sensors positioned at the fabric edge.

A set of preliminary tests carried out by MacoTechnolgy on a 1:1 scale mock-up allowed to investigate the main factors which can affect the reliability and the accuracy of the data recorded by the piezo electric sensors. The results indicate that a piezo sensor that is moving up and down will not provide a signal, for this reason it is very important to choose an appropriate location of the sensors (Fig. 7; Fig. 8). For this reason it is proposed to integrate a piezo coaxial wire in the keder of a tensile structure. In this way, the wire ends is fixed and fluttering will induce bending of the piezo wire. This will result in a clear electric signal which can be correlated to the vibration frequencies of the structure.

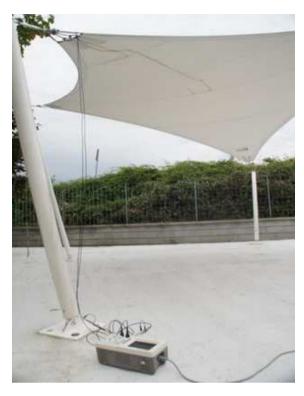
Fig. 8: Detail of the demonstrator for the calibration of the vibration sensors .
